# Fault Code: 631

## Exhaust Gas Temperature Deviation Low for Cylinder 2 - Data Valid But Below Normal Operating Range - Least Severe Level

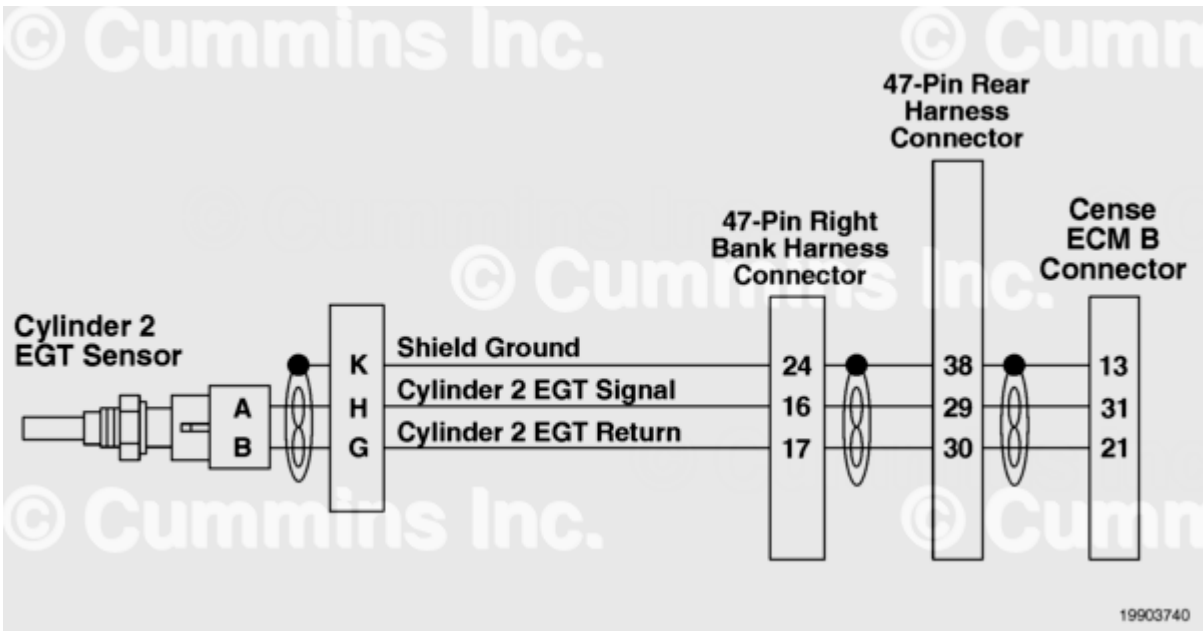
Exhaust Gas Temperature Sensor Circuit Cylinder 2 - QSK45 and QSK60 Engines

The exhaust gas temperature sensor circuit cylinder 2 monitors exhaust gas temperature and passes information to the engine control module (ECM) through the engine harness.

The exhaust gas temperature sensor circuit cylinder 2 for this fault code is located in the exhaust manifold at the cylinder head 2 to exhaust manifold interface.
