# Fault Code: 633

## Exhaust Gas Temperature Deviation Low for Cylinder 6 - Data Valid But Below Normal Operating Range - Least Severe Level

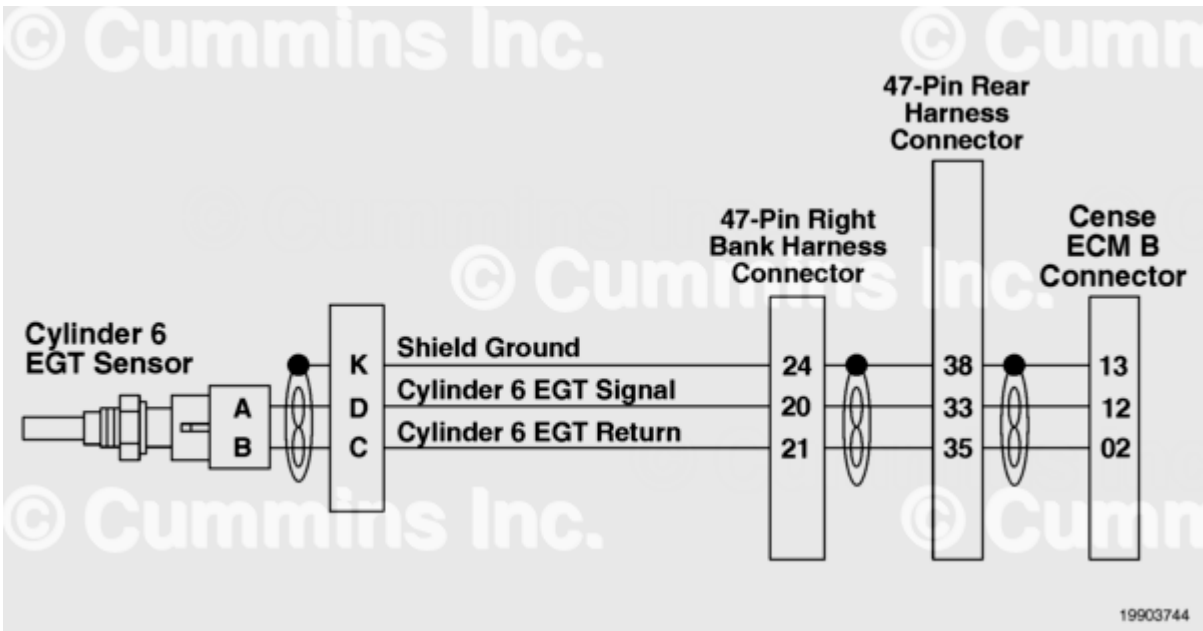
Exhaust Gas Temperature Sensor Circuit Cylinder 6 - QSK45 and QSK60 Engines

The exhaust gas temperature sensor circuit cylinder 6 measures the exhaust temperature of cylinder 6. The ECM monitors the temperature and compares it to the exhaust gas temperatures of other cylinders.

It is possible that the exhaust gas temperature sensor 5 volt supply can be open and a fault will **not** be set. If this happens, the temperature of the exhaust gas temperature sensor will read 474°C [885°F] for the entire bank of sensors connected to that exhaust gas temperature sensor converter. See the Engine Performance Troubleshooting Tree in Section TT of the QSK45 and QSK60 Service Manual, Bulletin 4021530, to troubleshoot this condition.

Possible causes of this fault include:

- Restricted aftercooler.
- Damaged, valves, rings, or piston.
- Injector damage.

Refer to Troubleshooting Fault Code t05-633. (/qs3/pubsys2/xml/en/procedures/81/81-t05-633.html)
