Service Bulletin Number: 4358564

Released Date: 06-dec-2013

Asbestos-Containing Gaskets on Cummins China Joint Venture Legacy Product

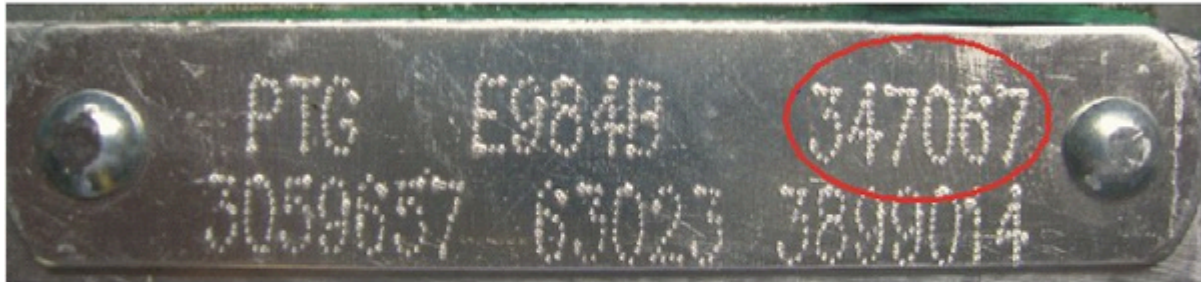
Typical PT™ Fuel Pump Dataplate from a China Sourced PT™ Fuel Pump

A sample of a typical PT™ fuel pump data tag, from a China sourced PT™ fuel pump, is included below for reference. The fuel pump serial number is the six digit number in the top right corner of the dataplate. The fuel pump with this dataplate was manufactured after the changeover to non-asbestos material.
