| Technical Service Bulletin: tsb100044 | Released Date: 04-May-2010 |
| Air Compressor Support Brackets Issue | |

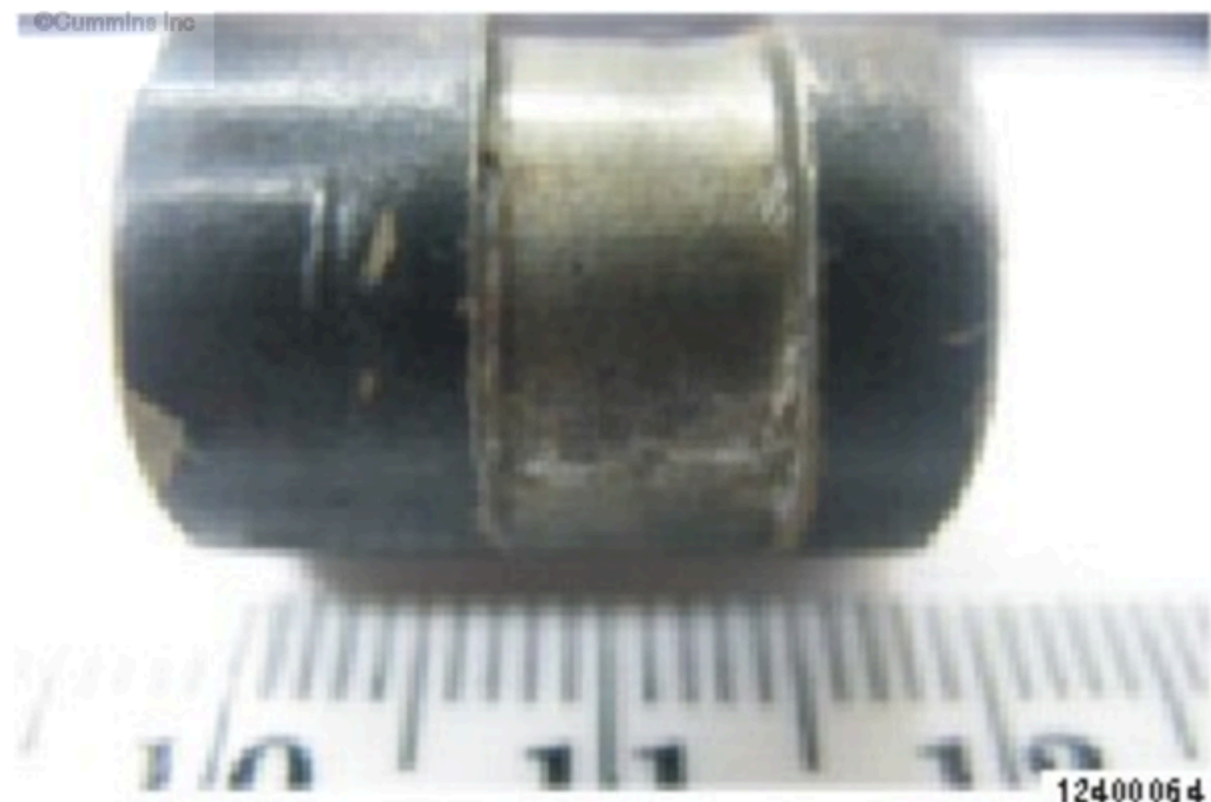
12400064

The issue is noted by wear or fretting between the sleeve and the holes in the brackets. This wear can cause the joint to become loose.

Cracking/breaking of the welds has also been observed.

Bracket cracking/breaking or wear can cause progressive damage to the compressor housing, as seen below. Compressor housings have been found cracked or broken due to lack of support from a worn or broken bracket.

Inspect the brackets at the regularly scheduled 250 hour maintenance intervals or during other repairs. If cracking/breaking or wear is seen, the brackets **must** be replaced.
