# Technical Service Bulletin

Technical Service Bulletin: TSB110039

Turbocharger Plumbing Routing Issue

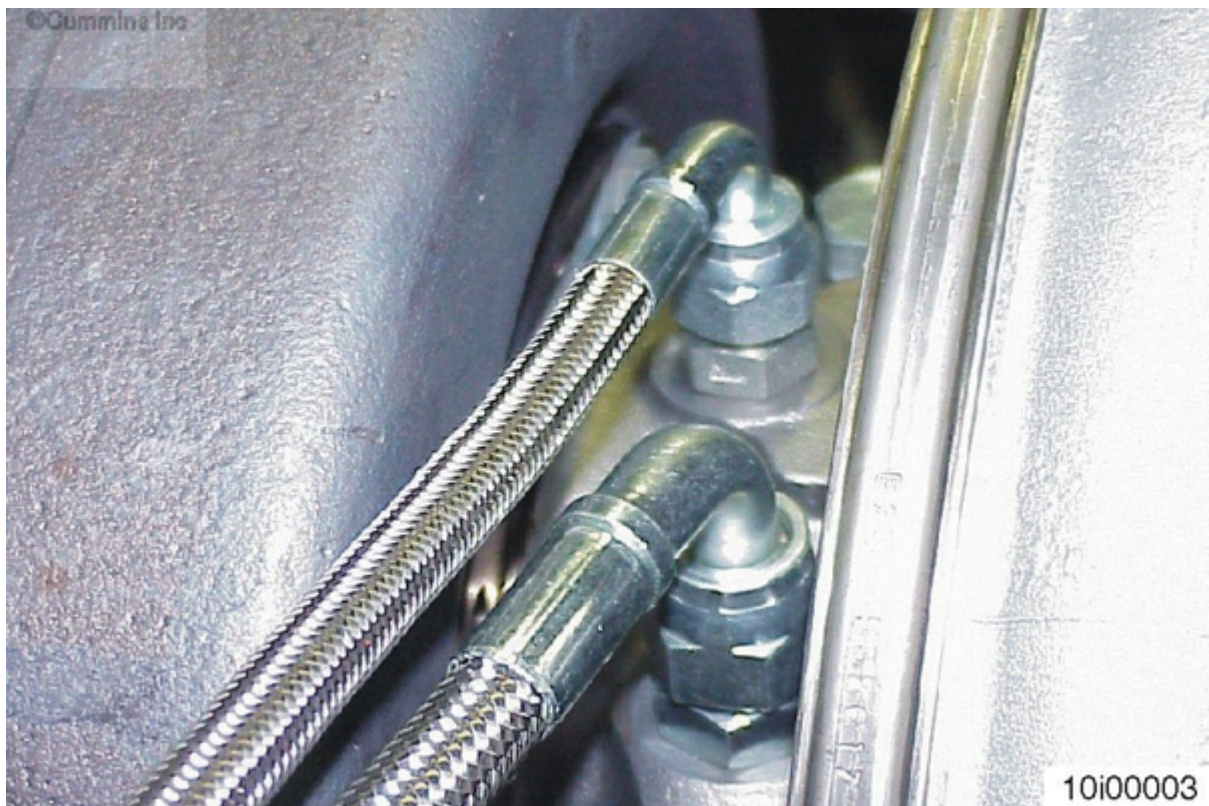
Figure 2 - Ideal Routing

The routing of all the turbocharger plumbing lines **must** be checked at the next service event or regularly scheduled 250 hour maintenance interval. If any contact is found, the lines **must** be adjusted so that they are **not** touching. If the lines are damaged, they **must** be replaced. Proper routing is shown in Figures 2 and 3. Ideal routing would be running the lines straight down with no bends to make sure of proper clearances, as shown in Figure 2. However, in some turbocharger configurations, this is **not** possible. If the lines **must** be bent, make sure there is as much clearance as possible between the turbocharger oil line and its surroundings as shown in Figure 3. Make sure the lines are **not** touching the turbocharger housing.

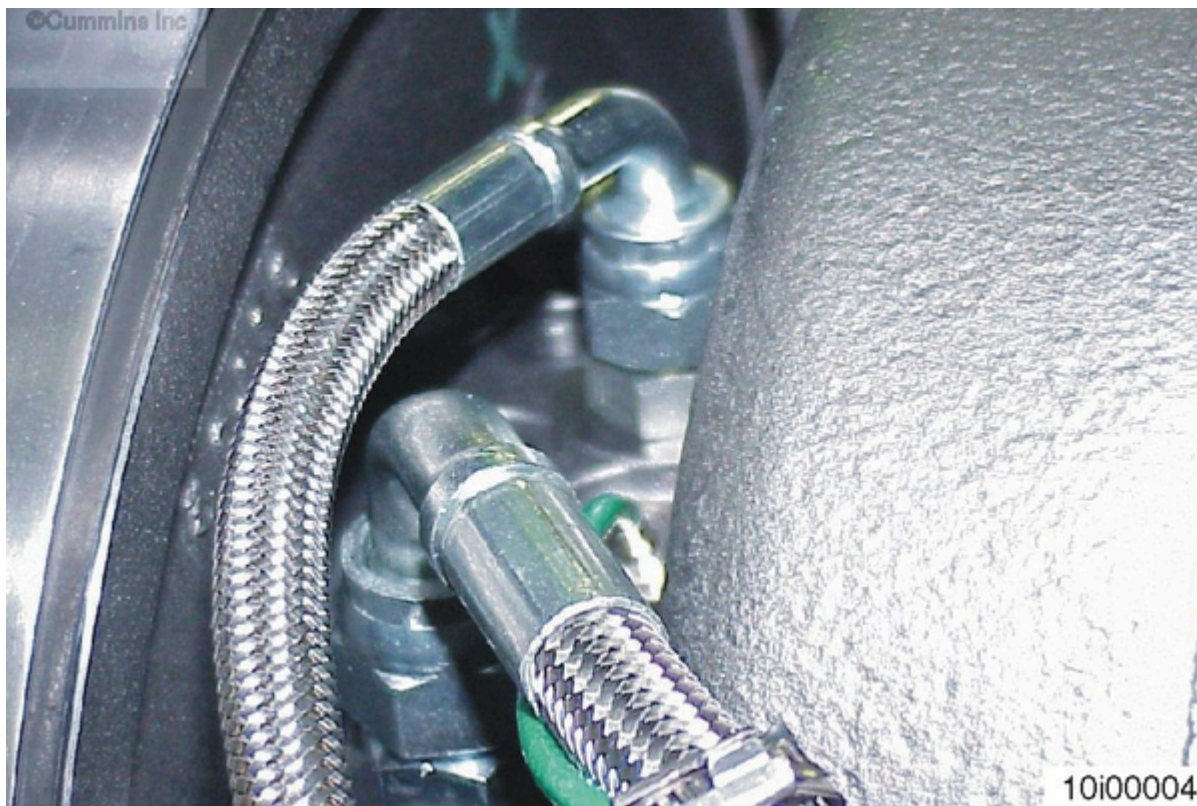
Figure 3 - Alternate Routing
