Technical Service Bulletin: TSB110070

New Turbocharger Clamp Plate and Capscrew

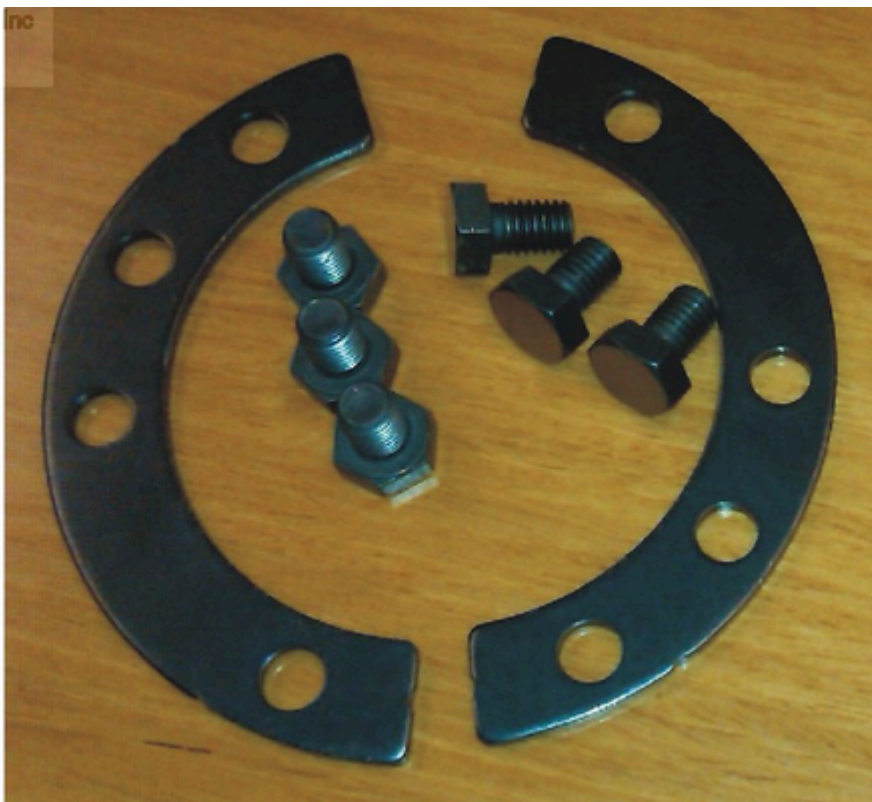
10v00004

Heavy Duty - Old Clamp Plate and Capscrews - Silver in Color/Stainless

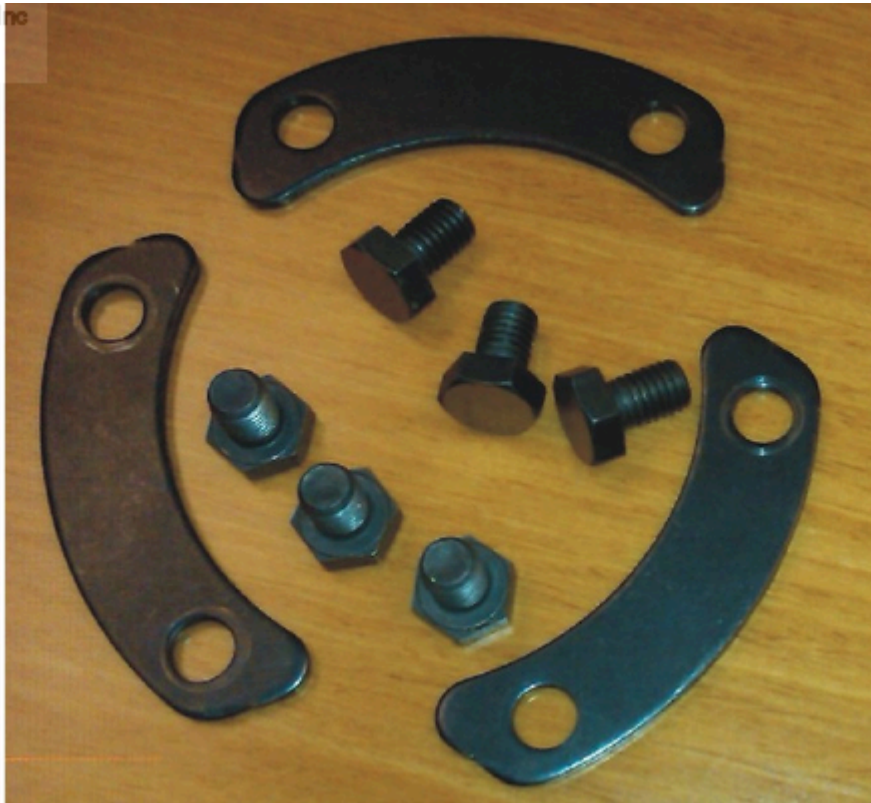
10v00003

MidRange - Black Oxide Clamp Plates with B16 Material Capscrews - Included in Kit 4032887
