Technical Service Bulletin: TSB110152

Released Date: 01-Jun-2011

K19 and QSK19 Flywheel Balance Holes Drilled in the Incorrect Location

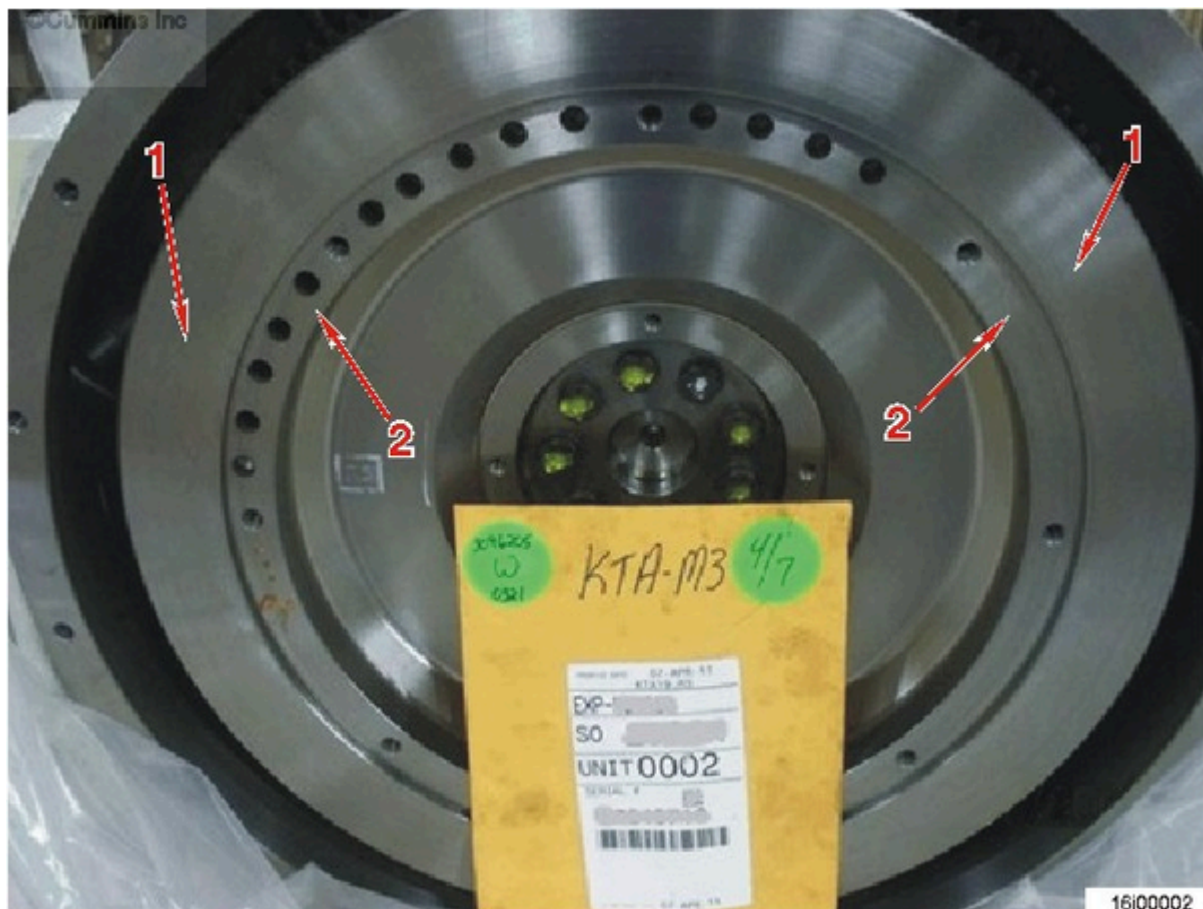
The balance holes in the flywheel should be on the outer most ring of the rear surface (1), but have been drilled on one of the inner rings (2). This is due to a supplier production error and does **not** affect the performance of the flywheel.

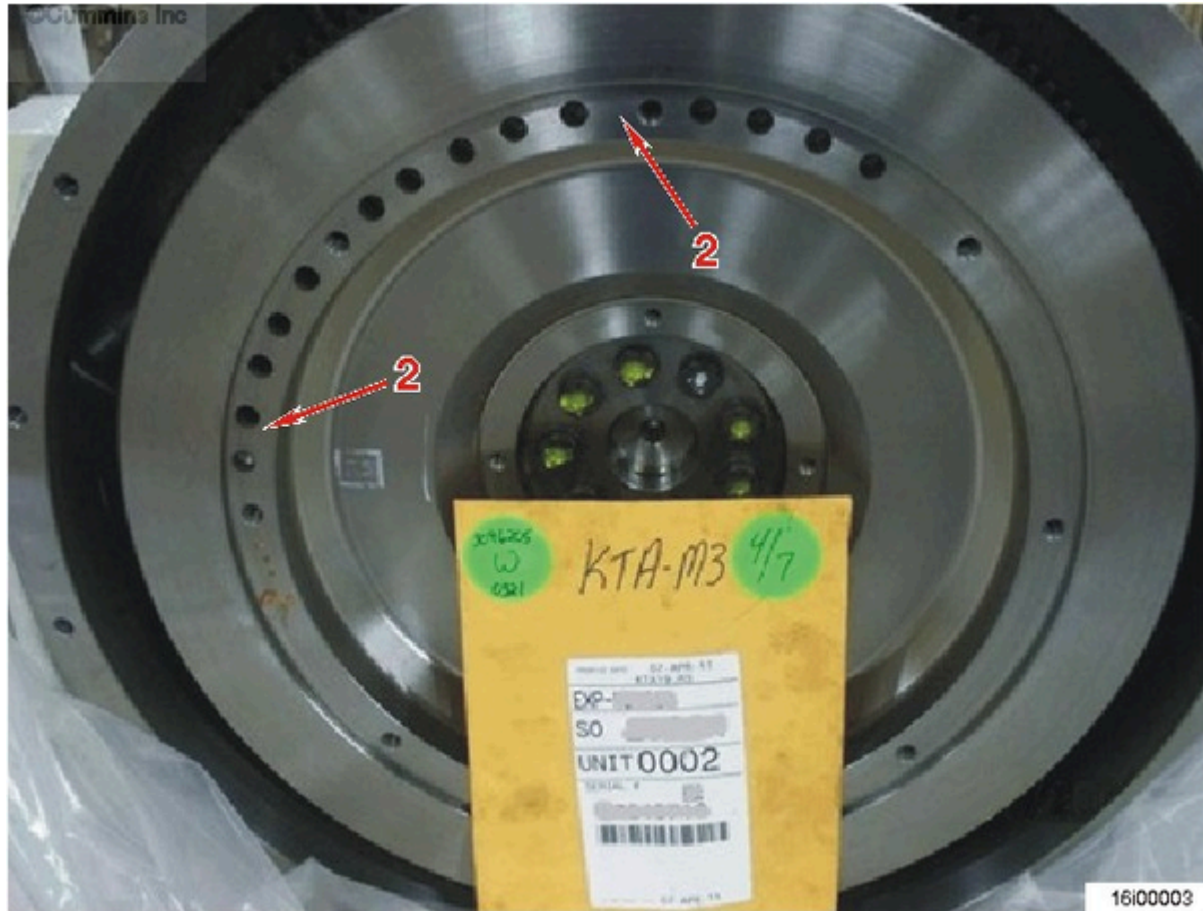
The K19/QSK19 flywheel balance holes were drilled in the incorrect location on Part Number 3090758, and 3024105 flywheels. The flywheels are permitted for use and will have no effect on engine performance or durability. These flywheels have been installed on production engines and sold as service parts.

Picture 1: Holes drilled in the incorrect location (Surface 2).

Flywheels with balance holes in the incorrect locations are permitted for use and will have no effect on engine performance or durability. These flywheels are **not** defective and should **not** be returned.

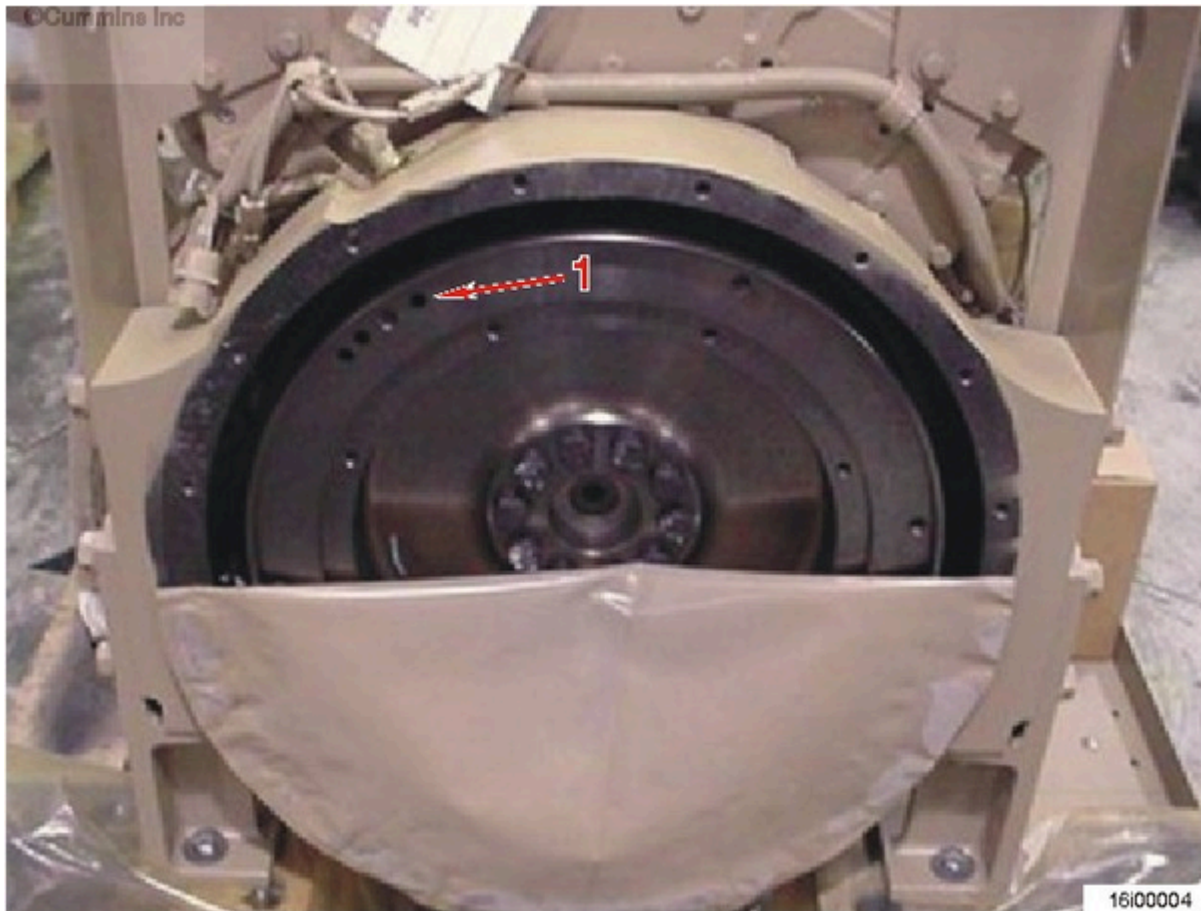
Picture 2: Holes drilled in the correct location (Surface 1).
