Technical Service Bulletin: TSB110189

Released Date: 12-Jul-2011

New Turbocharger Oil Supply Line Male Union, QSK19 Engine

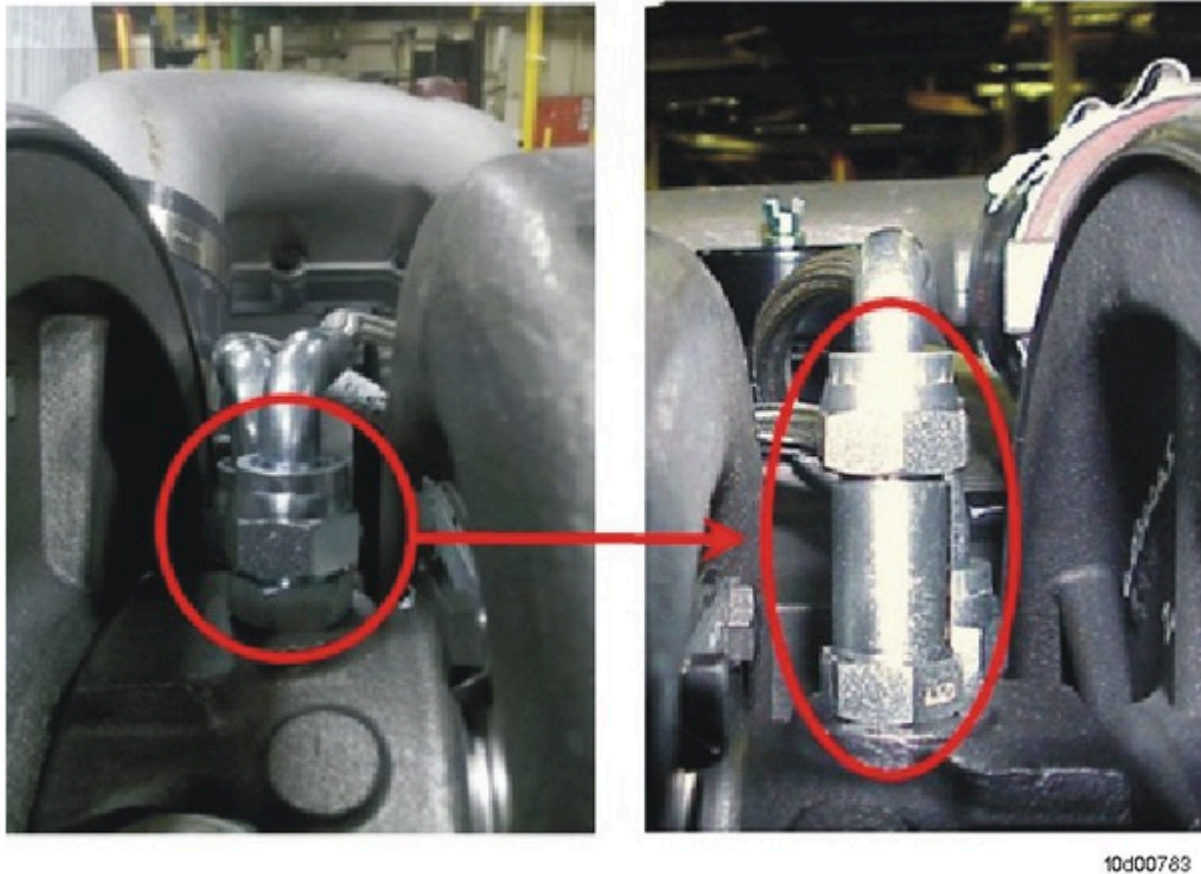
Figure 1. Old Male Union Versus New Taller Male Union

The new male union is taller than the previous unions used at the turbocharger oil inlet. This allows for more clearance between the turbocharger oil supply hose and other objects in this area, including the bearing housing and coolant vent line. Figure 1 shows the old fitting on the left and the new fitting on the right.

This document introduces new turbocharger lubricating oil plumbing hardware for the QSK19 engine. A new male union, Part Number 2888894, was released to address turbocharger plumbing routing issues. This document provides resolution to the issue described in TSB110039. Table 1 shows the new part number and o-rings included in this assembly.

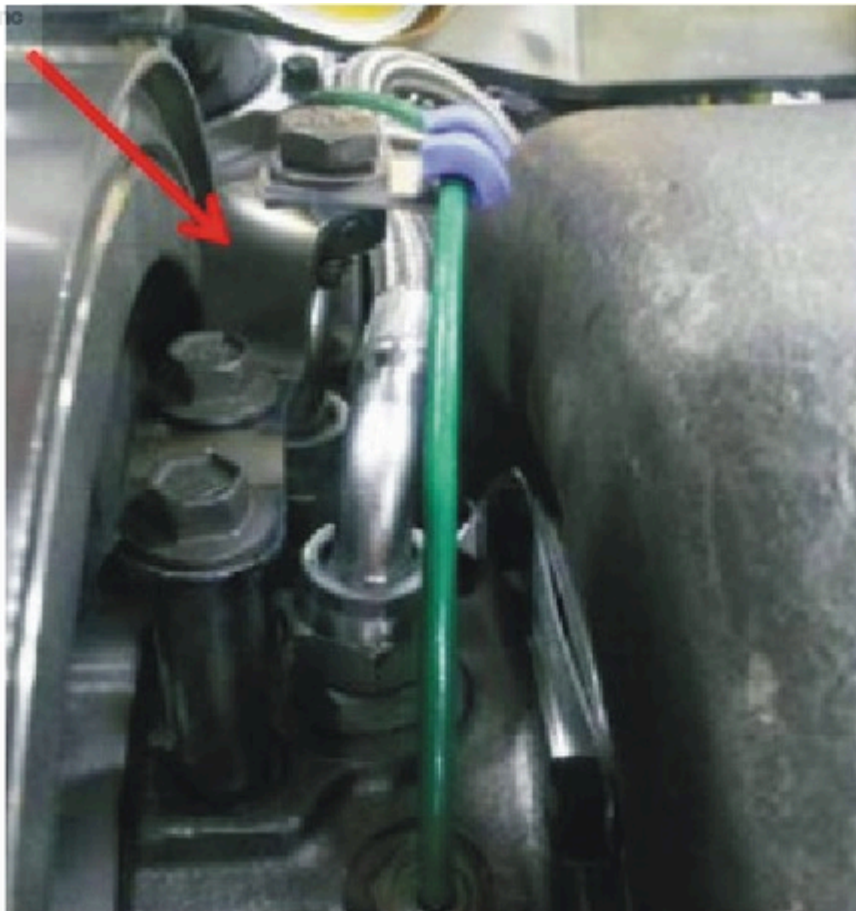
Figure 2. Previous Speed Sensor Wire Routing with Bracket

On QSK19 MCRS Tier 3 options with a turbocharger speed sensor, this new male union causes an interference with the bracket supporting the speed sensor wire. To resolve this, the bracket has been obsoleted and the hardware has been removed from the affected options. Now, the wire should be clipped to the oil supply line to allow for maximum clearance. This is similar routing to other turbocharger options. Table 3 shows the structure changes to these options. Figure 2 shows the bracket that is being obsoleted. Figure 3 shows the new turbocharger speed sensor wire routing. Table 4 shows the options that had the bracket removed.
