Technical Service Bulletin: TSB110285

Released Date: 18-Nov-2011

Improved Turbocharger Compressor (Cold Side) Oil Leaks Troubleshooting

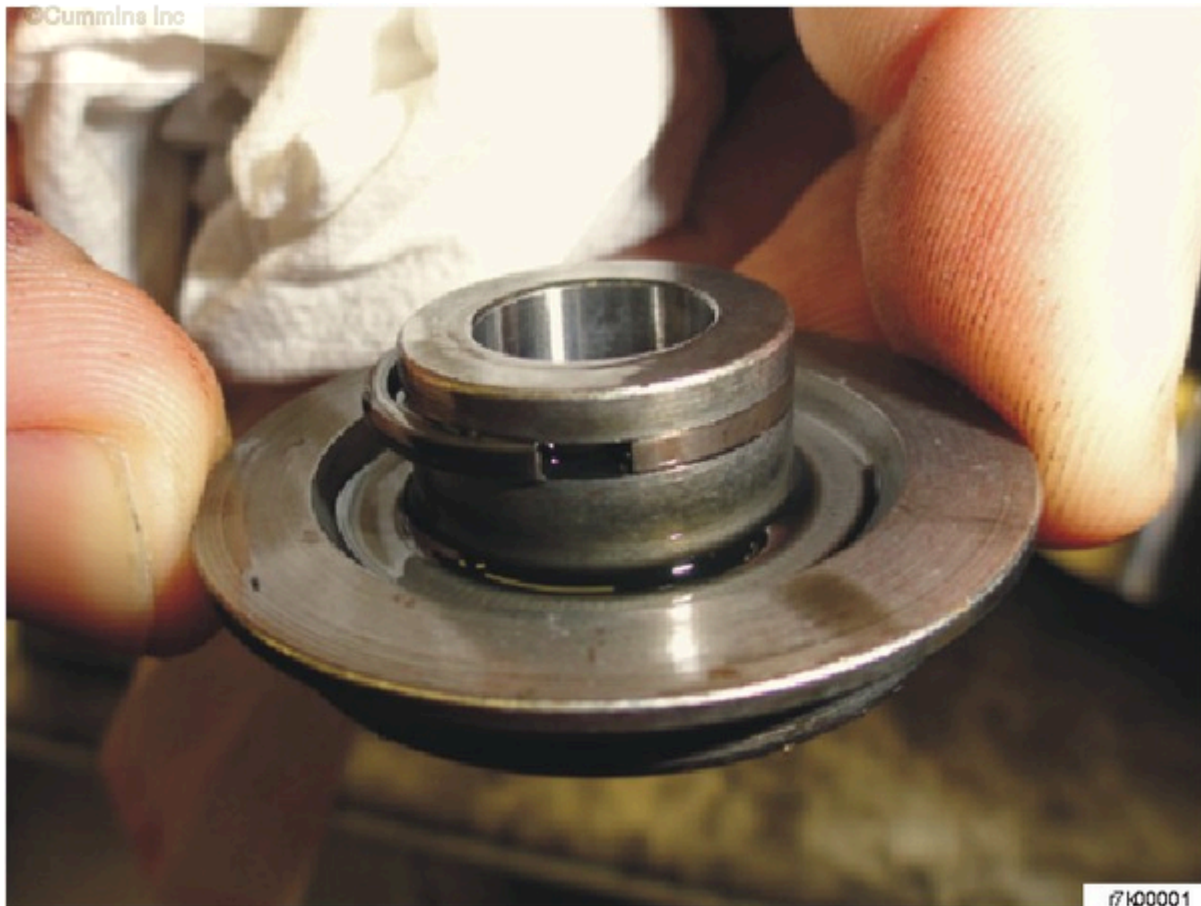
Figure 1 - Turbocharger Compressor Oil Seal

Oil leaks from the compressor (cold) side of the turbocharger do not always indicate a malfunction of the turbocharger oil seal. The oil seal is a piston-ring type seal, (see Figure 1) that is designed to function under a positive pressure differential between the compressor backwheel pressure (related to boost pressure) and the turbocharger bearing housing pressure (related to crankcase pressure).

If the compressor backwheel pressure drops below the bearing housing pressure, oil can be forced past the seal and into the compressor housing of the turbocharger. If bearing wear/damage has not occurred (radial and axial end play is still in specification), the turbocharger itself will be undamaged. It can be cleaned and put back into service. For cleaning instructions, Refer to Procedure 010-033 in Section 10. (</qs3/pubsys2/xml/en/procedures/20/20-010-033-tr.html>)

This failure mode is often identified by staining, oil pooled in the bottom of the compressor housing, or oil found in the intake piping downstream from the turbocharger. Often, the root cause of the problem can be related to low boost pressures or elevated bearing housing pressures, and not a malfunction of the turbocharger oil seal.

If oil leaks are seen in this area, follow the troubleshooting procedure linked above before replacing the turbocharger.
