Technical Service Bulletin: TSB130112

Released Date: 30-Jul-2013

N14 ReCon® Cylinder Head Combustion Face and Weld Appearance

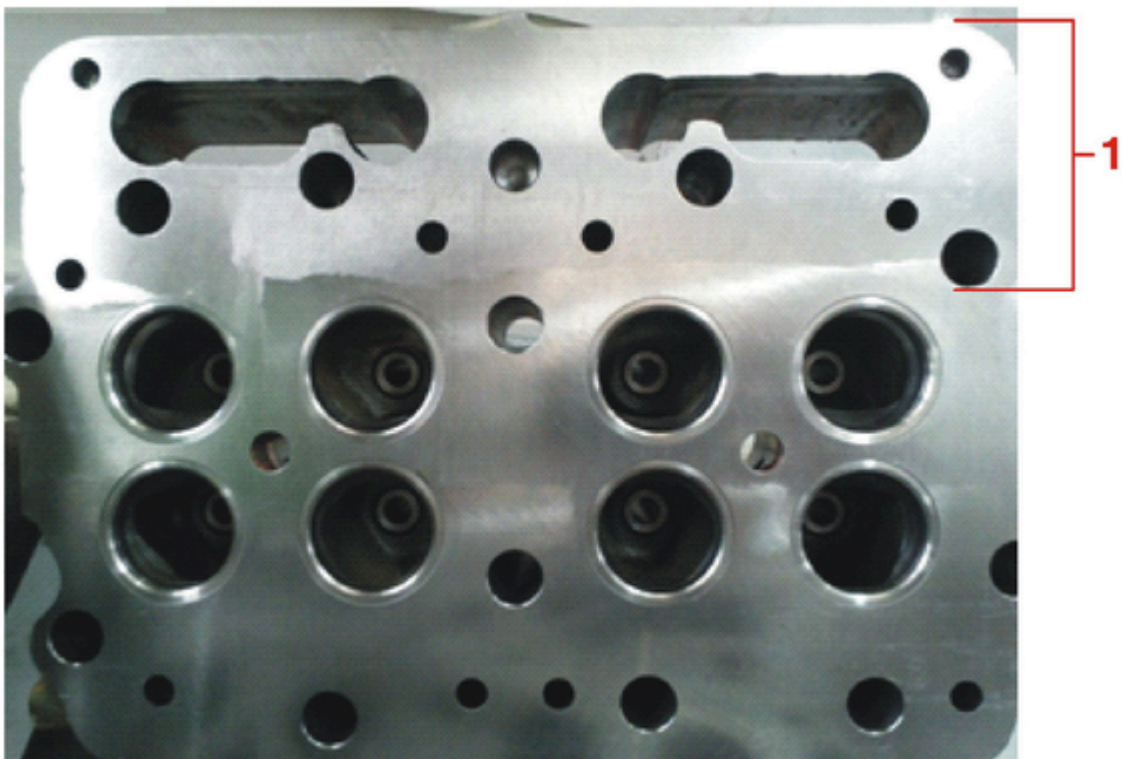
02900199

1. The present machining process leaves marks on the cylinder head that do **not** look up to standard. These marks are cosmetic and the combustion face meets all surface finish and flatness specifications.

## 1. Machining marks.

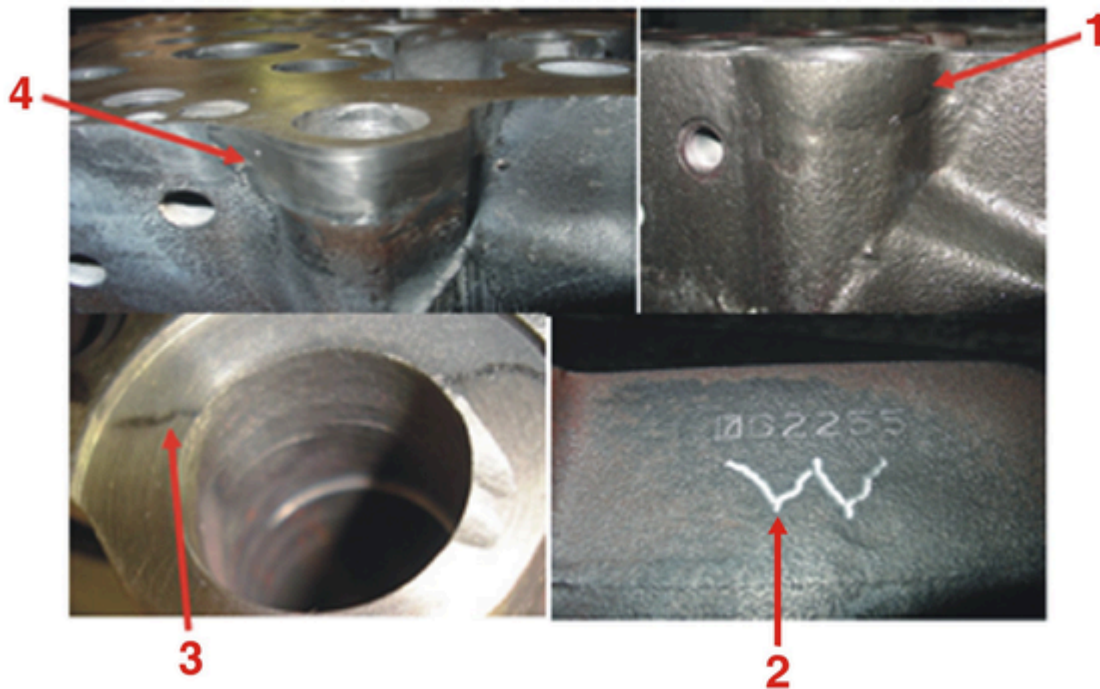
02900200

The salvage process for cylinder heads allows for the welding and re-machining of certain areas of the cylinder head. The photograph below shows examples of welded and re-machined areas, and their resulting appearance. Cylinder heads that have been welded and re-machined will be marked with a “W”.

1. Welding marks
2. “W” Indicates cylinder head was welded
3. Welded material line (this is **not** a fracture line)
4. Welding marks

**Note :** All the above machining and welding marks are **not** regarded as unacceptable and are approved by Cummins Inc. Welding and re-machining of cylinder heads is **only** allowed to be performed by Cummins® ReCon®.
