| Technical Service Bulletin: TSB140110 | Released Date: 05-Sep-2014 |

## 11-SI Alternator Front Bearing Malfunctions on 6C8.3 Tier 1 Engines Causing Difficulty Starting the Engine or Noise Complaints.

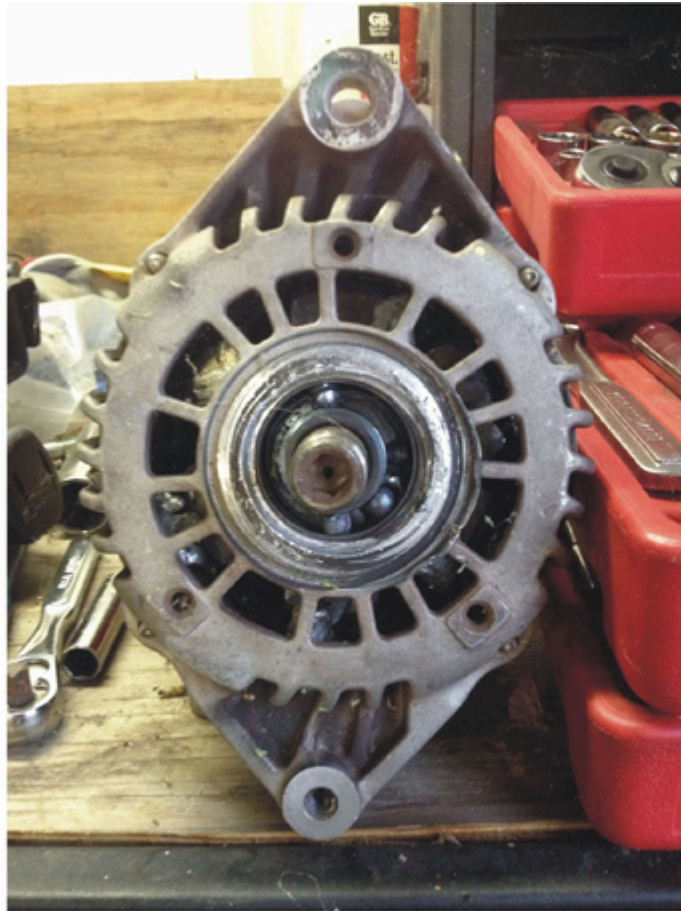
13500025

Issues with 11-SI alternators have been observed on rental power generation units. Customers experience difficulty starting the engine or noise complaints. Upon investigation, it's found the alternator is **not** properly charging the battery due to the alternator bearing being seized. This occasionally also causes progressive damage to the alternator pulley and the belt. The failure mode is internal bearing damage from water intrusion during power washing. Power washing 11-SI alternators can cause bearing damage.

11-SI alternators with bearing damage from power washing will cease to function. It will not spin freely or may not spin at all. The bearing(s) may be damaged to the extent that the shaft is no longer centered in the bearing (see photograph below).

The best way to avoid this situation is to **not** power wash near the alternator. If power washing is necessary in this area, be sure to provide ample water protection for the alternator.
