# Technical Service Bulletin

Technical Service Bulletin: TSB180087

New Junction Box

- NH, NT / PT Fixed Time
- NTA855

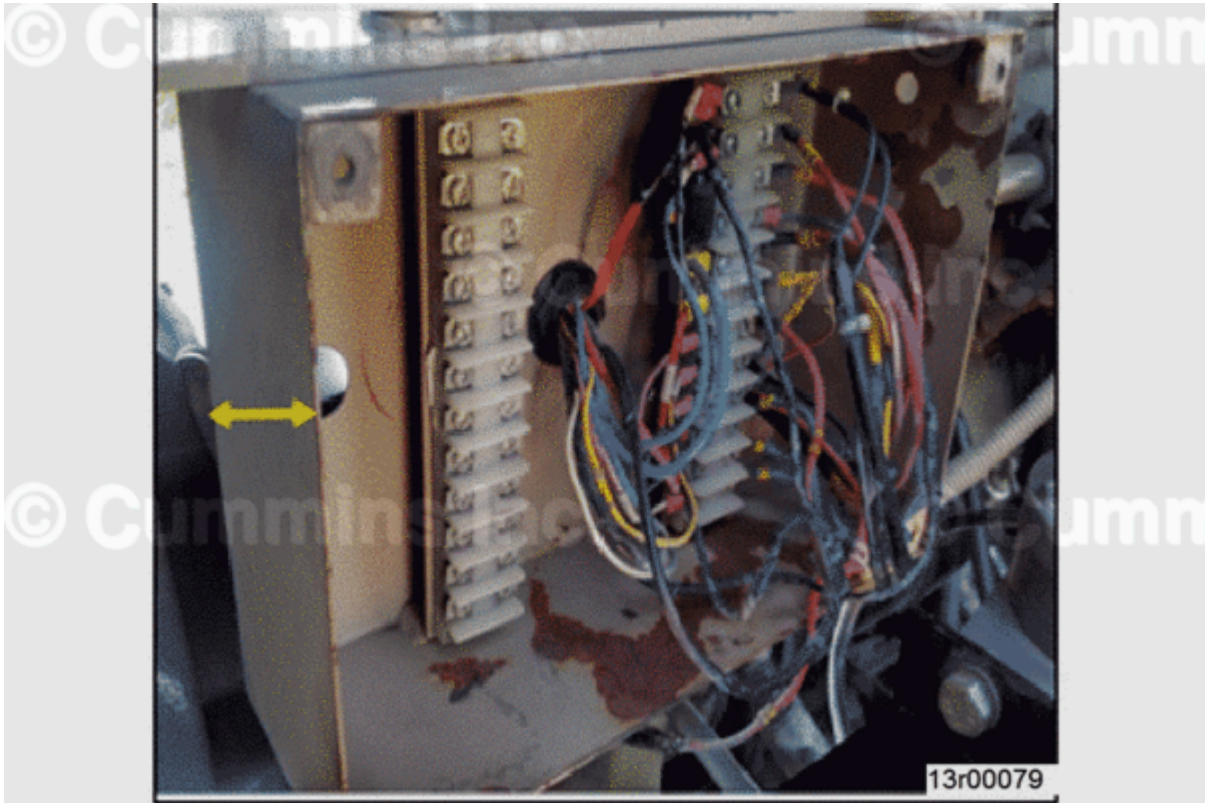
Figure 1, Old Box Junction Width – 89mm [ 3.5 in ]

- Width increased by 30mm [ 1.18 in ] for clearance between harness and front cover plate.
- Addition of 12mm +/- 1 mm [ 0.5 in ] thick plain foam (Firend TB 070) on inside of front cover plate, with self-adhesive backing.

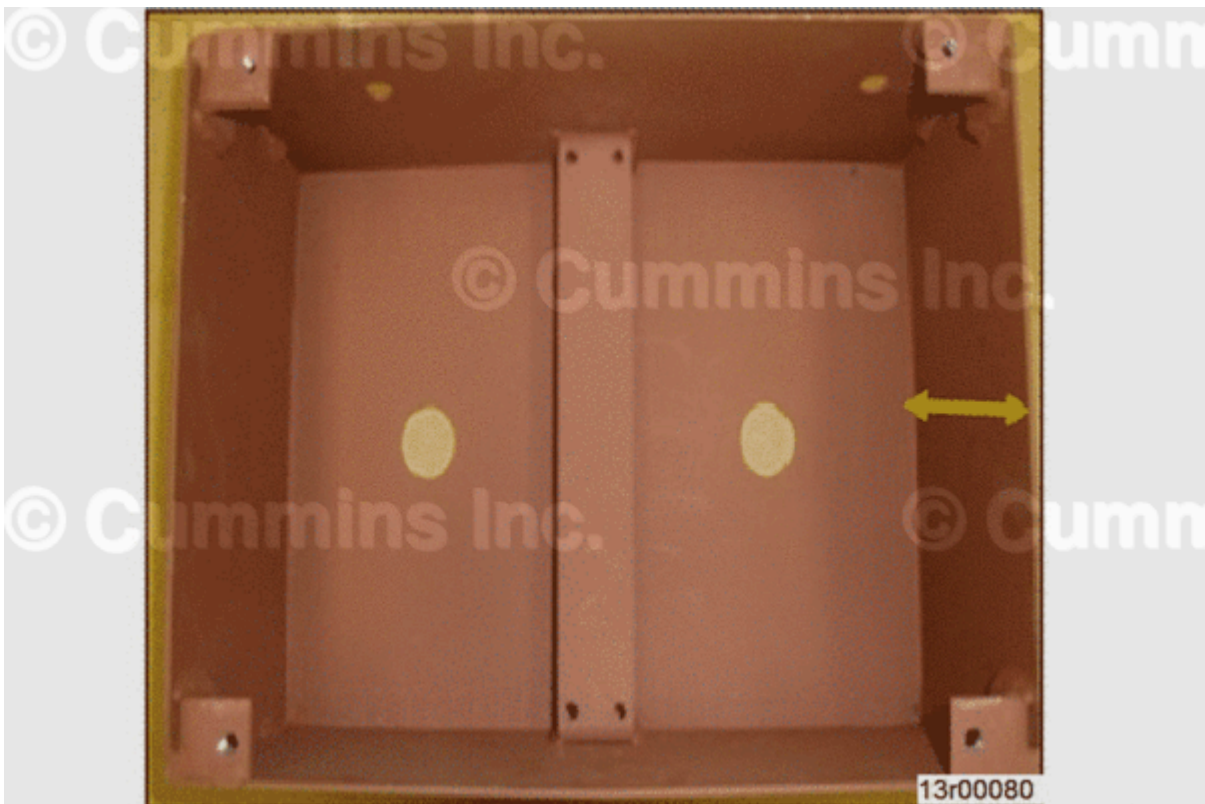
Figure 2, New Box Junction Width – 119mm [ 4.7 in ]

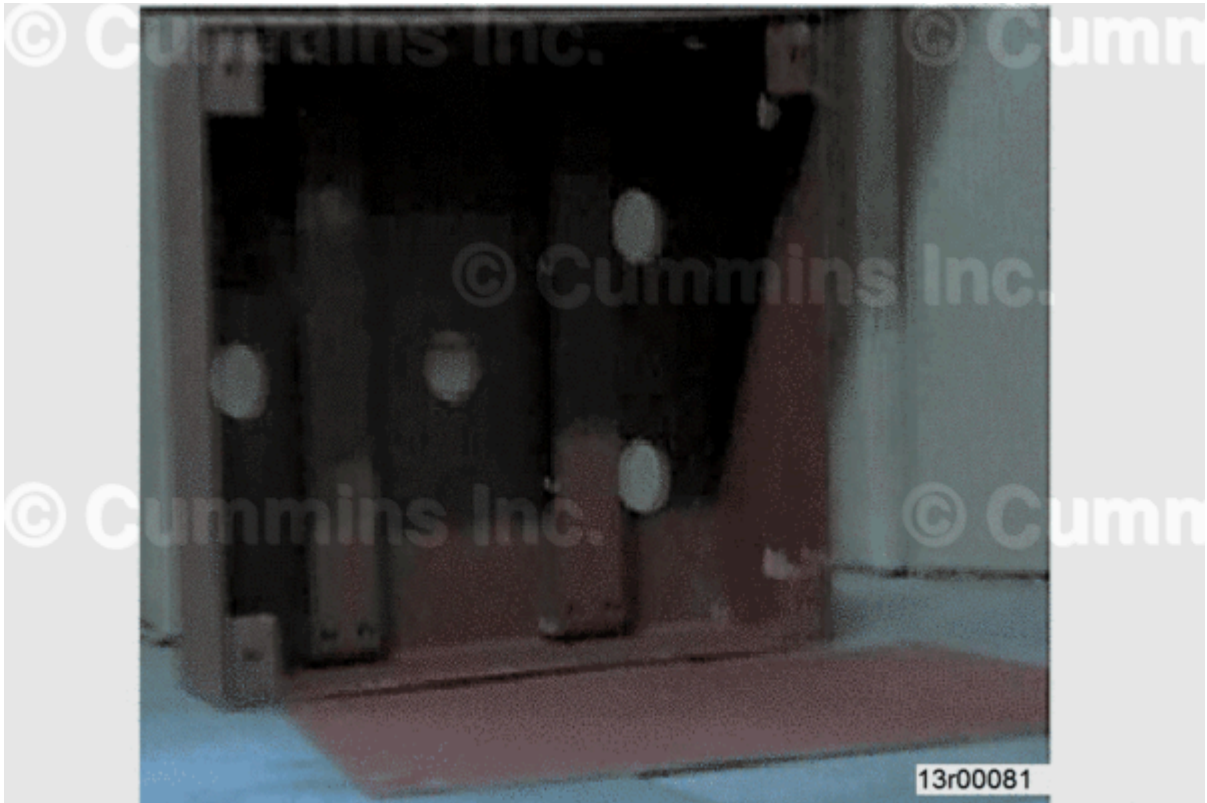
Figure 3, Old Cover Plate Without Foam

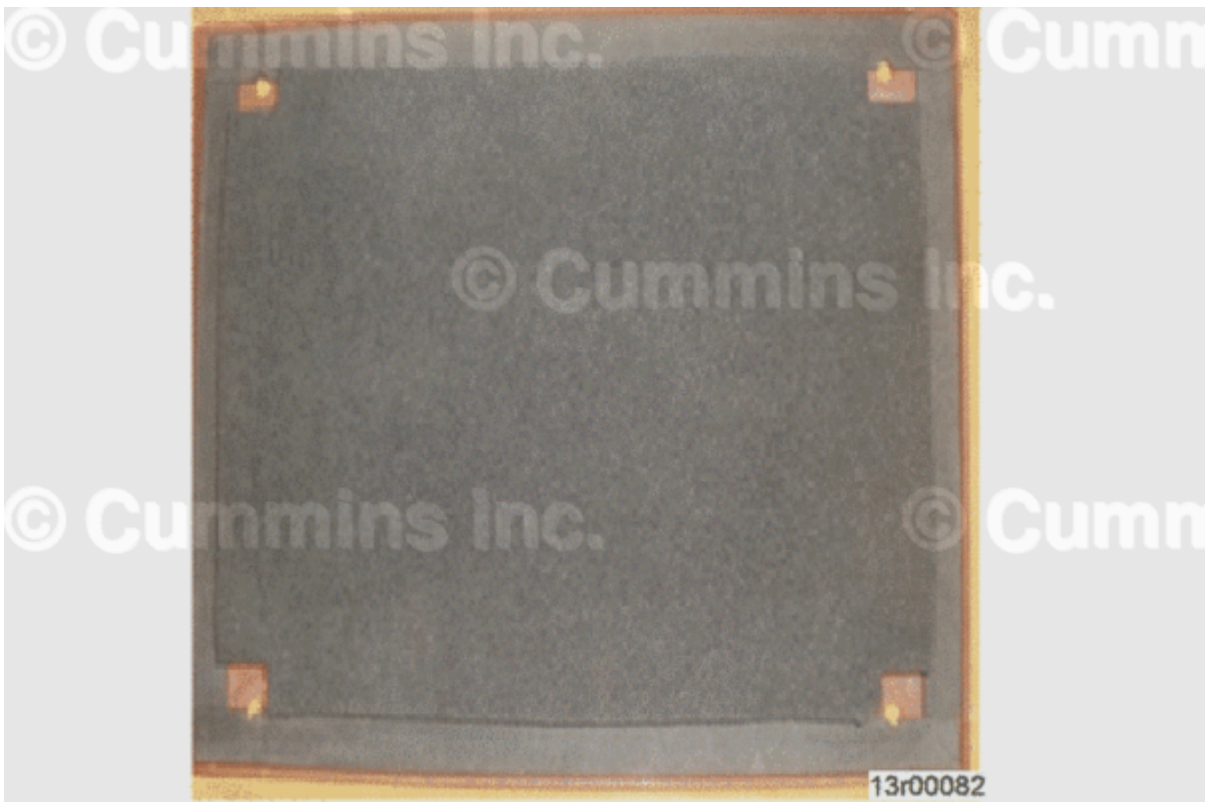
Figure 4, New Cover Plate with Firend TB 070 Foam

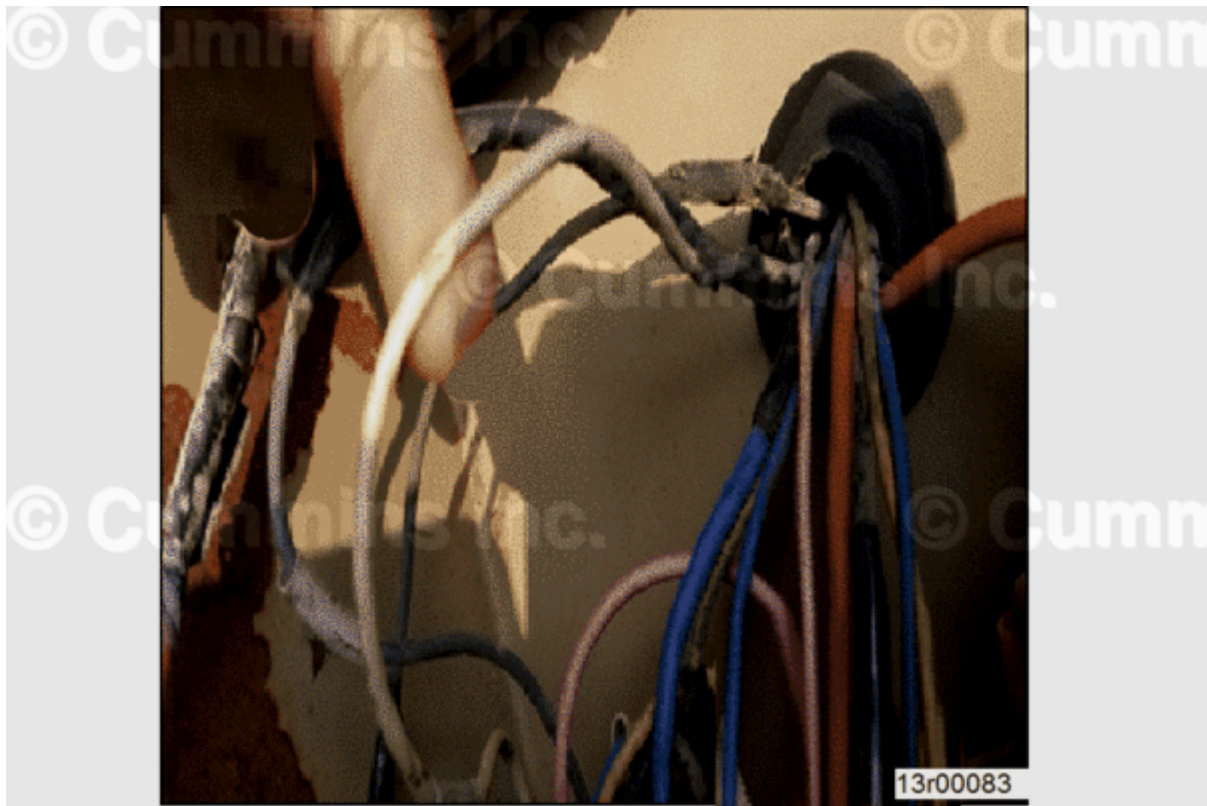
Wire insulation can malfunction because of contact with junction box front cover plate. This can lead to electrical system shorting and other component damage.

Figure 5, Wires Losing Insulation

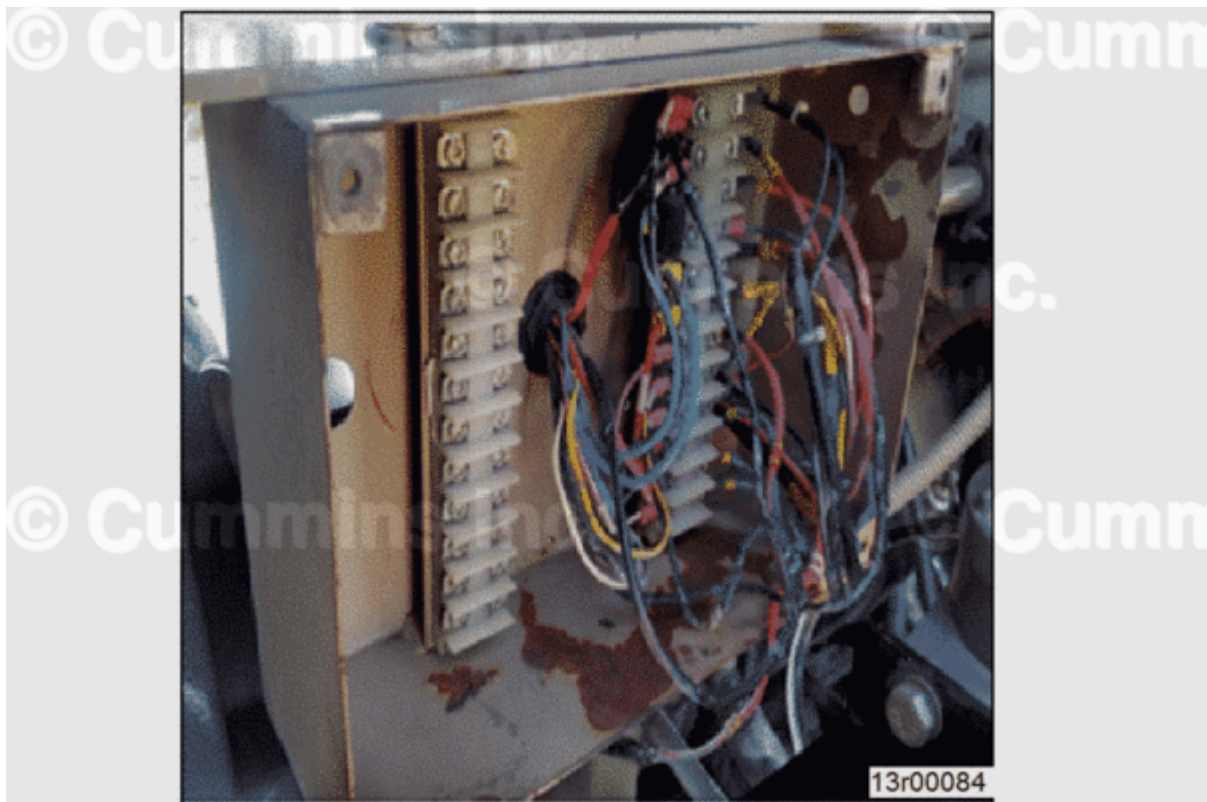
Figure 6, Lack of Clearance Between Wires and Cover
