Technical Service Bulletin: TSB180174

Thin Wall Block Condition

- QSK19 CM500
- QSK19 CM850
- QSK19 CM2150

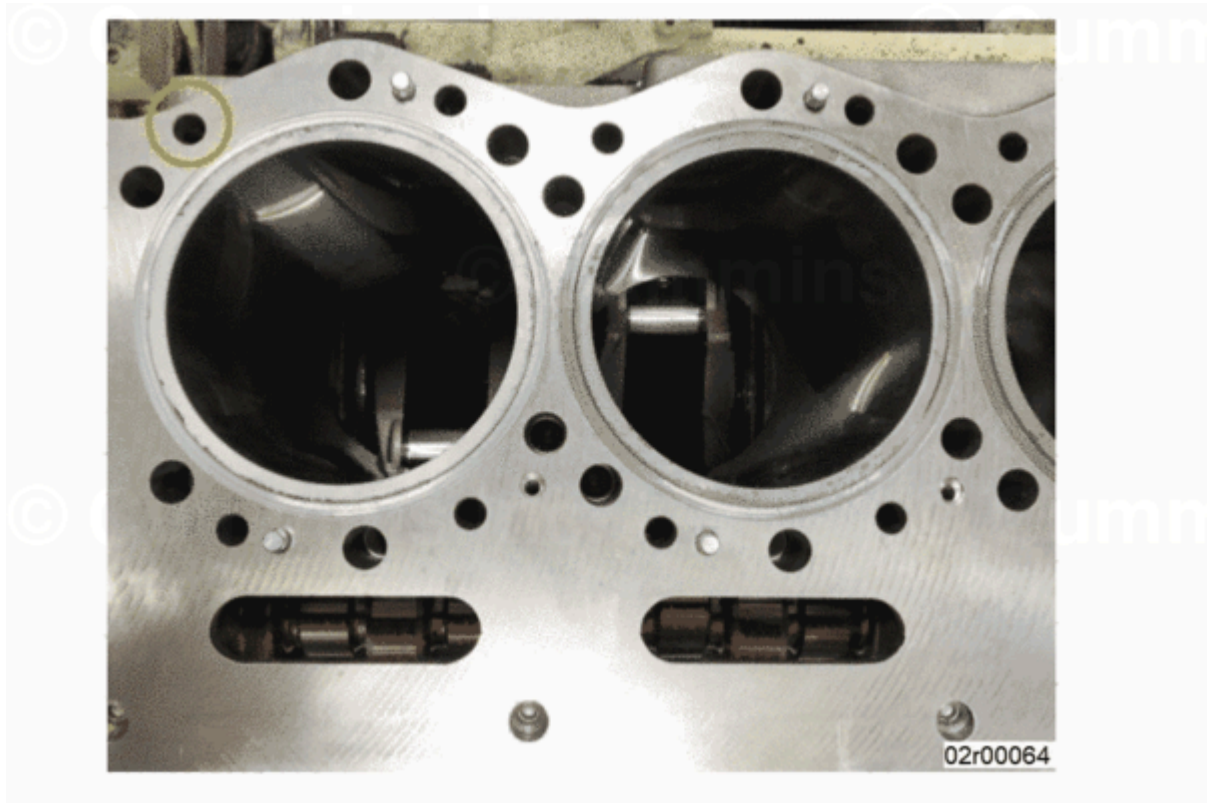
Coolant leaks from the cylinder head gasket cylinder number 1 forward coolant port.

- Casting variation of cylinder block resulting in a thin cylinder block wall next to cylinder number 1 forward coolant port.

Figure 1, Coolant Port Measurement Location.

Replace cylinder head gasket.

- Industrial application cylinder blocks with a measurement between 3.25mm [ 0.128in ]and 5mm [ 0.197in ] use head gasket Part Number 3634664.
- Rail application cylinder blocks with a measurement between 4.25mm [ 0.167in ] and 5mm [ 0.197in ] use head gasket Part Number 3634664.
- For cylinder blocks with a measurement of over 5mm, use cylinder head gasket Part Number 4334080.

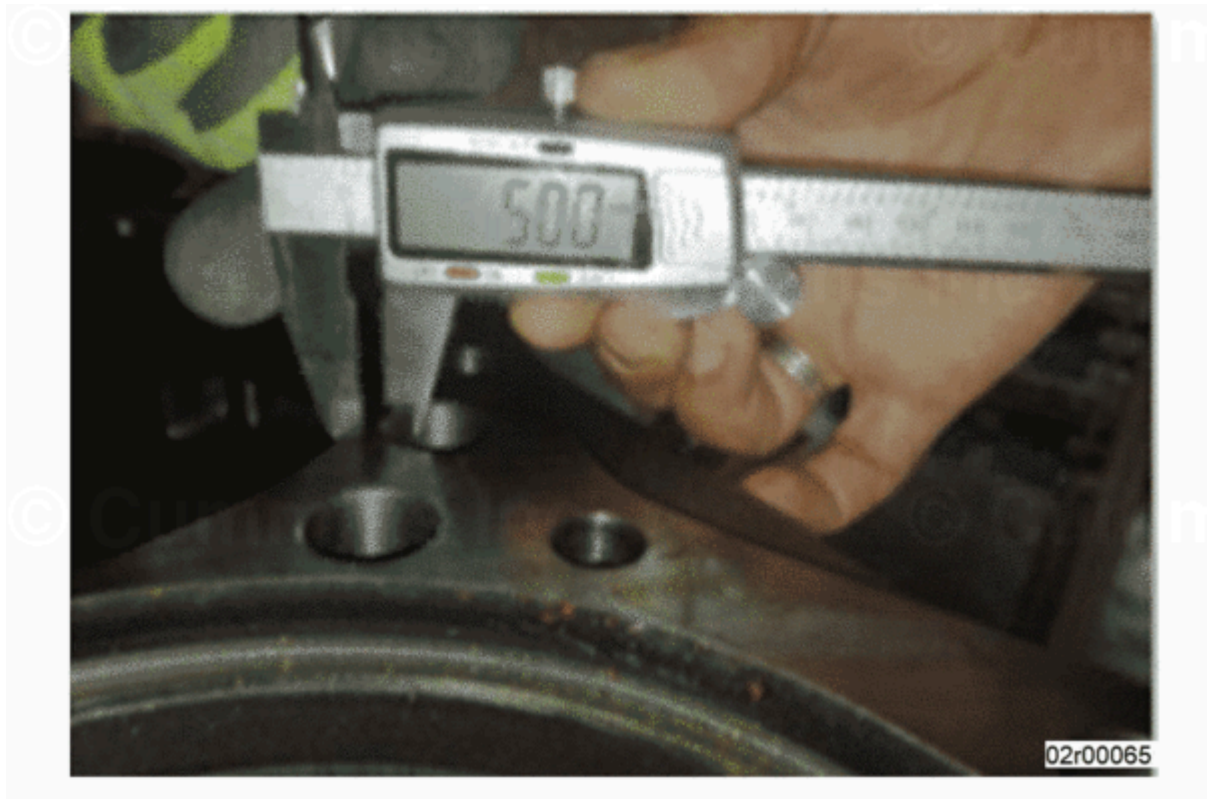
Figure 2, Use Calipers to Measure Cylinder Block Coolant Port Wall Thickness.
