# Technical Service Bulletin

| Technical Service Bulletin: tsb020016 | Released Date: 17-Oct-2002 |
| Engine Lube Pump Suction Head to Housing Gasket | |

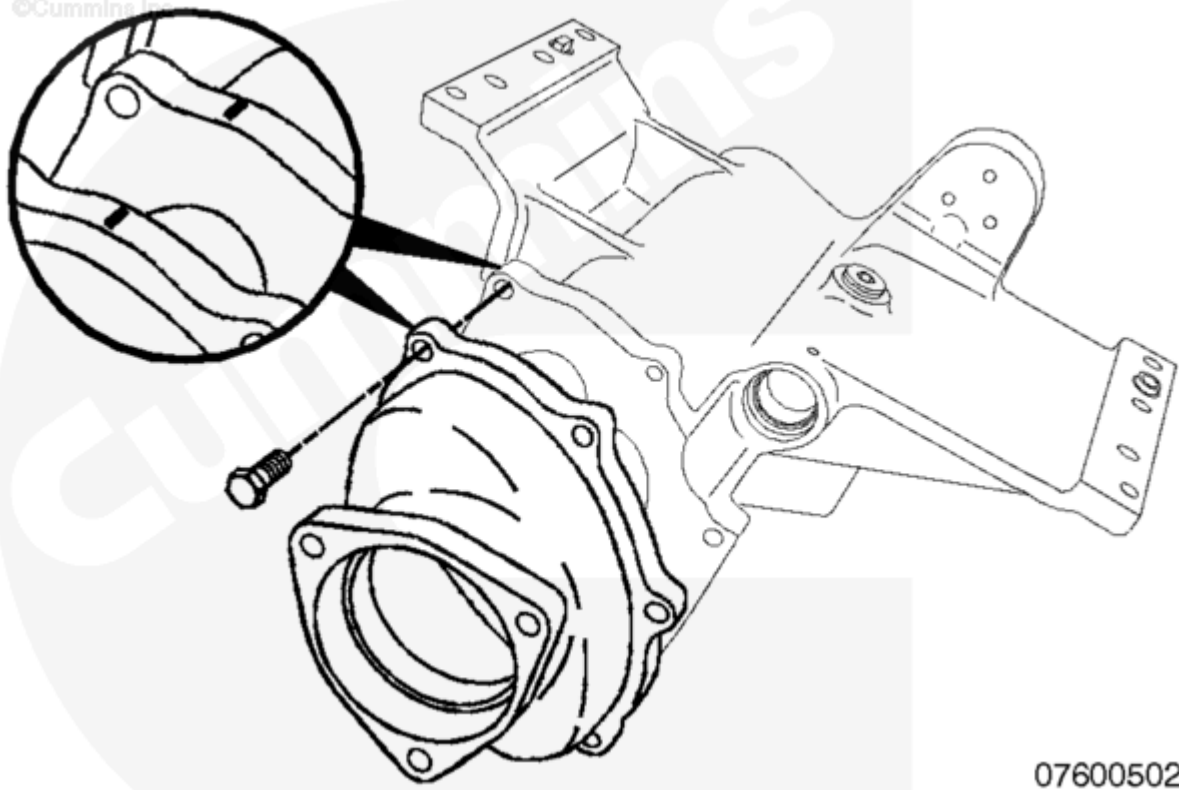
07600502

The capscrews that hold the engine lube pump suction head to the housing do **not** meet the 47 N•m [35 ft-lb] specification.

The gasket between the engine lube pump suction head and housing is crushing, and the capscrews are losing some of their torque.

If the torque is completely lost, the engine lube pump could lose suction, causing a loss of engine oil pressure.

Torque the engine lube pump suction head to housing capscrews to specification.

**Torque Value:** 47 n·m [ 35 ft-lb ]
