| Technical Service Bulletin: tsb090029 | Released Date: 21-Apr-2009 |
| Injector Copper Seal Corrosion Issue | |

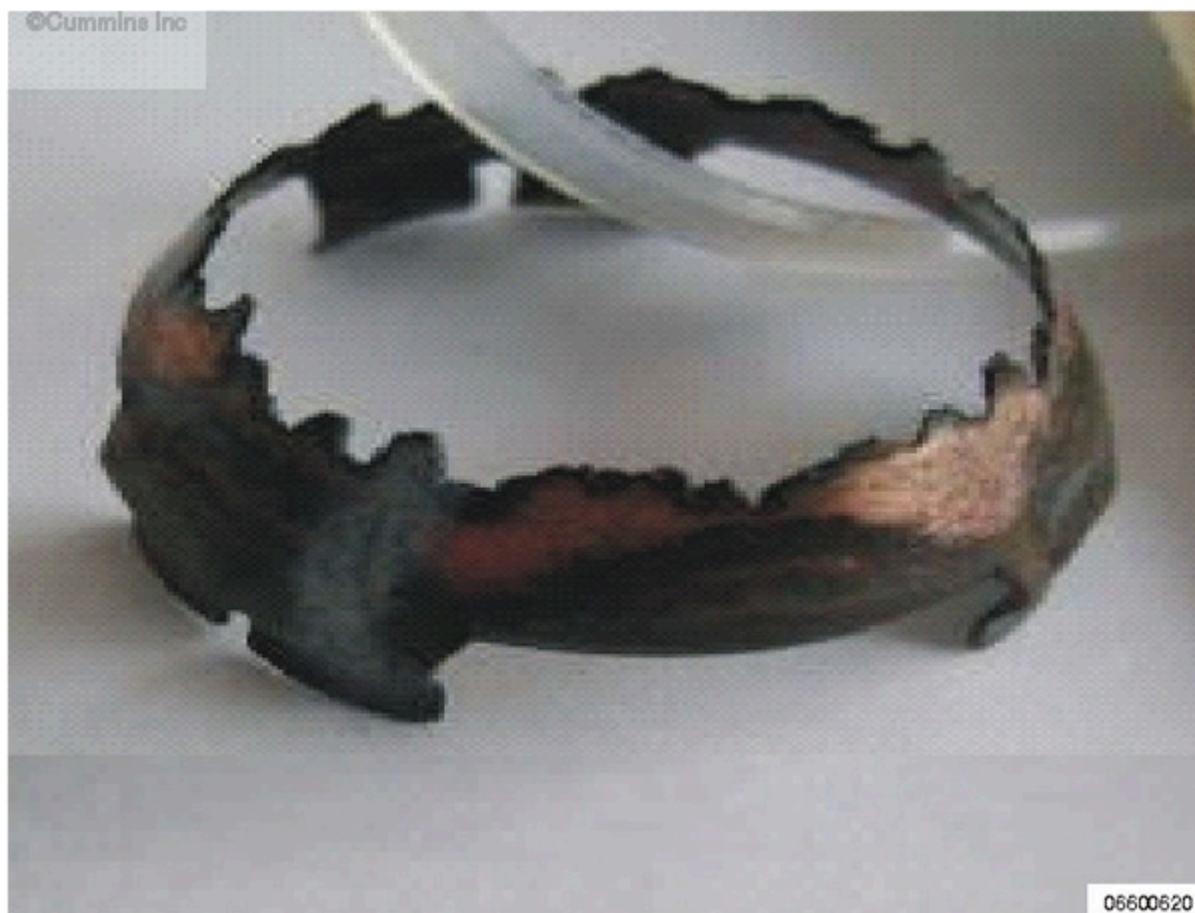
Copper seal corrosion is often referred to as a burned copper seal, due to the black marks found around the corroded or removed area.

Injector copper seal corrosion can be identified by noting that a portion of the copper seal appears to be dissolved or worn away.

Figure 1. Illustration of a burned copper seal.

Replace corroded or burned copper seal with new seals (see figure 1). Analyze the sulfur content of fuel to make sure it is below 300 ppm. Analyze engine operation to make sure that the engine is not operating at low idle more than 50 percent (and load factor <25 percent) of the time. If ambient conditions have been below 5°C [41°F] and fuel with a >300 ppm sulfur content has been, used this could possibly also be an indication that copper seal damage is present. If repeated failures of copper seals are witnessed, it is recommended that the potential causes noted in this Early Field Notification be addressed for improved copper seal performance.
