Technical Service Bulletin: tsb100164

Released Date: 23-May-2002

HX82 High Pressure Turbocharger Improvement

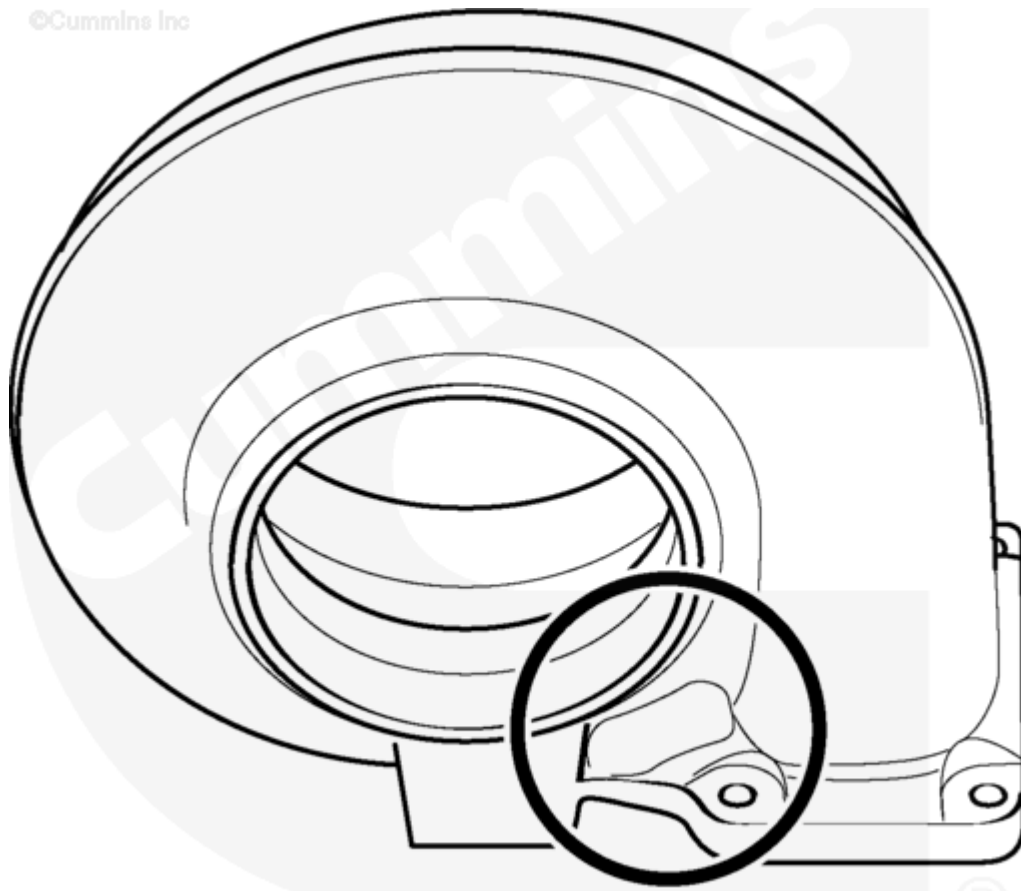
10600211

This Technical Service Bulletin announces the release of a new HX82 turbocharger service kit, Part Number 4089126. The turbocharger has a new turbine housing, designed to eliminate cracking at the exhaust mounting flange due to thermal fatigue.

Fig 1, New Design Turbocharger Housing. Note the casting change at the exhaust mounting flange.

**Note :** When replacing the turbine housing, the capscrews, lockplates and exhaust flange gasket must be changed. These parts must be ordered in addition to the turbine housing.
