Technical Service Bulletin: tsb100204

LTA Junction Block Pipe Support Brace.

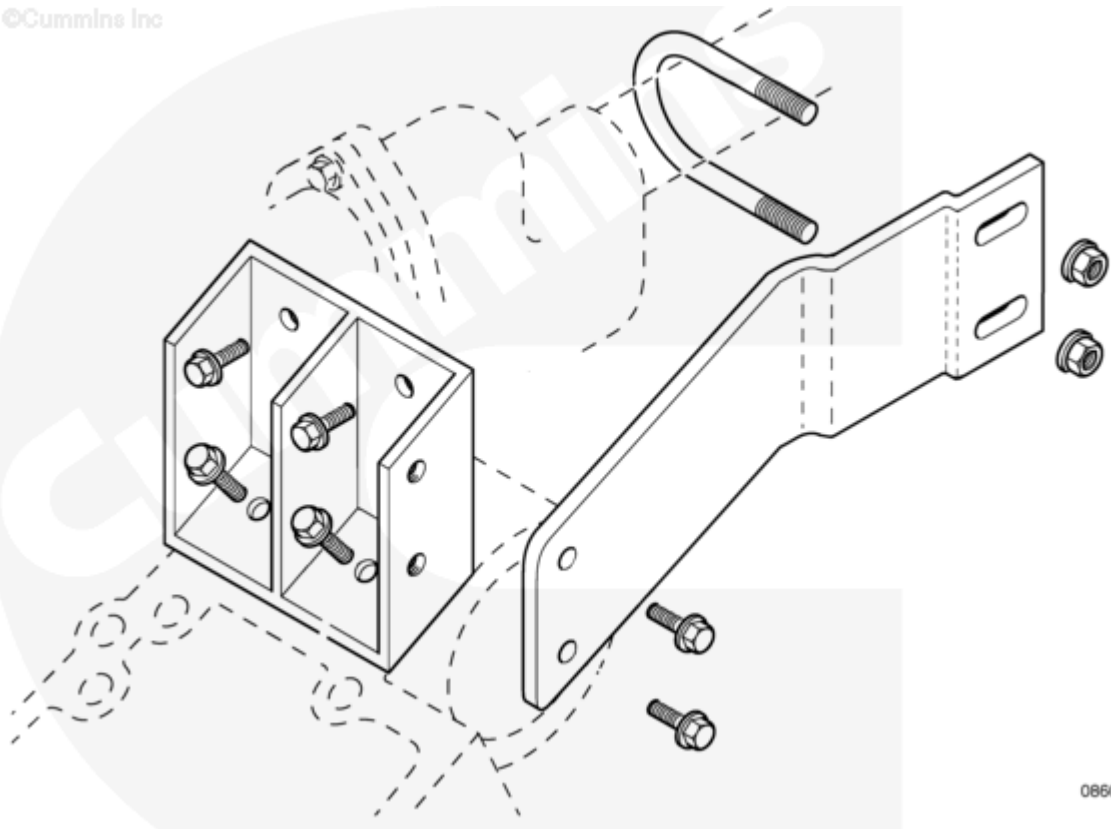
08600393

New LTA junction block support bracket with pipe support brace.

The purpose of this topic is to inform the field of the introduction and of an LTA (Low Temperature Aftercooler) pipe support brace, designed to help prevent water leakage from the LTA junction block located on the left bank Number 1 rocker housing on QSK45/60 engines. The junction block bracket has been stiffened to improve its rigidity, and a brace and U-bolt clamp has been incorporated to improve the pipe to junction block joint integrity.
