# Technical Service Bulletin

Technical Service Bulletin: tsb100465

Lubricating Oil Centrifuge Modification

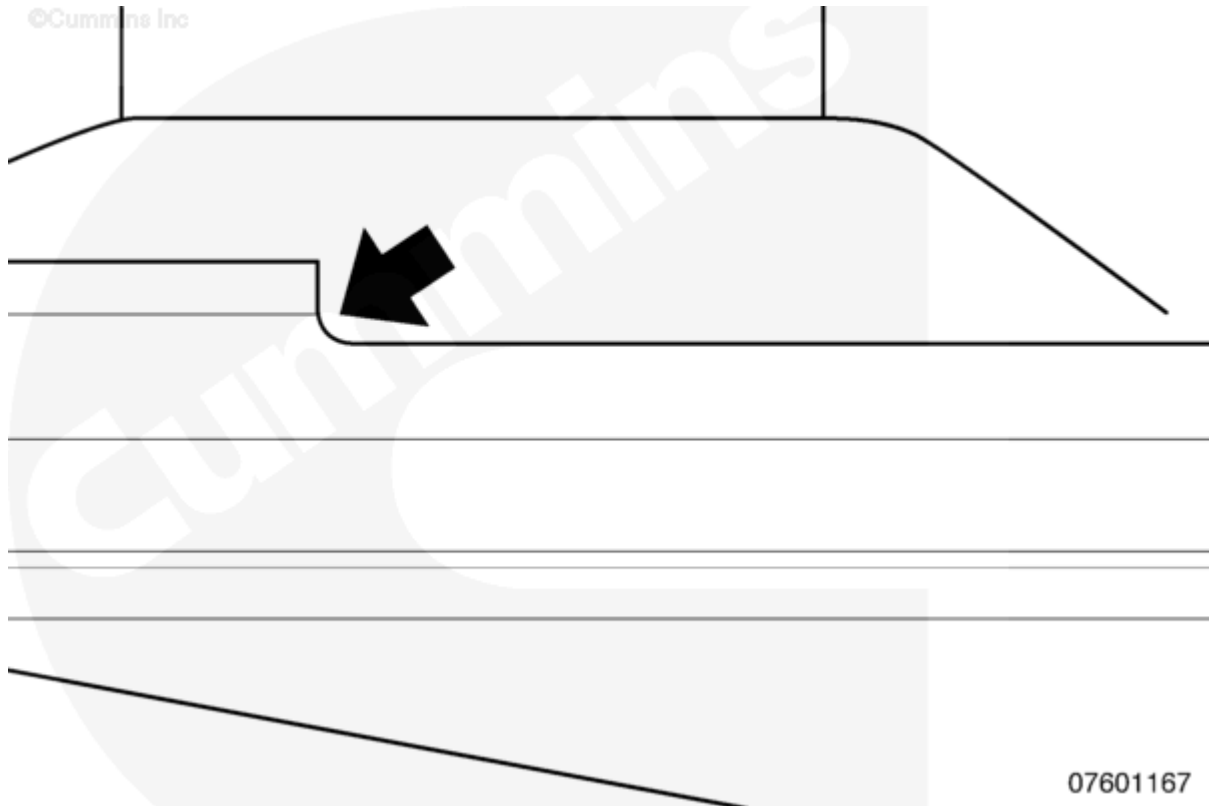
This Technical Service Bulletin details a modification carried out on the lubricating oil centrifuge (Fleetguard® Part Numbers 389497500S, CH4410500 and CH4412000), fitted on some QSK60 Construction series engines. To resolve an issue of high pressure spikes within the centrifuge and subsequent rotor cracking, the balance notch on the rotor turbine has been modified to include a radius which will lower the stresses and eliminate the cracking.

Fig 1. New Radius on Balancing Notch.

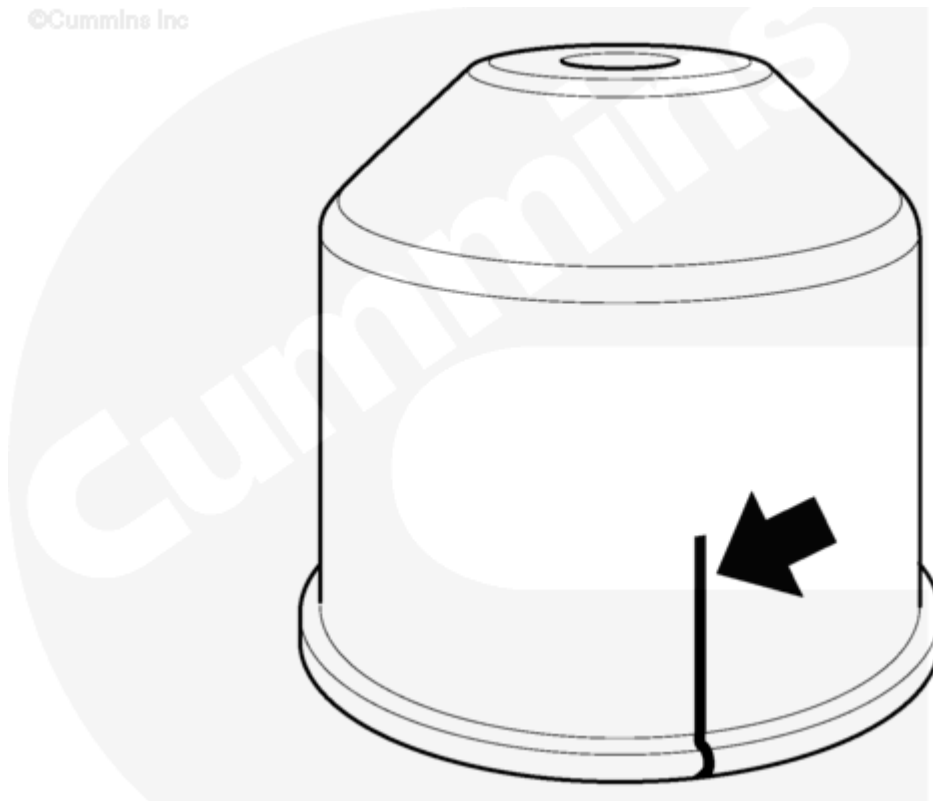
No part number change was required. Fleetguard® have marked all the present stock of modified rotor assemblies with a white line on the outside of the turbine can, as well as a white check mark on the bottom of the centrifuge.

Fig. 2 and Fig. 3 show markings on modified centrifuge.
