Technical Service Bulletin: tsb100555

Released Date: 30-Jan-2007

Modified Lubrication Oil Centrifuge

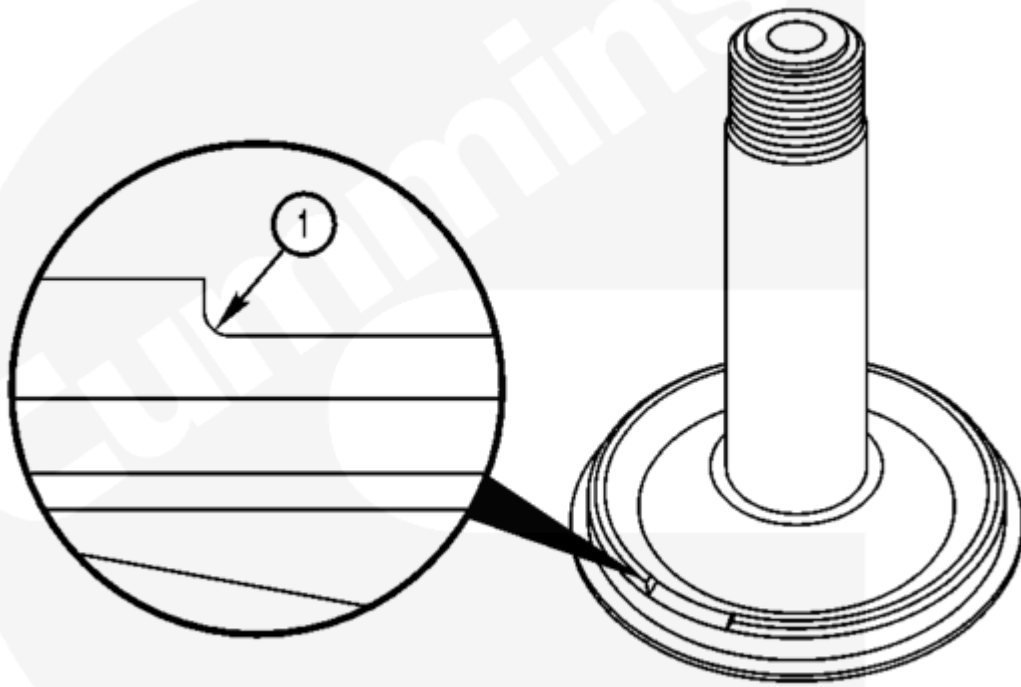
07601198

This Technical Service Bulletin describes a modification carried out on the lubrication oil centrifuge, Fleetguard Part Numbers 389497500S, CH4410500, and CH4412000, fitted to some QSK60 Construction series engines. This modification resolves an issue of high oil pressure spikes within the centrifuge and subsequent rotor cracking. The balancing notch on the rotor turbine has been modified to include a radius which lowers the stresses and eliminates the cracking. The centrifuge oil supply **must** be tapped after the full-flow lubrication filter(s) (clean side) to eliminate potential issues of high oil pressure spikes, which can be detrimental to centrifuge performance.

#### New Radius on Rotor Balancing Notch

##### 1. Radius.

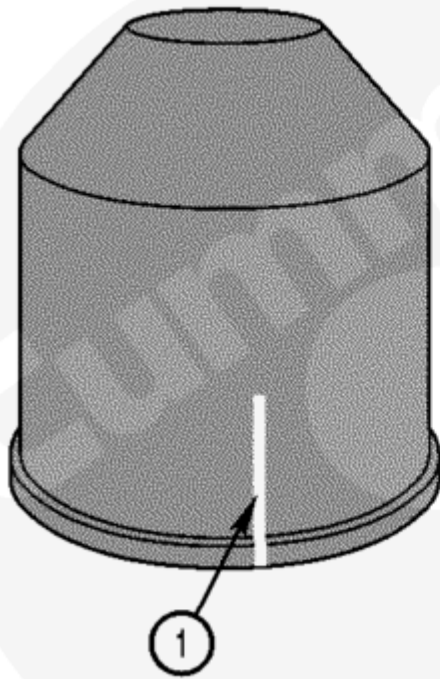
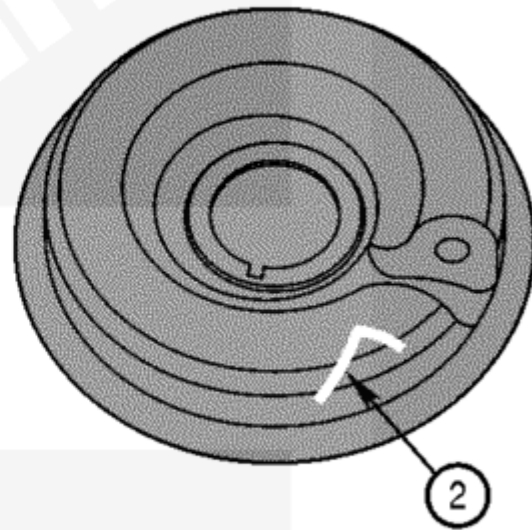
07601199

No part number change was required. Fleetguard® have marked the modified rotor assemblies with a white line on the outside of the turbine can as well as a white check mark on the bottom of the centrifuge.

1. White line on outside of turbine
2. White check mark on bottom of centrifuge.
