Technical Service Bulletin: TSB101036

Field Notification of Mislabels QSK60 Phase 2.0 CENSE™ Wiring Diagram, Bulletin 4021412 (Version-02 and -03)

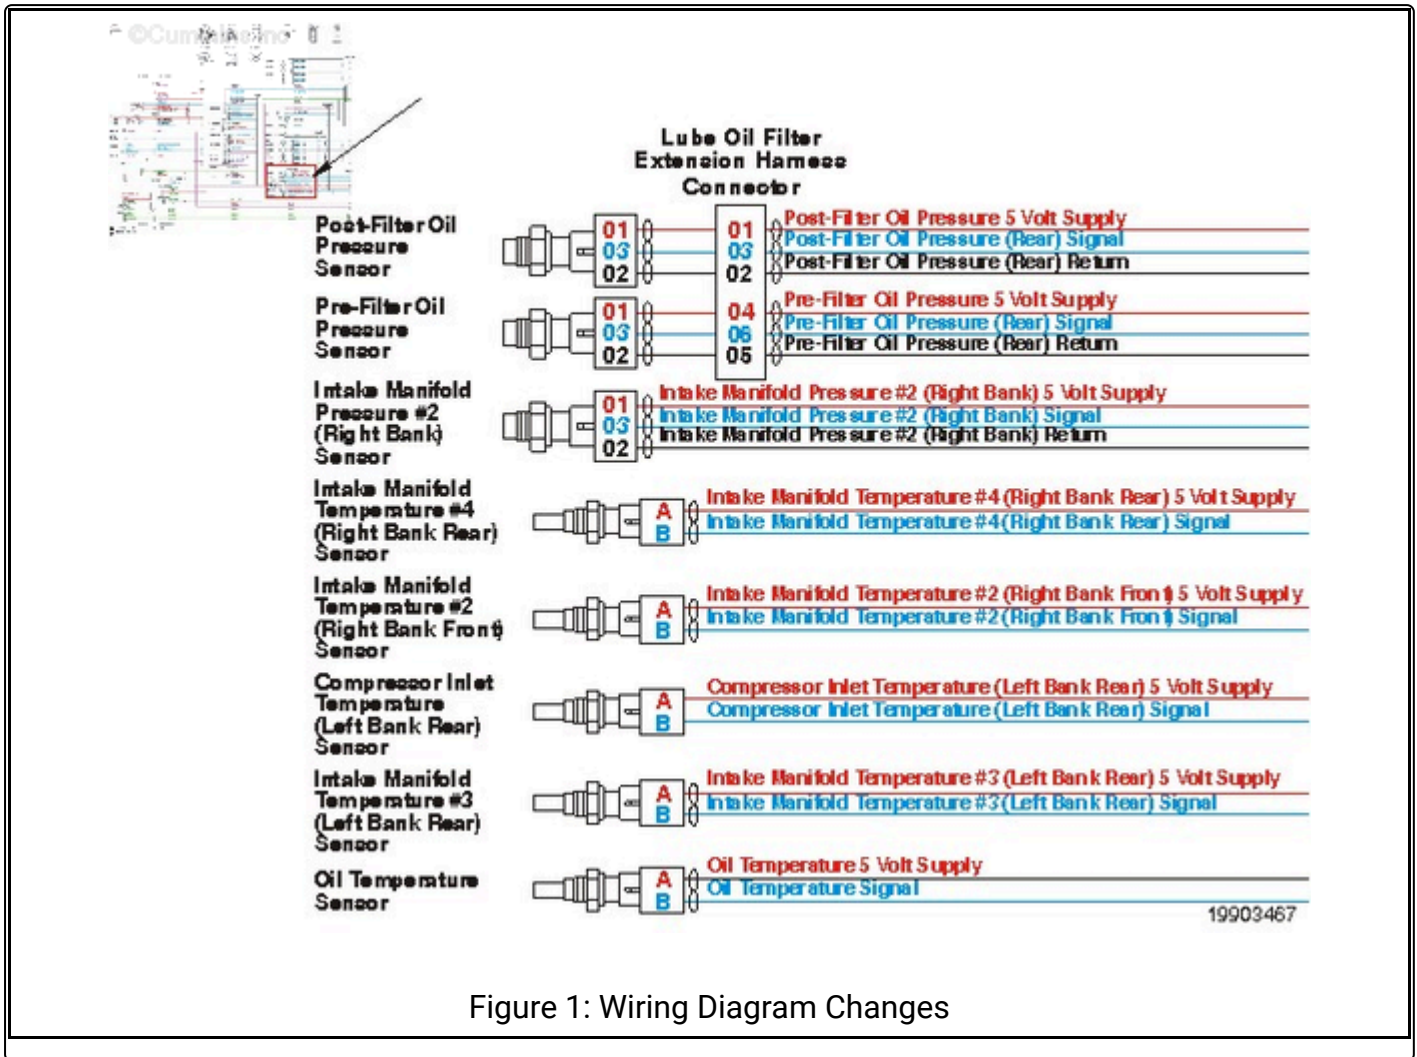
Figure 1: Wiring Diagram Changes

The purpose of this document is to inform the field of three sensor and six wire mislabels on the Lube Oil Filter Extension Harness Connector for the QSK60 Phase 2.0 Industrial with CENSE™ Wiring Diagram, Bulletin 4021412. These mislabels exist on two versions of the wiring diagram, Bulletin 4021412-02 and 4021412-03. Reference Table 1 and Table 2 for the intended label information until Bulletin 4021412-04 of the wiring diagram is available.
