Technical Service Bulletin: tsb101240

Released Date: 22-Jan-2003

Jacket Water Cooling Circuit Improvement

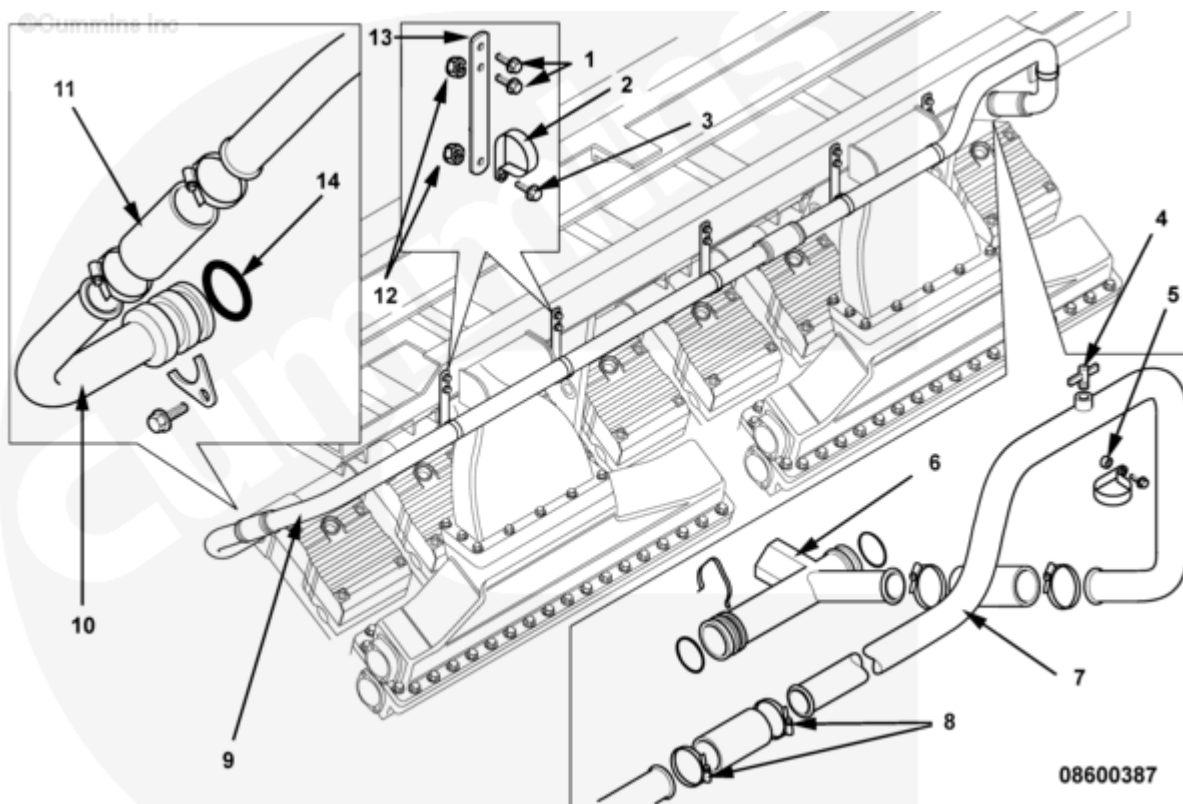
Figure 1, New Arrangement (Right Bank)

This Service/Parts Topic announces an improvement to the jacket water cooling circuit on QSK60 engines with 2-stage turbocharging. The intent of the design change is to increase coolant flow around the right bank cylinder liner number 8, resulting in greater cooling and ultimately extended piston ring life. This is achieved with the addition of a loop in the cooling system which balances the coolant flow between the right bank cylinder number 1 and cylinder number 8.

This coolant loop is unique to QSK60 2-stage engines because the coolant supply for the intercoolers is located near the right bank cylinder number 8.

It is recommended that the right bank cylinder number 8 coolant loop is fitted at engine rebuild.
