Technical Service Bulletin: tsb101277

Released Date: 26-Aug-2003

New Oversize Head Gasket

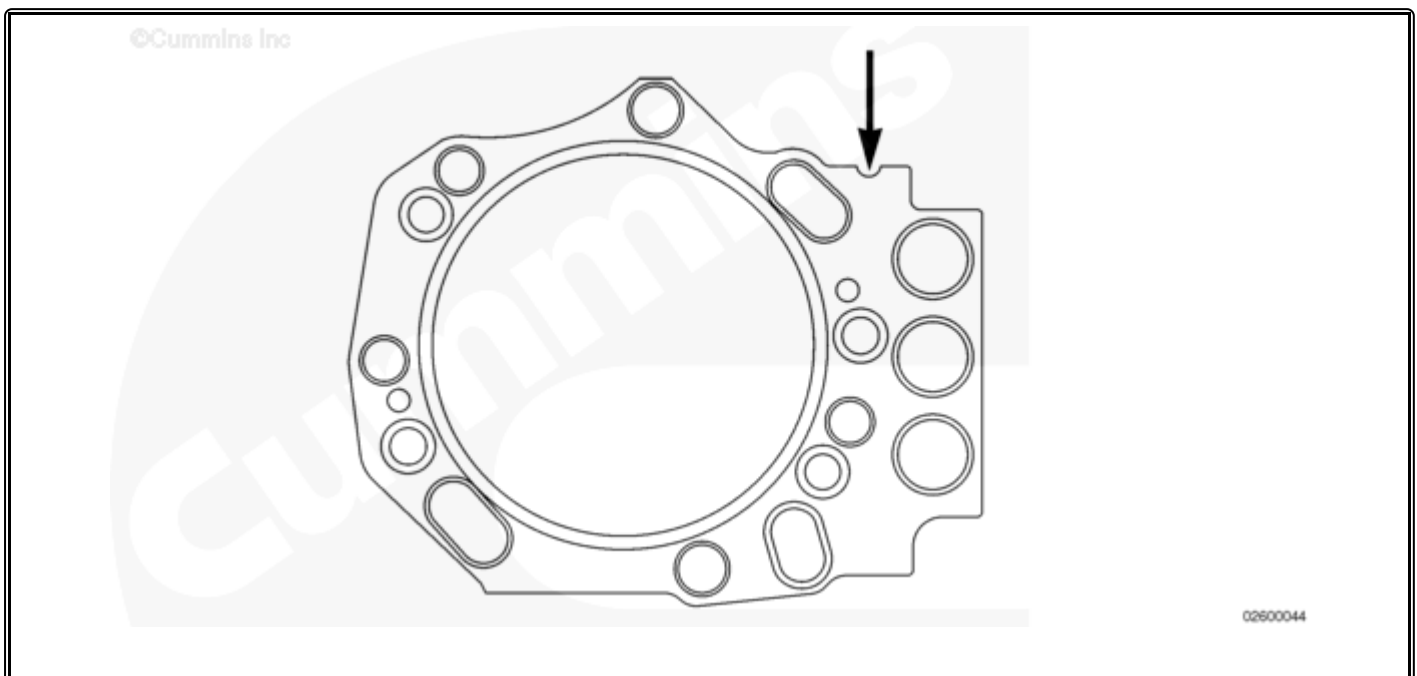
This service/parts topic introduces a new oversize head gasket and wear limits for the cylinder block head deck of the QSK45 and QSK60 engines. The new cylinder head gasket, Part Number 4086730, has been released to allow the repair of worn cylinder blocks at engine rebuild/overhaul. The new gasket makes use of the same material and form as the existing gasket but is 0.51 mm [0.020 in] thicker. The gasket has a notch in the carrier to denote the gasket is a service oversize gasket, see the illustration above.

Cylinder block head decks wear due to several factors, some are listed below:

- In operation, fine particles of dirt can get under the head gasket where it becomes trapped. In operation, the cylinder head moves on the head gasket (very small amounts) and the gasket moves on the cylinder block. When dirt is trapped between the gasket and the block, motion frets the cylinder block surface.

- If coolant leaks from the head gasket, the counterbore, or leaks externally, corrosion can start. The cylinder head deck is eroded by corrosion and pitting .

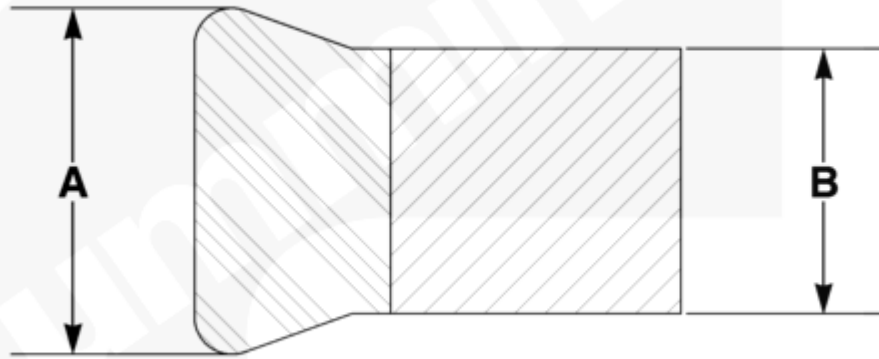
02600045

The illustration above shows the dimensions for the oversize gasket.
