Technical Service Bulletin: TSB180091

New Camshaft Thrust Bearings

- QSK45 CM500
- QSK60 CM500
- QSK60 CM850
- QSK60 CM2150

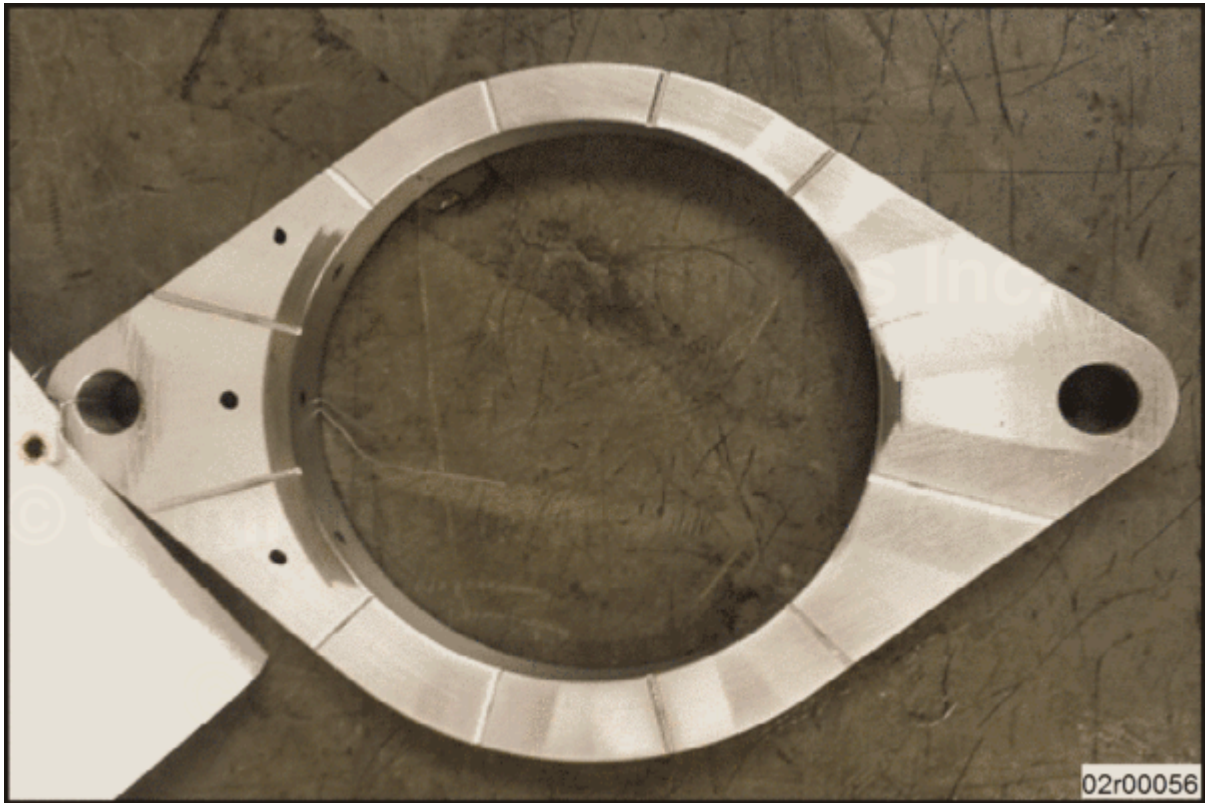
New part has 12 oil grooves, existing part has 6 oil grooves. See Figure 1.

Figure 1, New Cam Thrust Bearing.

New camshaft thrust bearing is made from a more robust material. New camshaft thrust bearing also incorporates a ramp and pad design on the thrust surface, creating an oil film between camshaft thrust bearing and camshaft.
