Technical Service Bulletin: TSB200112

Released Date: 01-Jun-2020

QSK60 CM500 Lube Pump White Stripe Check

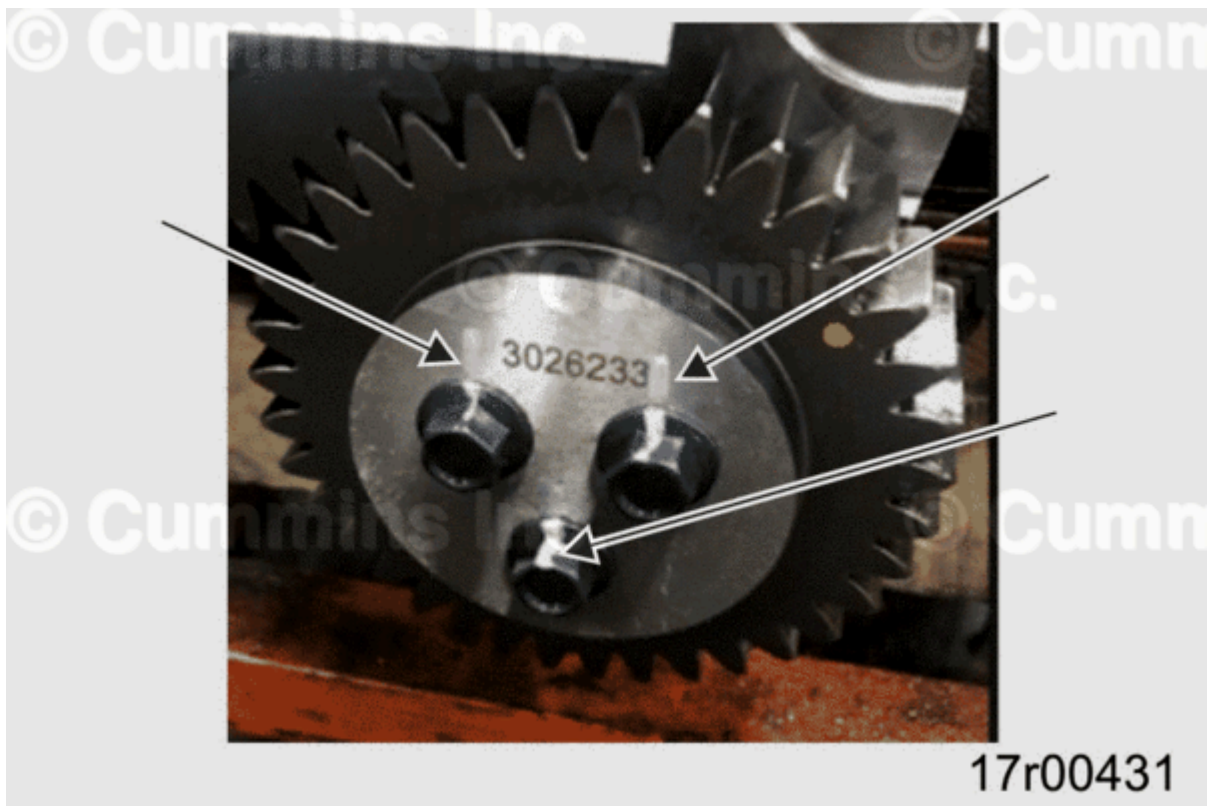
Figure 1, Bolts and Gears

Root Cause: Gear bolts have not been torqued correctly from the supplier meaning there is less pre-load.

- The cap screws start to back out and cause fretting on the mating surfaces.
- At least two of the bolts back out leaving the final bolt to maintain the gear loading.
- All of the bolts fracture losing oil pressure.

Check the bolts and gear for the white stripe as shown below.

If the white stripes are present, no further action is required and the lube pump can be installed to the engine.

If there are no white stripes, follow the torque instructions for the bolts in manual 4021530, Section 007, Procedure 031.
