Technical Service Bulletin: TSB210009

Released Date: 12-Jan-2021

New Cylinder Block to Reduce MCRS Fuel Pump Malfunction

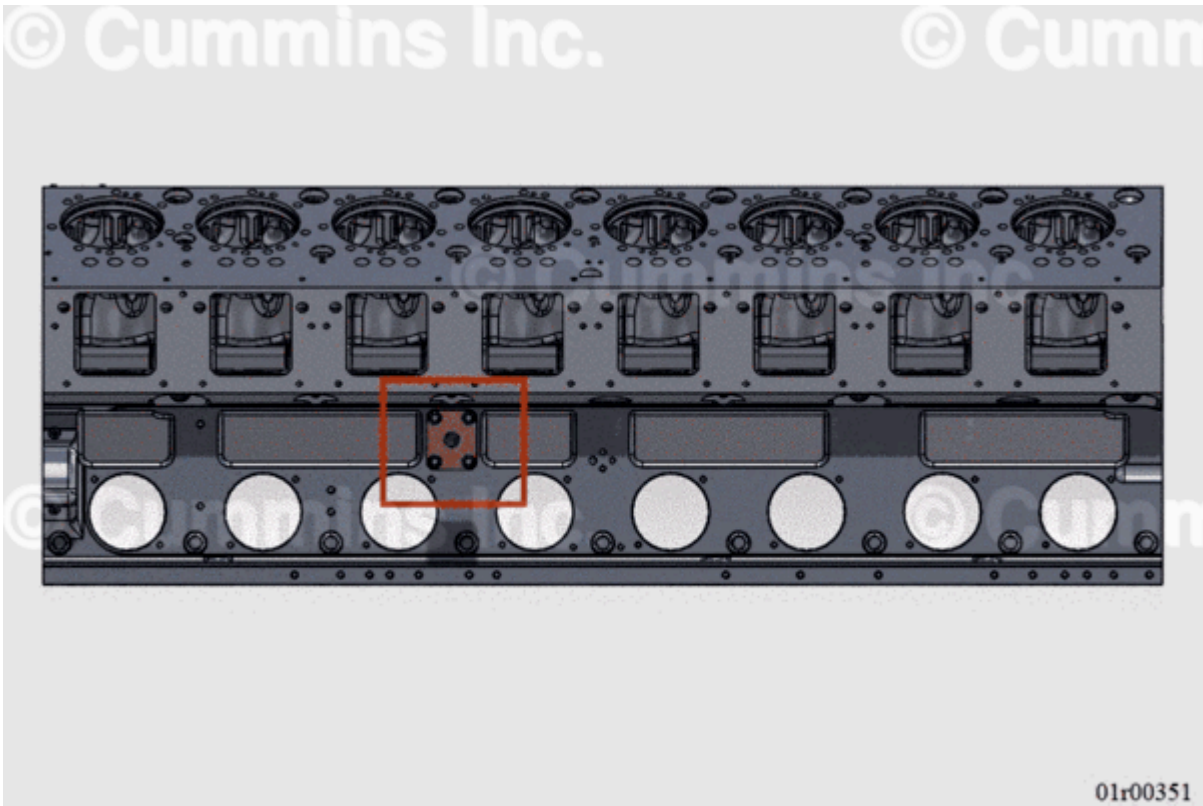
The new cylinder block part number can be identified by the hole drilled in the side of the left bank of the cylinder block. See Figure 1 below.

Figure 1, Location of New Drilling in Left Bank of New Cylinder Block Part Number.

- To increase the oil supply pressure to the MCRS fuel pump, a new cylinder block has been released with a new drilling on the left bank side of the cylinder block. The drilling provides a location for a dedicated high-pressure oil supply line to be linked to the MCRS fuel pump. This drilling will be utilized by Daventry production line to install this supply line once available.
- All service orders of this new cylinder block **must** block off this hole with the blanking plate provided. See Table 1 below for part numbers.
