Technical Service Bulletin: TSB160095

New Exhaust Gas Temperature Sensor and Injector Quadrant Wiring Harness and Mounting Bracket

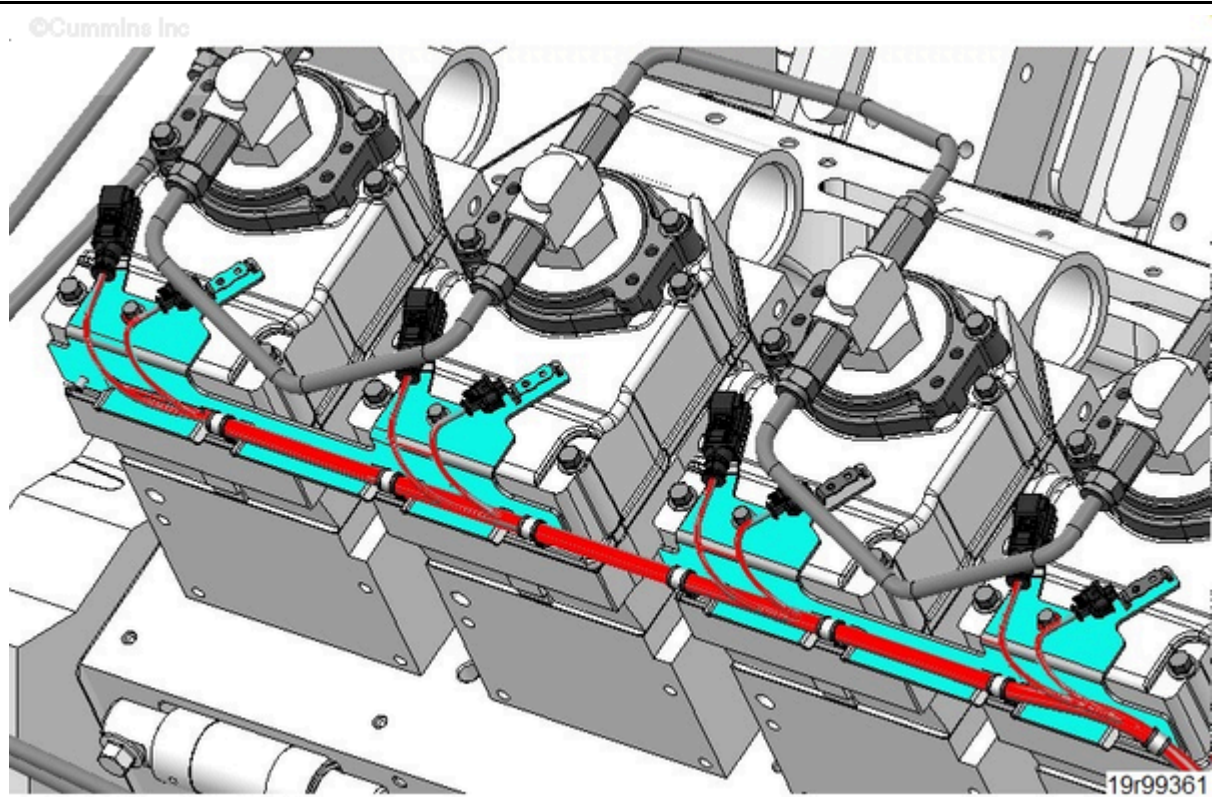
The new wiring harness incorporates a mounting bracket that spans two cylinder heads. Each wiring harness consists of two mounting brackets in total, covering four cylinder heads. See Figure 1 below.

Figure 1, New Exhaust Gas Temperature Sensor and Injector Wiring Harness with Mounting Brackets.

- A new engine wiring harness and bracket assembly including the new exhaust gas temperature sensor and injector wiring harness, and new cylinder head mounting bracket has been released.

- The new components reduce the likelihood of the wiring harness connectors coming loose during operation and reroute the wiring harness to prevent wiring harness fretting caused by incorrect contact with the cylinder block, cylinder head, camshaft cover, or aftercooler housing.
