Technical Service Bulletin: TSB190158

Engine Cooling Fan Will Not Disengage: New Rockford Fan Clutch Solenoid

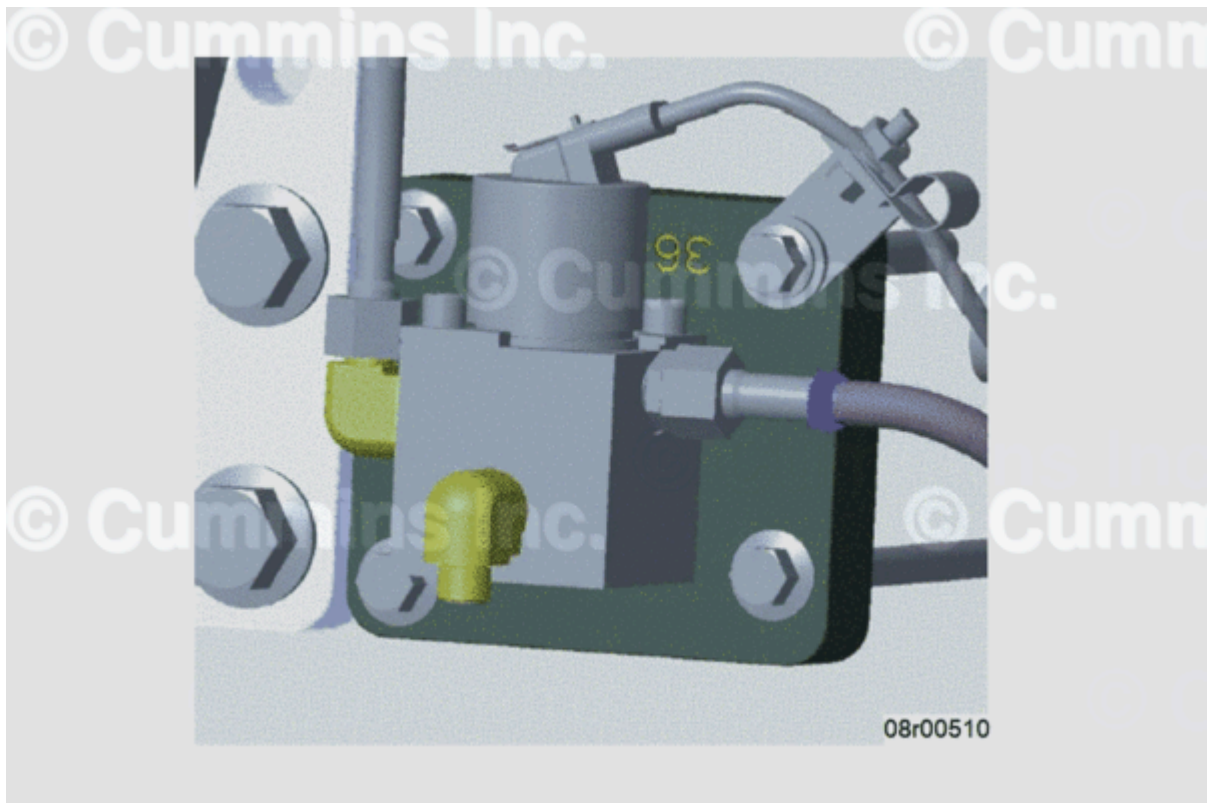
- Rockford fan clutch solenoids malfunctioning caused by fan clutch solenoid coils burning out

Figure 1, Existing Rockford Fan Clutch Solenoid.

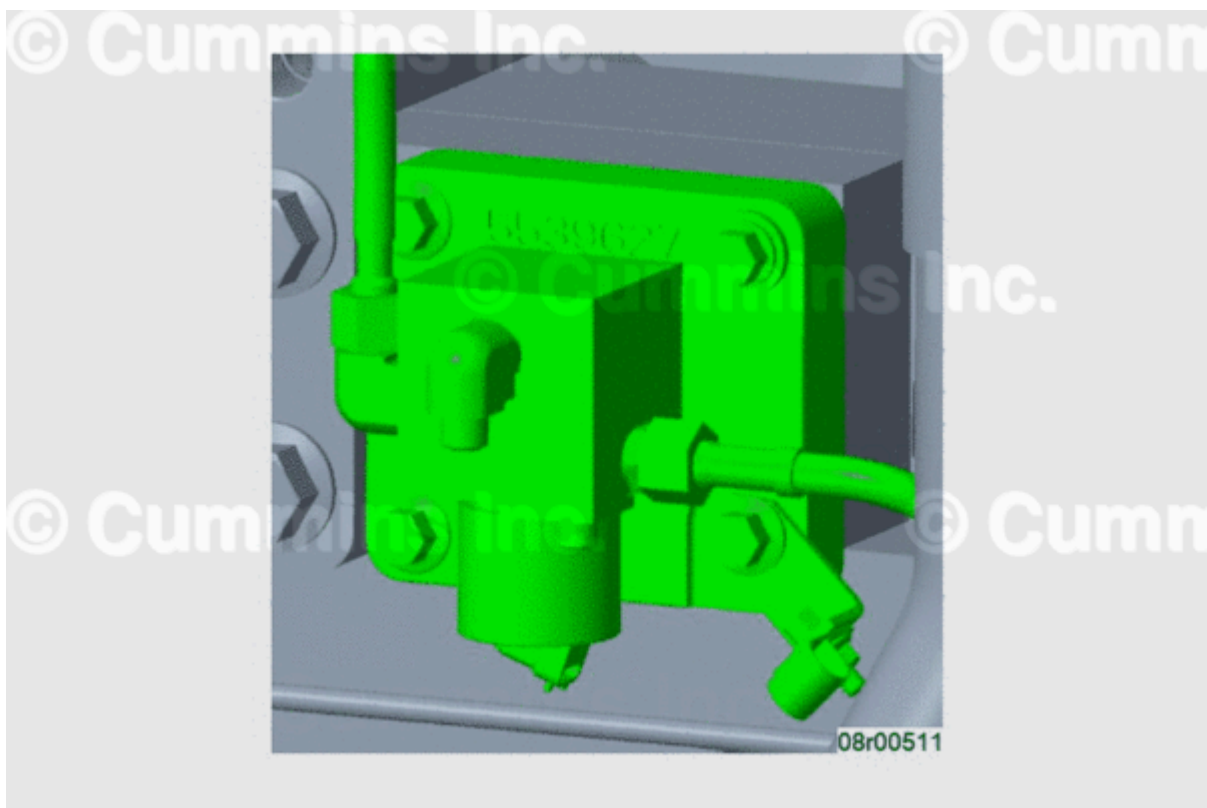
Figure 2, New Rockford Fan Clutch Solenoid.

- A new rotated fan clutch solenoid part number has been released. The new fan clutch solenoid is mounted 180 degrees from the existing position, see Figures 1 and 2 below. See Table 1 below for part number.

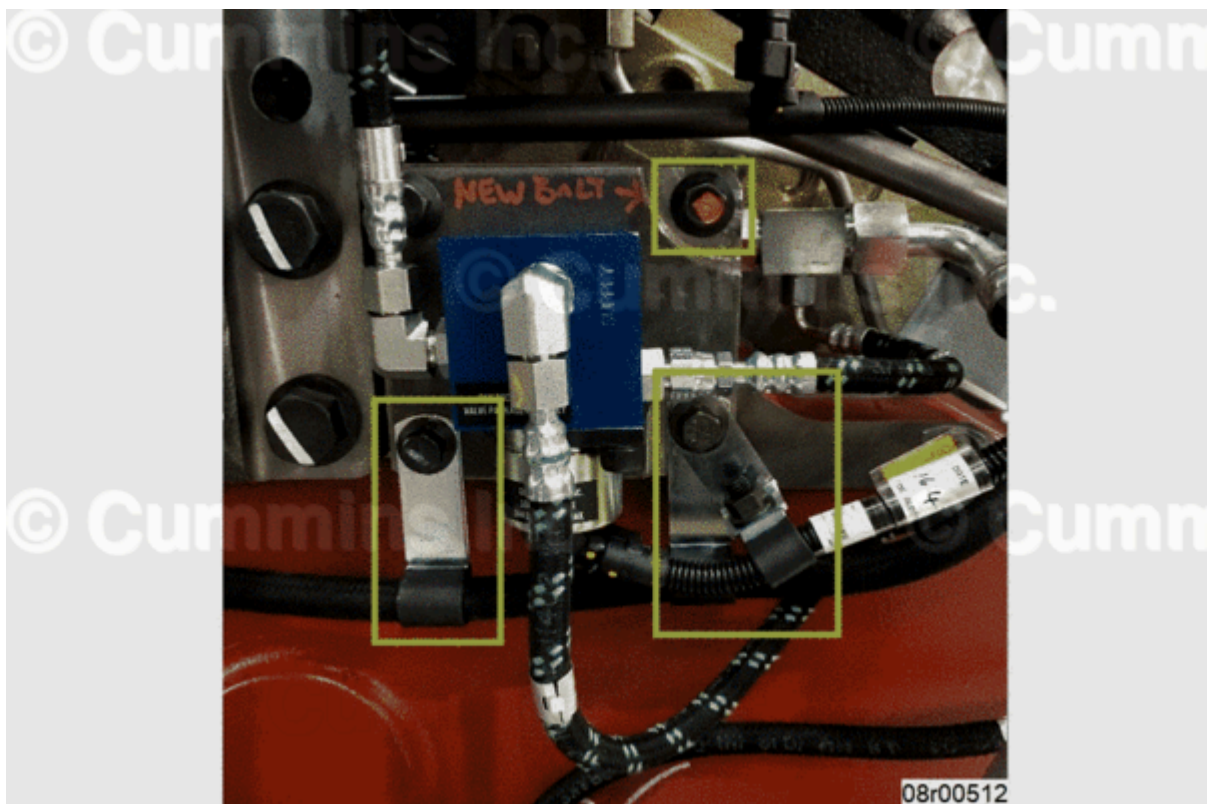
Figure 3, Location of New P-Clip and Shortened Capscrew.

- A new fan clutch solenoid mounting plate part number has been released to enable the rotated fan clutch solenoid to be mounted in the same location. See Table 1 below for part number.
- The new fan clutch new solenoid has the control and sump ports flipped compared to the existing fan clutch solenoid, so the flexible hoses do **not** need to be changed and remain on the same side when the fan clutch solenoid is rotated 180 degrees.
- The top right capscrew has also been changed. See Figure 3 below. Due to the removal of the need for the P-clip in this location, a shorter capscrew is now used in this location, and the washer removed; to avoid the capscrew bottoming out.
- For QSK60 CM500 engines **only**, a new p-clips are used to hold the fuel hose that runs underneath the fan clutch solenoid, see Figure 3 below.
