Technical Service Bulletin: TSB240007

Camshaft Thrust Plate Installation

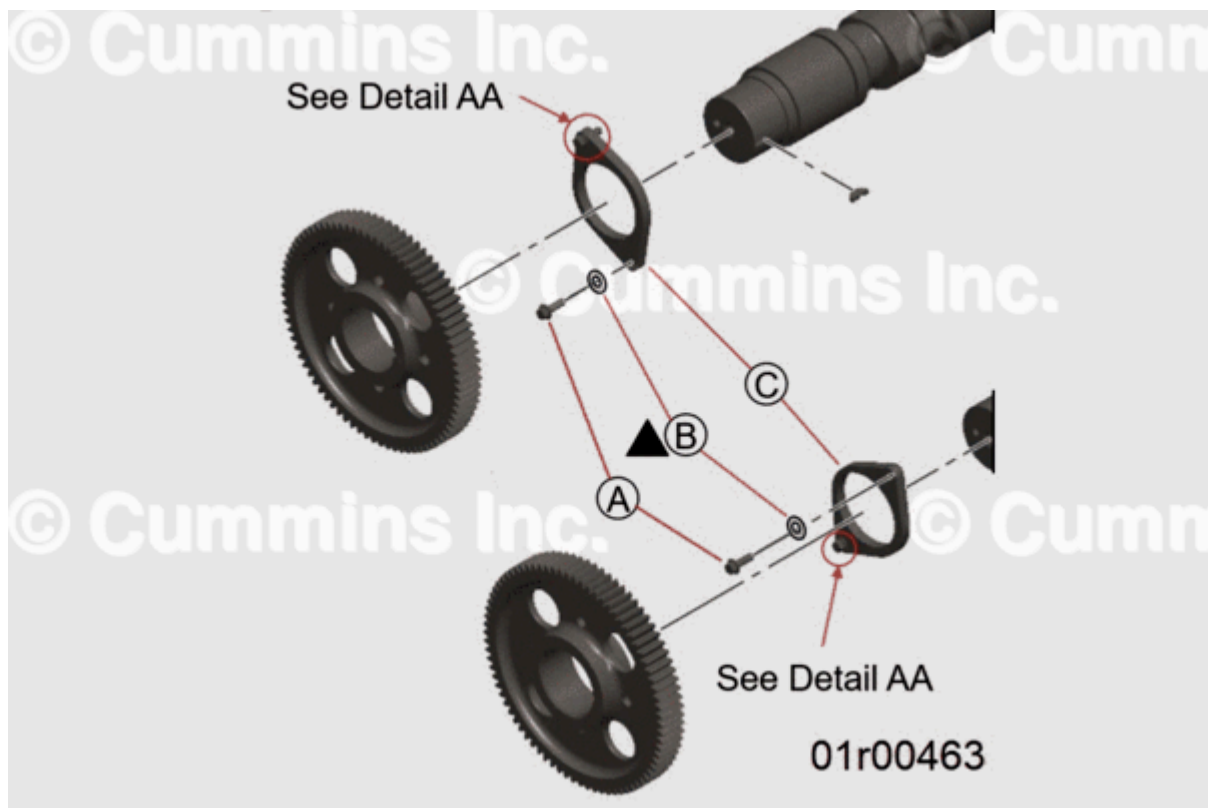
Figure 1, Factory Step 3 Exploded Diagram.

Washer listed in Table 1 and Item B within Figure 1 **must** be used with the existing capscrews, and in the specified orientation, when installing new camshaft thrust plates.

Factory step 3 action has been implemented to address under head embedment of the bolts in the camshaft thrust plate material. Installation of the washers should be targeted in a fix as fail situation or at a scheduled rebuild interval.
