Technical Service Bulletin: TSB260035

Released Date: 26-Feb-2026

Exhaust Valve Malfunction

- QSK60 CM2150 MCRS
- QSK60 CM850 MCRS
- QSK60 CM2350 K116
- QSK60 CM2350 K121
- QSK60 CM2350 K135
- QSK60 CM2350 K136

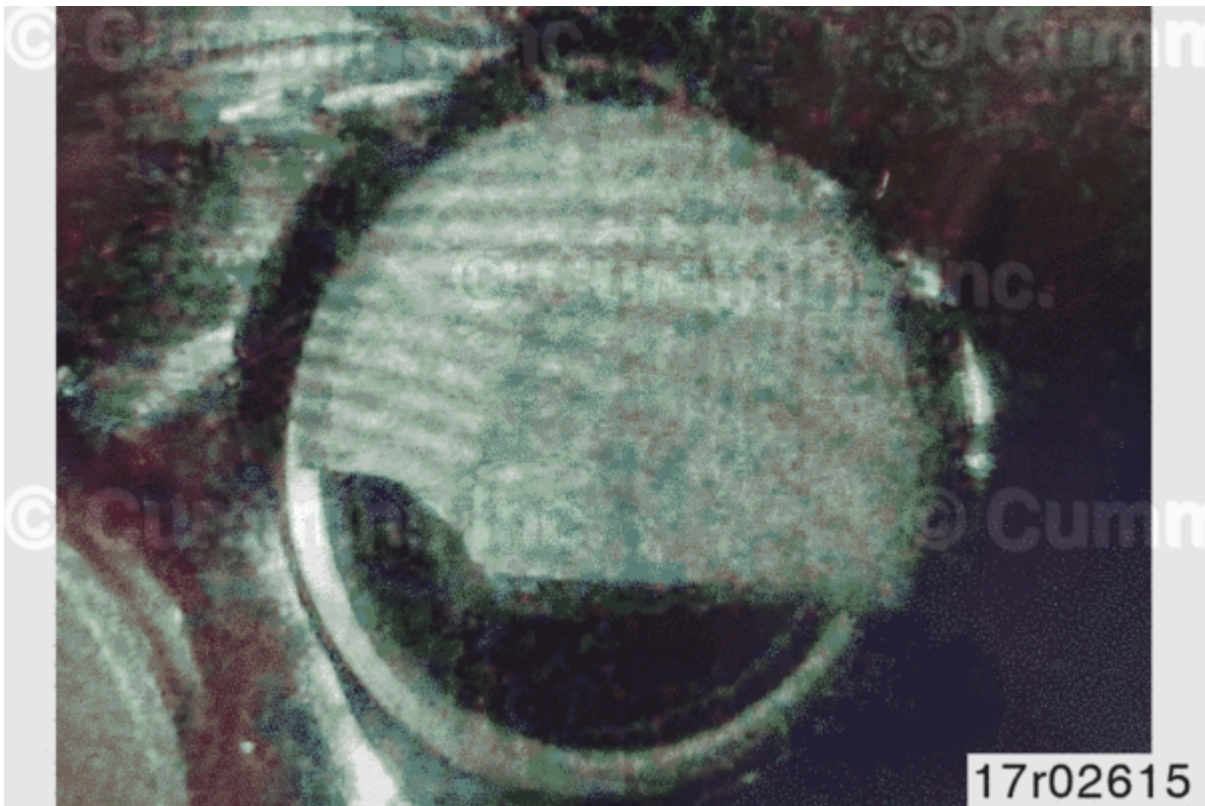
- For chordal fractures:
  - Visual surface defects on valve seat and head; dings, dents, scratches, cracks and surface porosity.
  - Valve head material hardness too low.
- For seat material de-bond:
  - Poor seat weld fusion to valve head base material.

Figure 1, Borescope image showing chordal fracture on an exhaust valve

The latest exhaust valve hardware has been improved to combat all failure modes. The latest exhaust valve hardware should be used in replacement of all above verified cases.

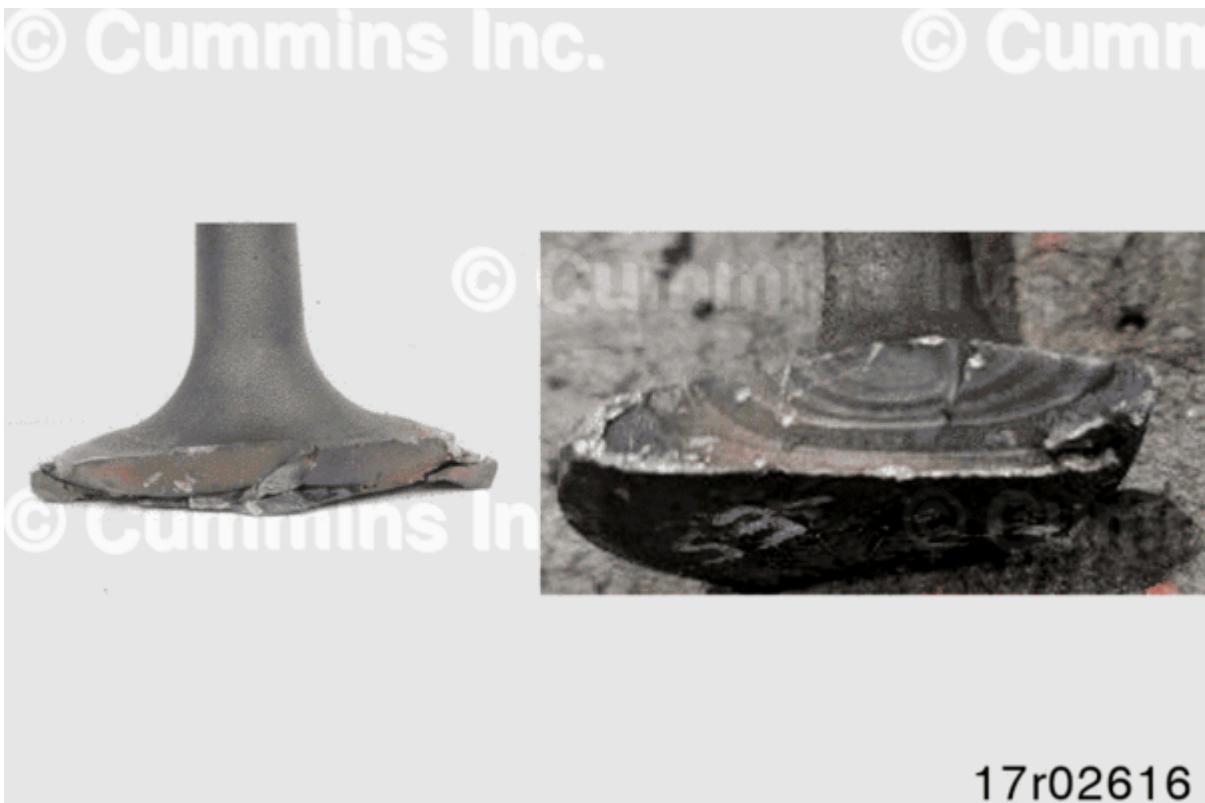
Figure 2, Examples of Exhaust Valve Chordal Fracture

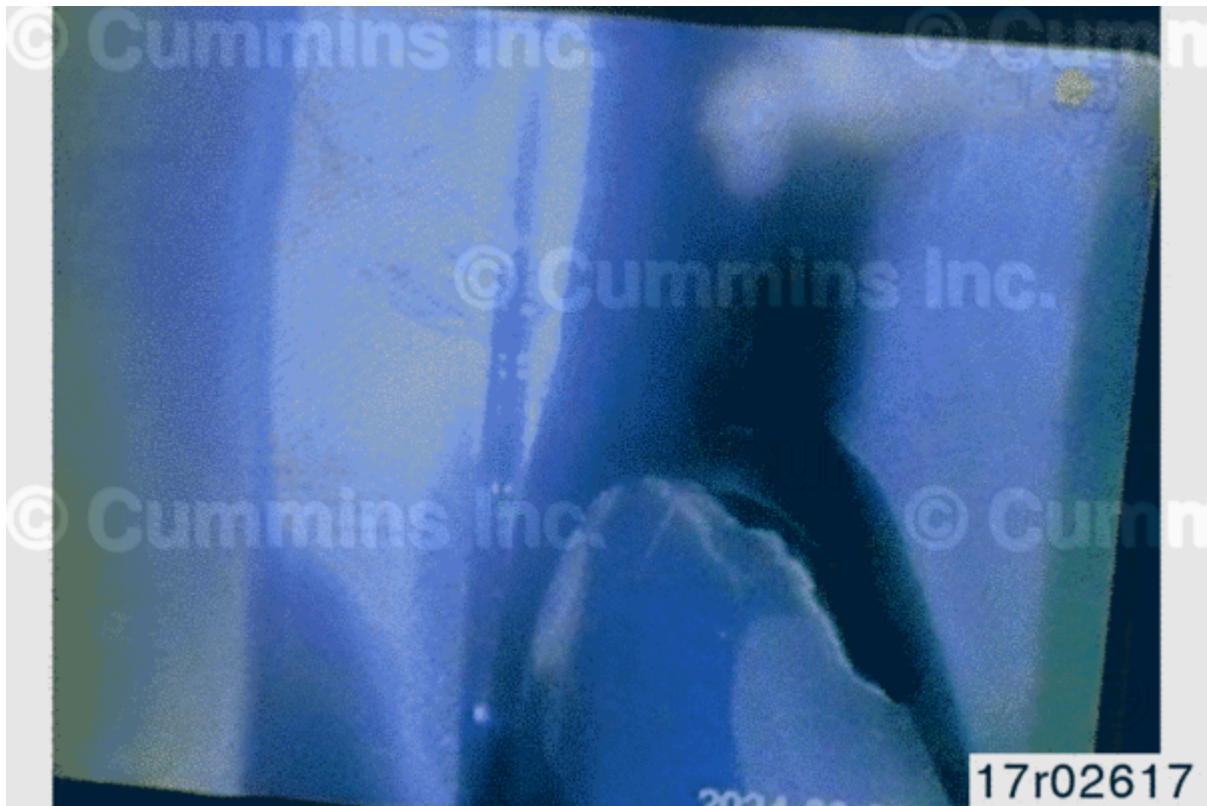
Figure 3, Borescope image showing seat material de-bond on an exhaust valve.

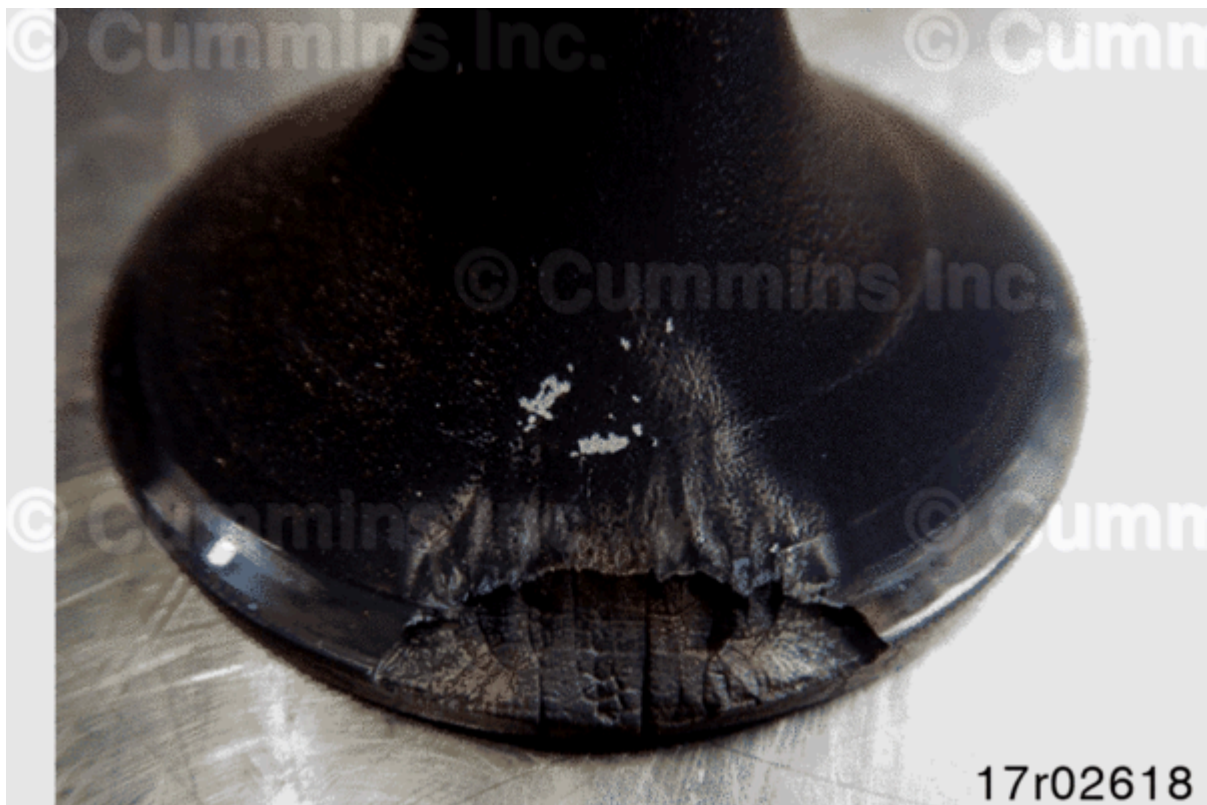
Figure 4, Exhaust Valve showing Seat Material De-Bond and subsequent torching.

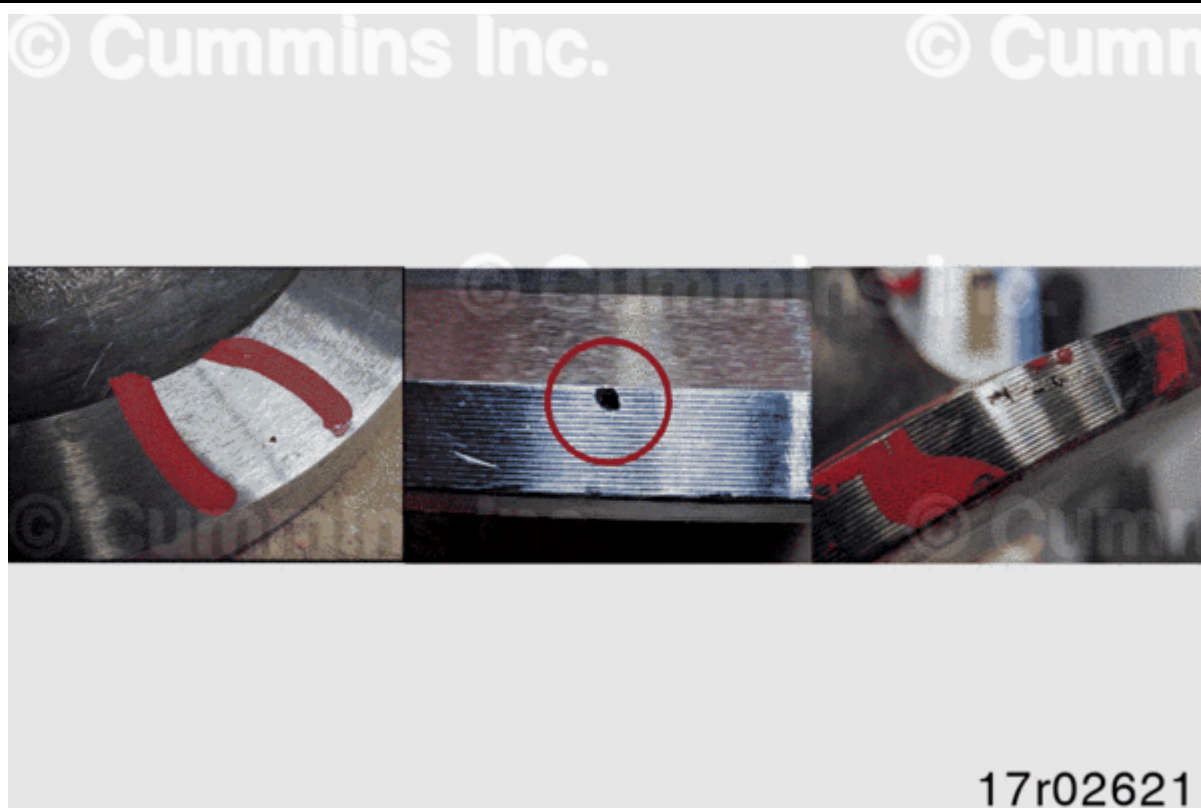
1. Use a magnifying glass (5x) or equivalent to check the outer diameter (1), exhaust valve seat (2) and exhaust valve seat edge (3) for porosity or obvious holes in the material surface around the full circumference of the valve, see Figure 7.

Figure 7, Example porosity

If non-conforming parts are found, please return them to the local parts distribution center or branch from which the parts were received. Parts stocking locations can process this non-conforming stock via the parts alert process. See alert 2025-174 for loose valves and valve kits. See alert 2025-175 for cylinder head assemblies.

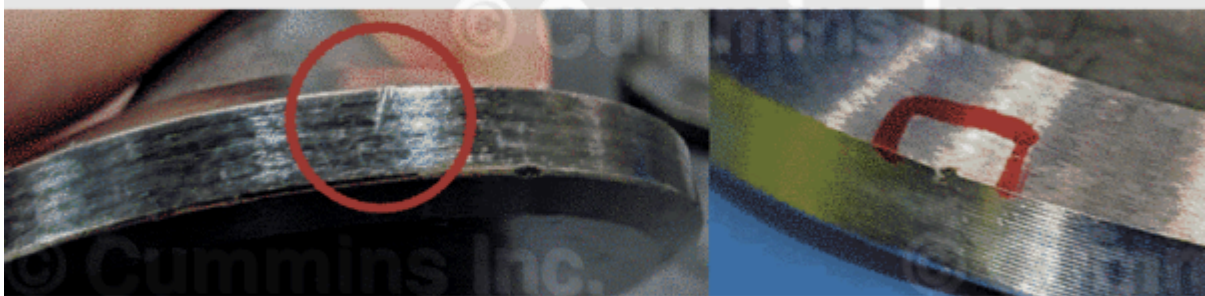
17r02623

2. Check for dings, dents or scratches on the exhaust valve seat surface (2). See Figures 8 and 9

Figure 9, Example dings/dents

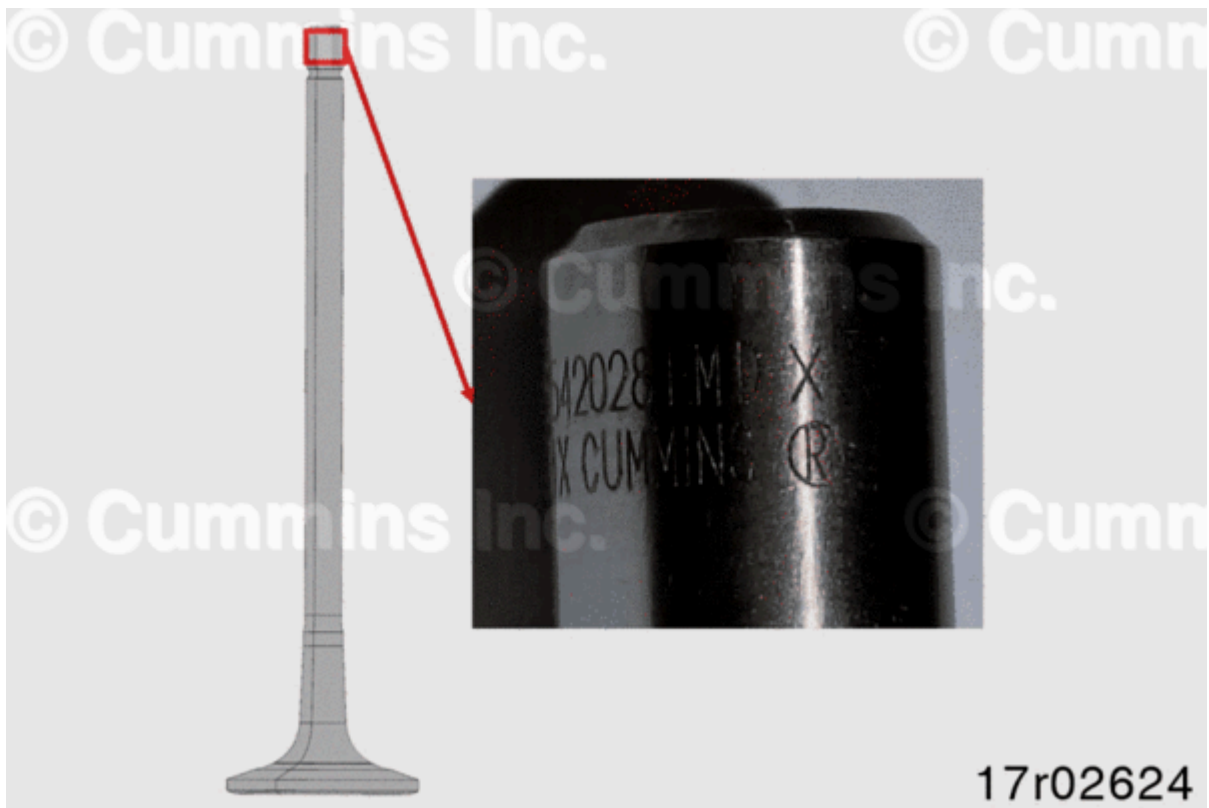
Exhaust valves are identifiable by the marking on the tip of the valve stem. The valve part number, date code and manufacturing facility will be visible, see Figure 10.

Figure 10, Example valve tip information
