Service Bulletin Number: 3666052-03

Released Date: 15-mar-2007

Camshaft Reuse Guidelines for Cummins® Engines with Roller Followers or Roller Tappets

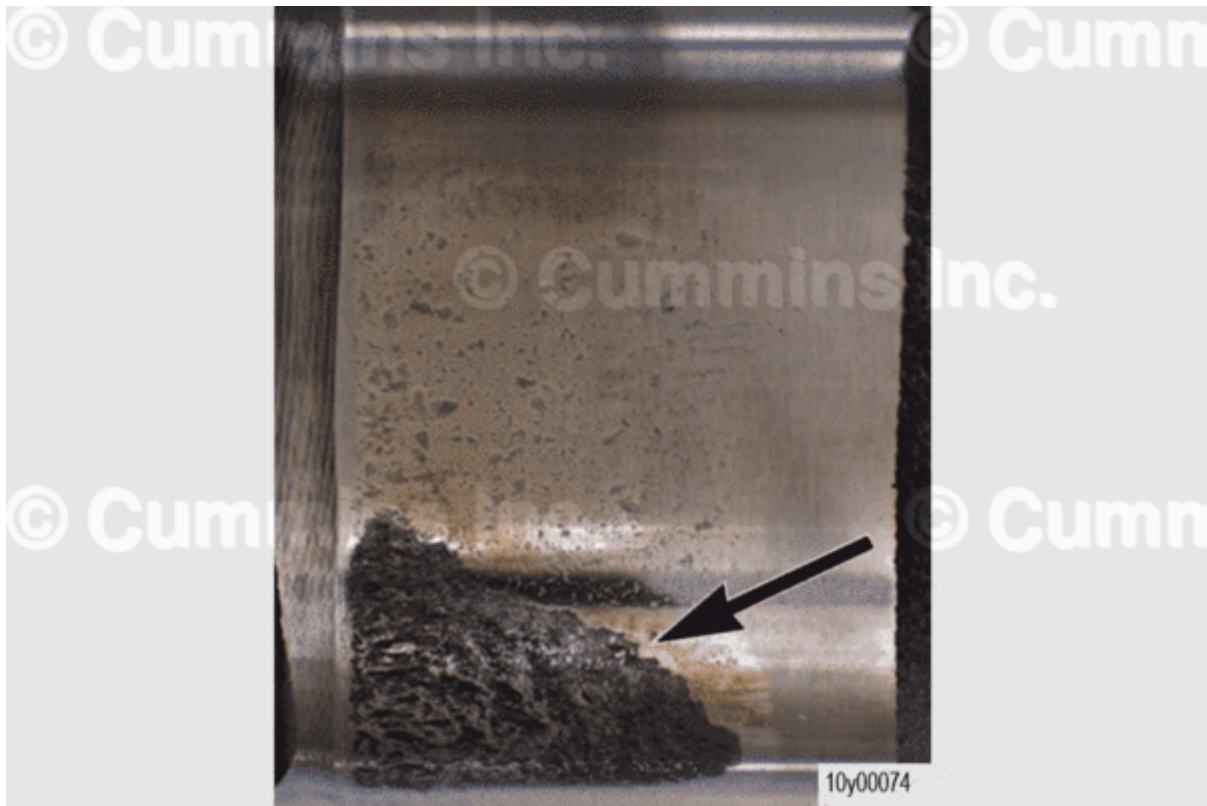
M. Pitting: Do Not Reuse
