Service Bulletin Number: 3810387

Released Date: 02-nov-2015

Analysis and Prevention of Bearing Failures

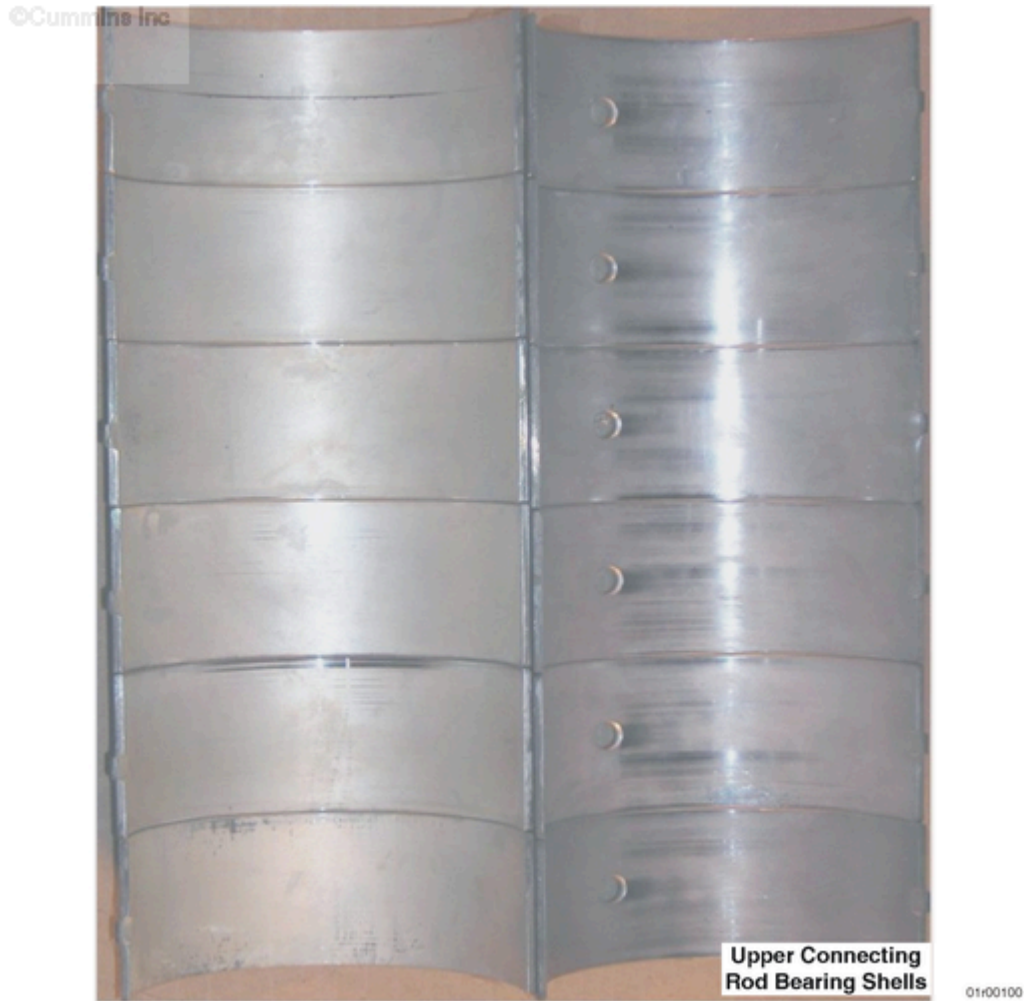
Figure 27: Minor wiping of trimetal connecting rod bearings.

Figure 27 shows the upper and lower connecting rod bearing shells from a QSX15 engine that suffered a failed lubricating oil pump at two hours. The engine was shut down before any bearings were damaged. The bearings in the photograph could have been reused if they had been marked for location and installed in the same connecting rod on the same throw of the same crankshaft. This is a trimetal bearing with a nickel layer but the nickel layer is **not** visible.

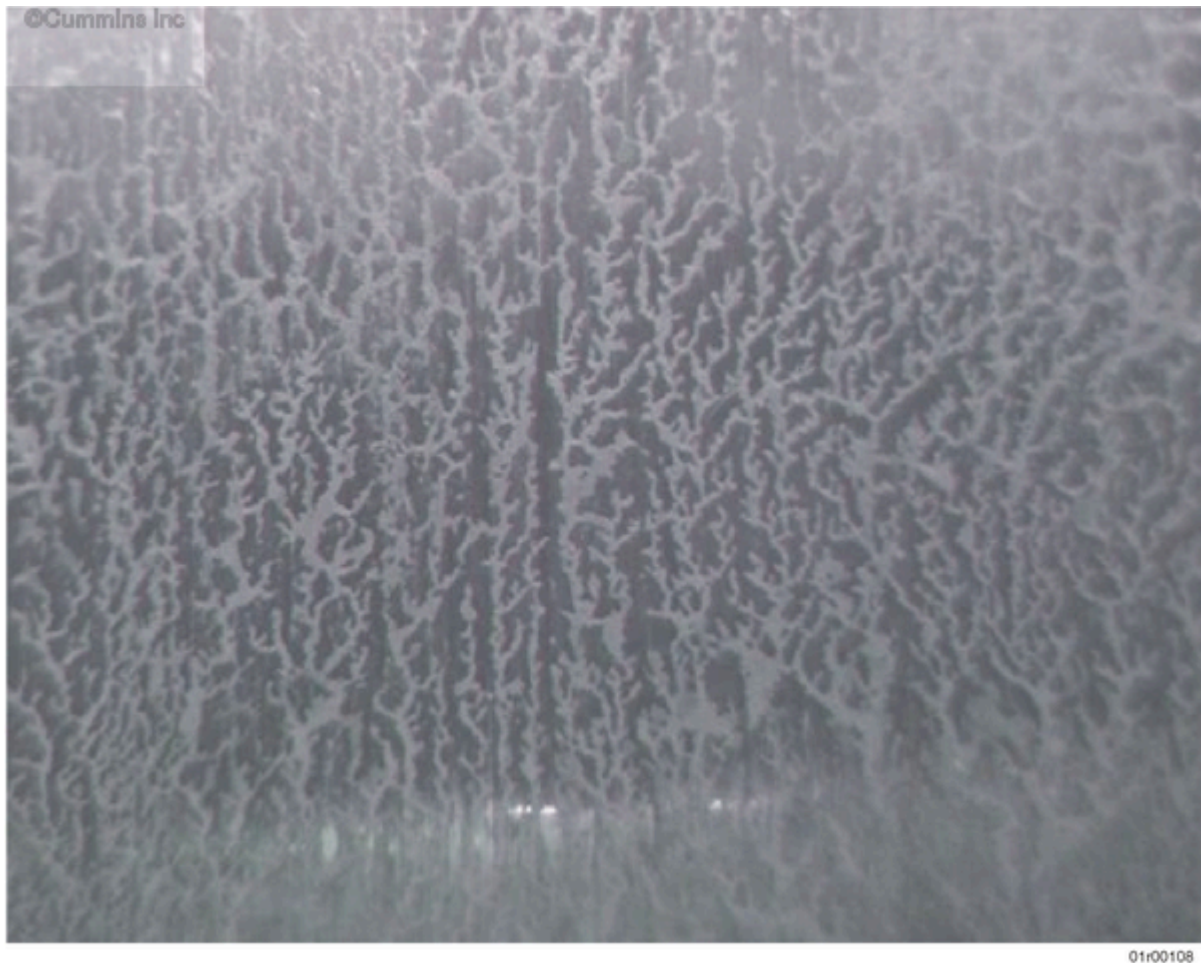
Figure 35: A less common form of overlay fatigue on a trimetal rod bearing shell.

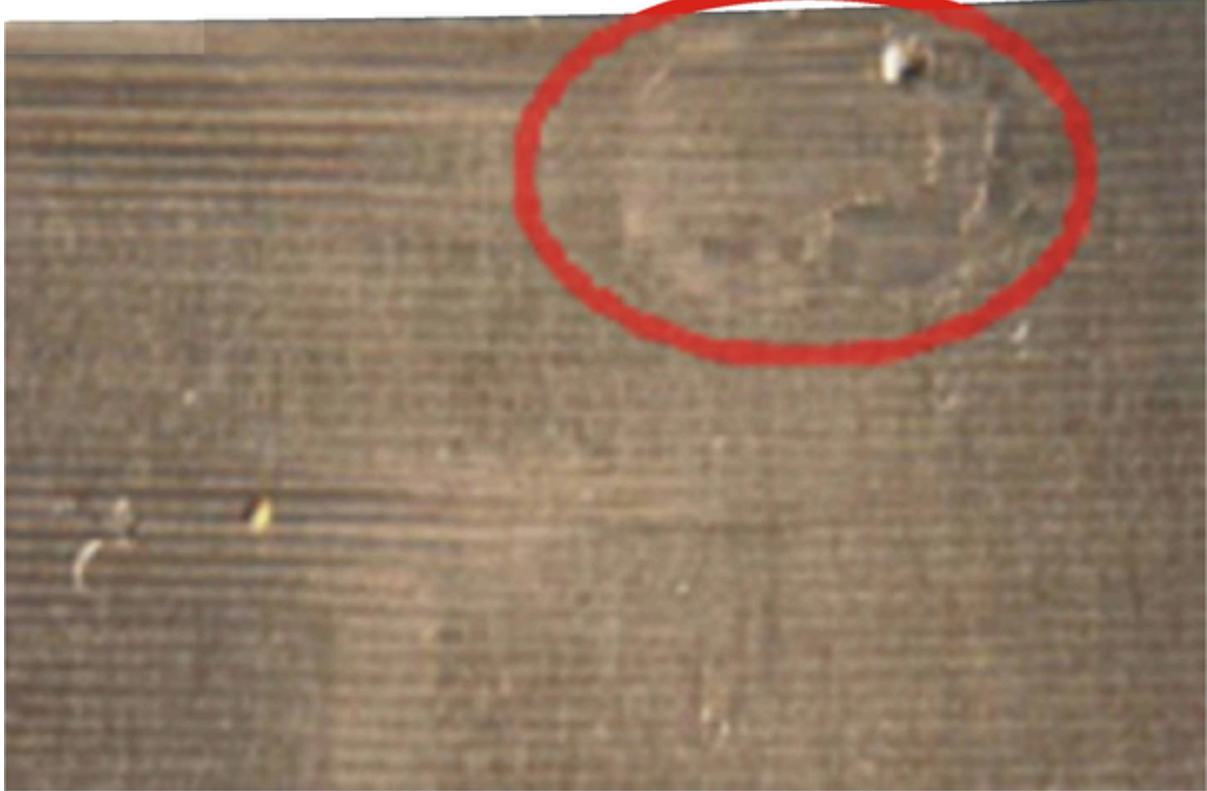
Figure 39: Early lining fatigue of a bimetal bearing shell.

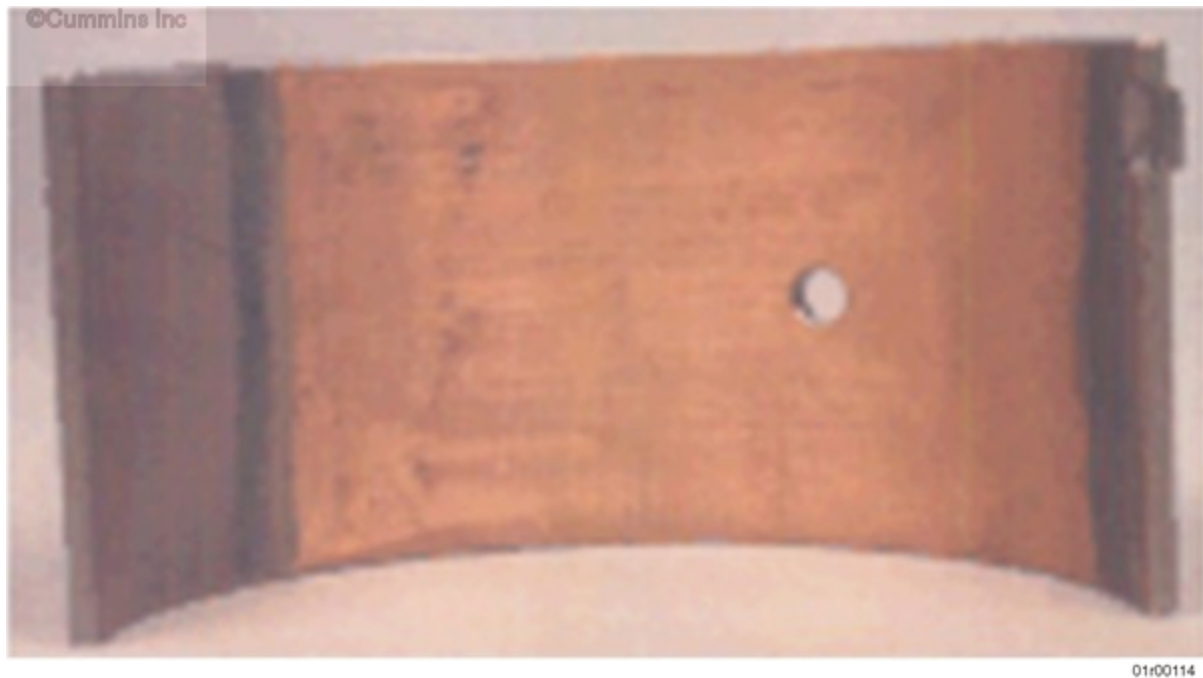
Figure 41: Corrosion of a trimetal bearing shell that has been exposed to glycol in the coolant.

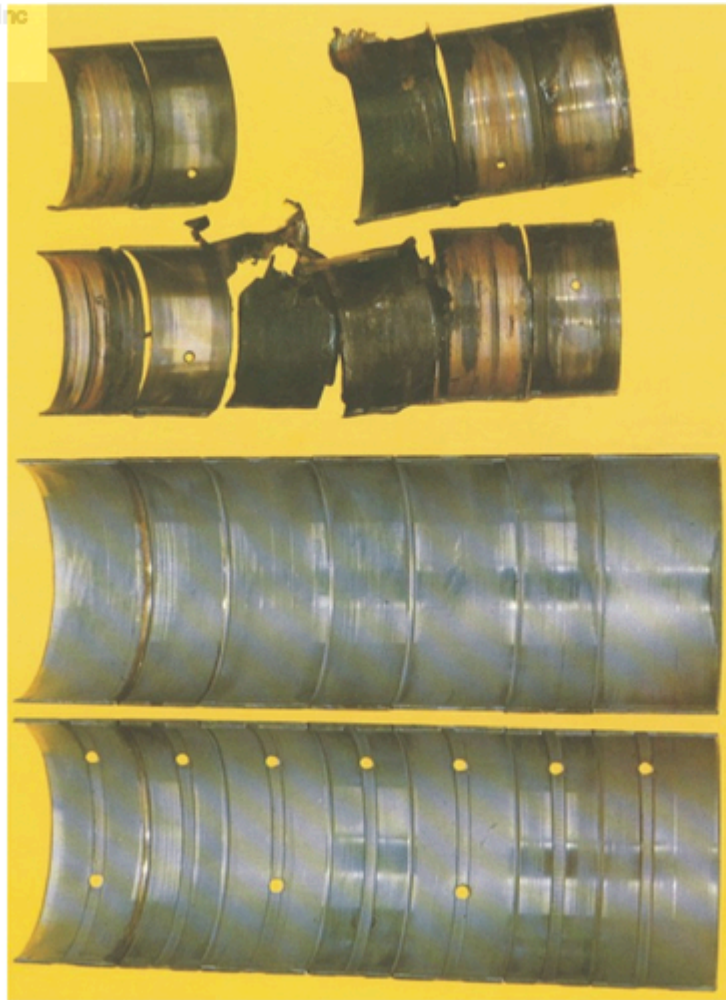
01K00119

Figure 46: Set of trimetal bearings from a destructive test.

Figure 46 shows a set of bearings from an engine that had the oil drained in a test cell.

In the case of the bearings shown in Figure 46, the test cell operator decreased the load in effort to keep the engine speed at 2100 rpm. The engine speed quickly began to decrease so the engine was stopped.

Note that the main bearings show some wiping of the overlay. The number 1 main bearings (on the far left), have copper showing on the edge. The wiping and the copper exposure are **all** the result of the crankshaft main and rod journals moving out of correct alignment due to overheating from the friction that results from the bearing seizure.

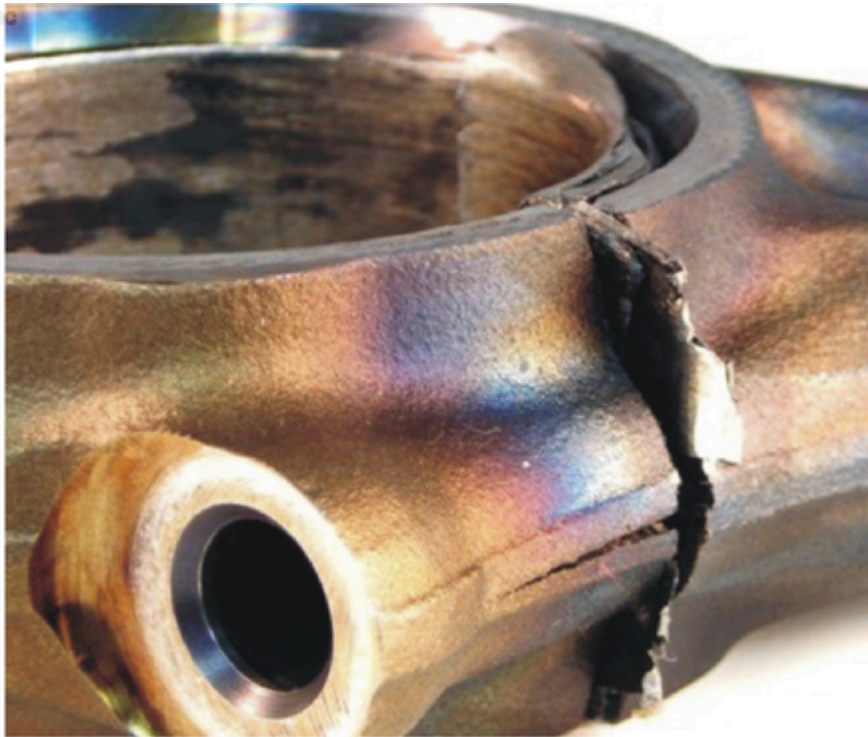
01r00131

Figure 58: Rod bearings pushed between rod and cap.

Note the shiny appearance inside the boxes in Figure 57. The shiny appearance is caused by movement between the rod and cap. The movement is allowed by the low clamp load of the loose rod bolt. In this case the rod bolt loosened enough to allow the rod bearings to be forced into the gap between the rod and the cap. See figure 58.

The crack in the rod cap visible in Figure 58 was caused when the rod cap cooled off and closed in after the engine was shut down. The rod bolt on that side was still in place and was tight due to the load created by the part of the bearings forced between the rod and cap.

Note that the surface areas in Figures 56 and 57 show little indication of being overheated. There is some indication of overheating in Figure 58. However, in this case there was no problem with the lubricating oil system, so there was pressurized oil available to cool the parts to some degree.

In addition to causing the rod bore to be out of round, under-tensioning also results in loss of correct crush load on the bearings. Crush load will also be reduced if the rod bore is oversize or the bearings are too short. Loss of crush load allows the bearing to move and flex in the bore, resulting in a fretting or polished appearance on the back of the bearing. Flexing causes fatigue and cracking of the steel back. Figure 58 shows an example of this condition.

Note the dark stain on the back of the lower bearing in Figure 58. These dark areas are the result of micro-movement of the bearing. Note the absence of stain around the oil hole where there is chamfer on the oil hole in the rod. This condition is normal on both tri-metal and bi-metal bearings.

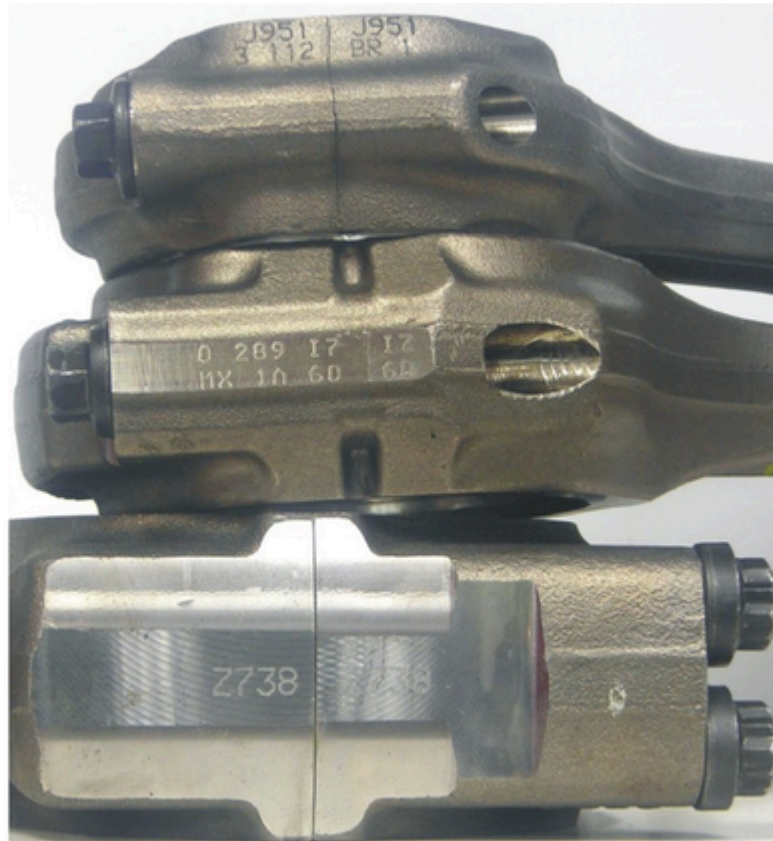
01r00133

Figure 60: Typical connecting rod and cap markings.

Figure 60 exhibits typical rod and cap markings. The markings are **not** standard and vary from engine model to engine model and connecting rod supplier. However, **all** rods will have some sort of marking.

**Not only must** the parts be installed together, the marks **must** be on the same side of the connecting rod assembly as shown in Figure 60. Some rods are machined in such a way as to prevent the parts from being installed backward.

If the parts are mixed or **not** assembled correctly, the risk of failure is high.

It is recommended that the connecting rod and piston assemblies be marked for position in the engine before disassembly. Marking the parts will aid in failure analysis.

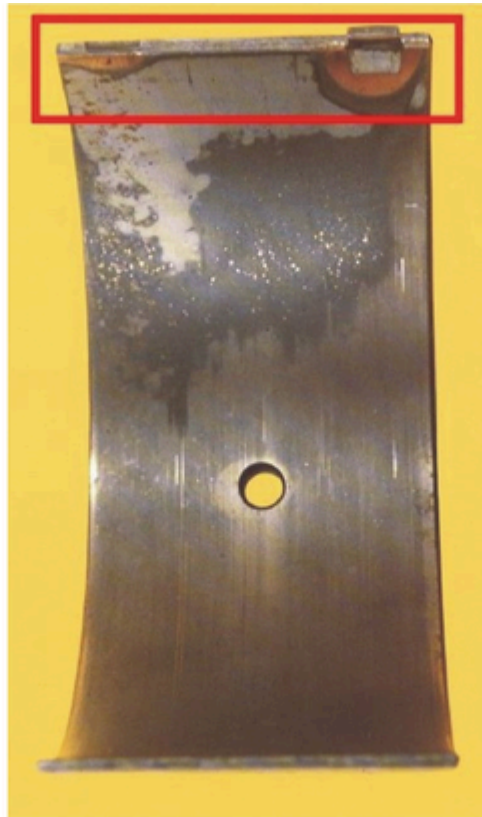
01r00134

Figure 63: Connecting rod bearing not installed correctly.

Evidence of such mis-location type failures can be found by closely examining the lock tangs on the bearings and the seating patterns of the tangs against the rod and the rod cap. The lock tangs will usually be mashed or mutilated, indicating the manner of bearing mis-location. Distortion of the bearings will result in metal-to-metal contact and heavy wear in the area of the lock tang such as shown in Figure 63.

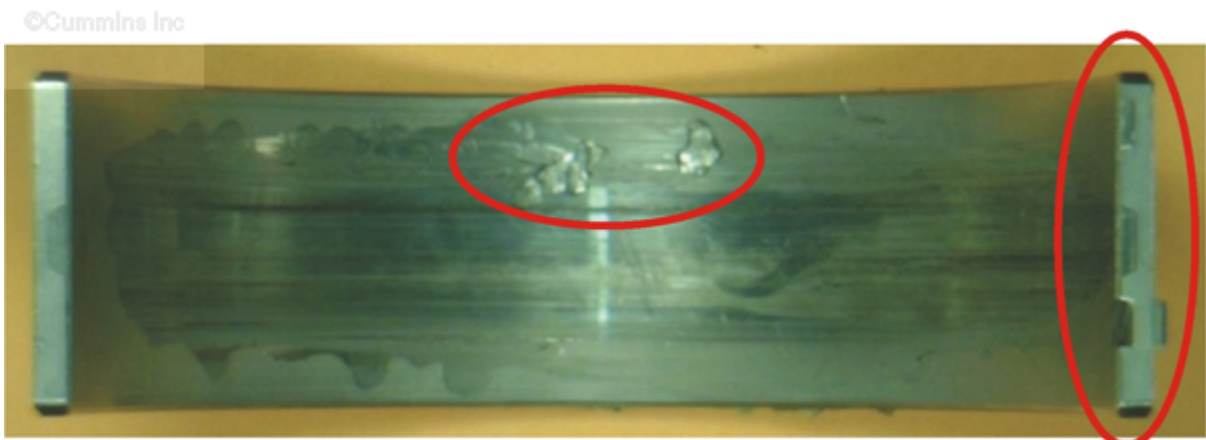
01r00136

Figure 65: Bimetal bearing with fatigue from loss of crush.
