Service Bulletin Number: 4021325

Low-Hour, False Head Gasket Oil Leaks

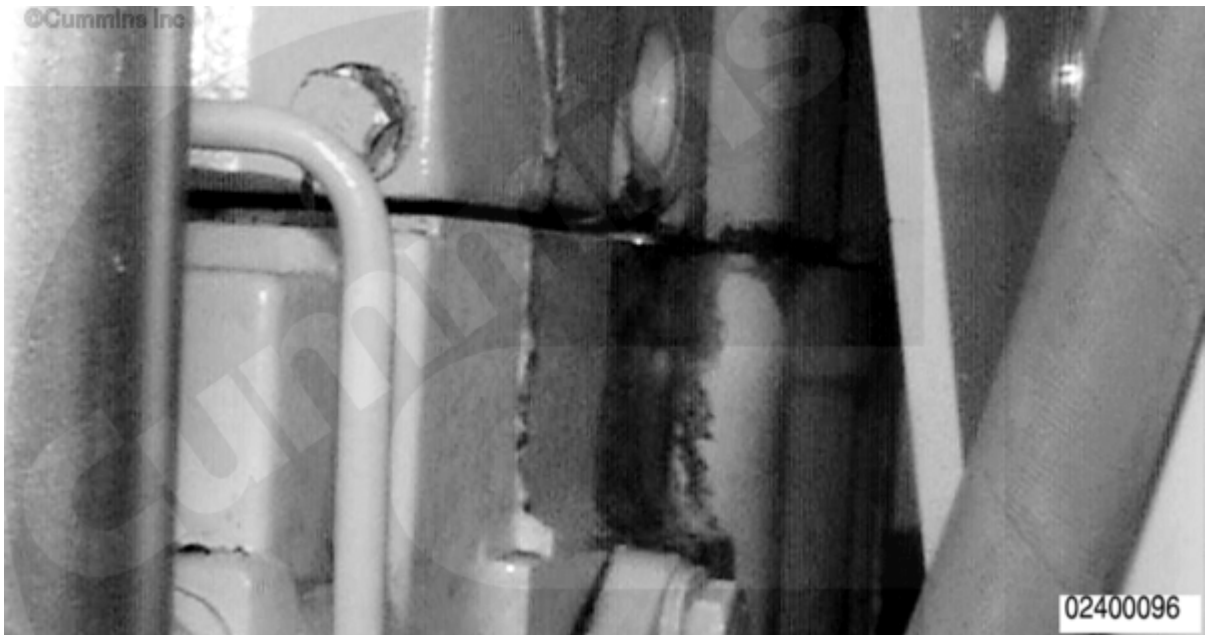
Fig. 2, Thick Black Streaks between the Cylinder Head and Cylinder Block Deck Are Not Engine Oil

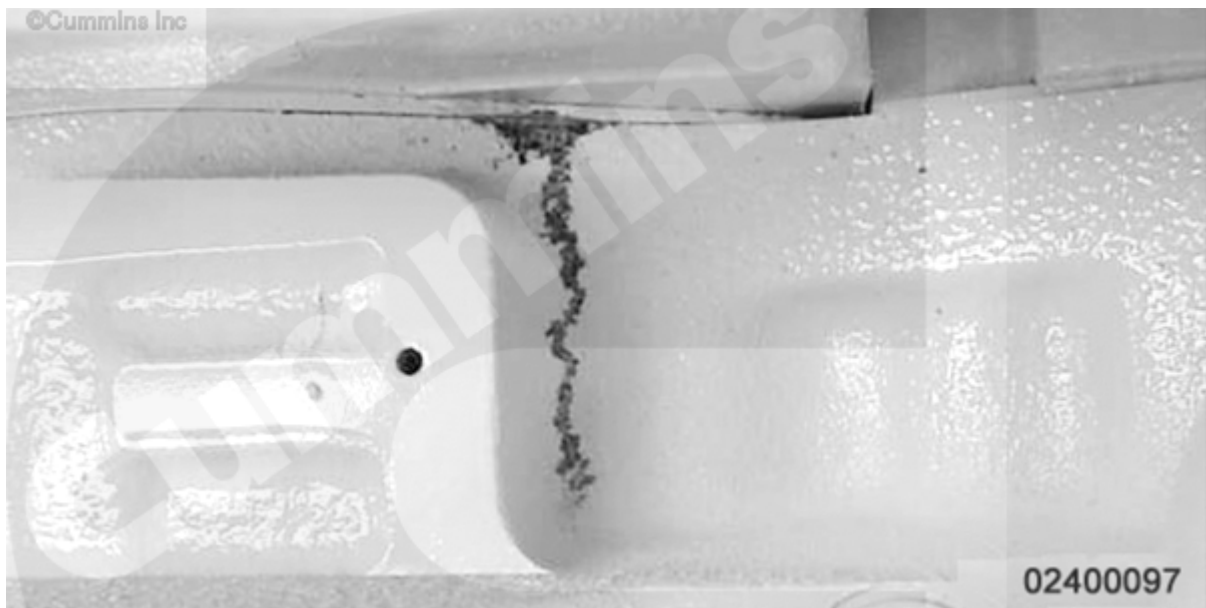
Fig. 3, Small, Thin Streaks First Appear after Engine Heats Up

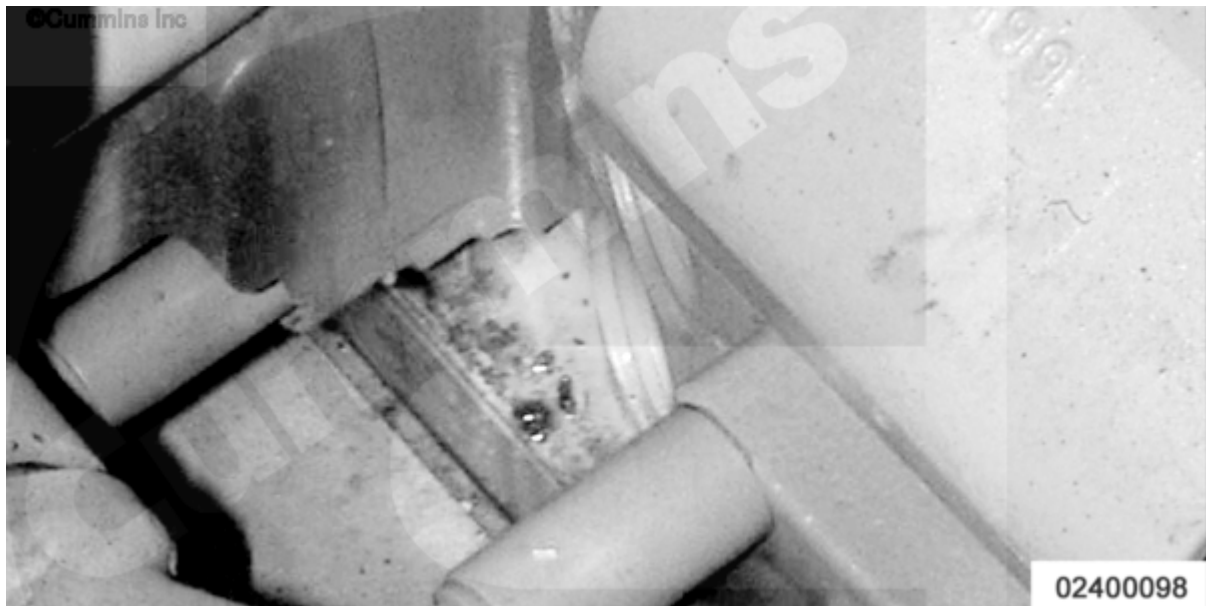
Fig. 4, Dripping Near the Exhaust Manifold Where It Bolts into the Cylinder Head

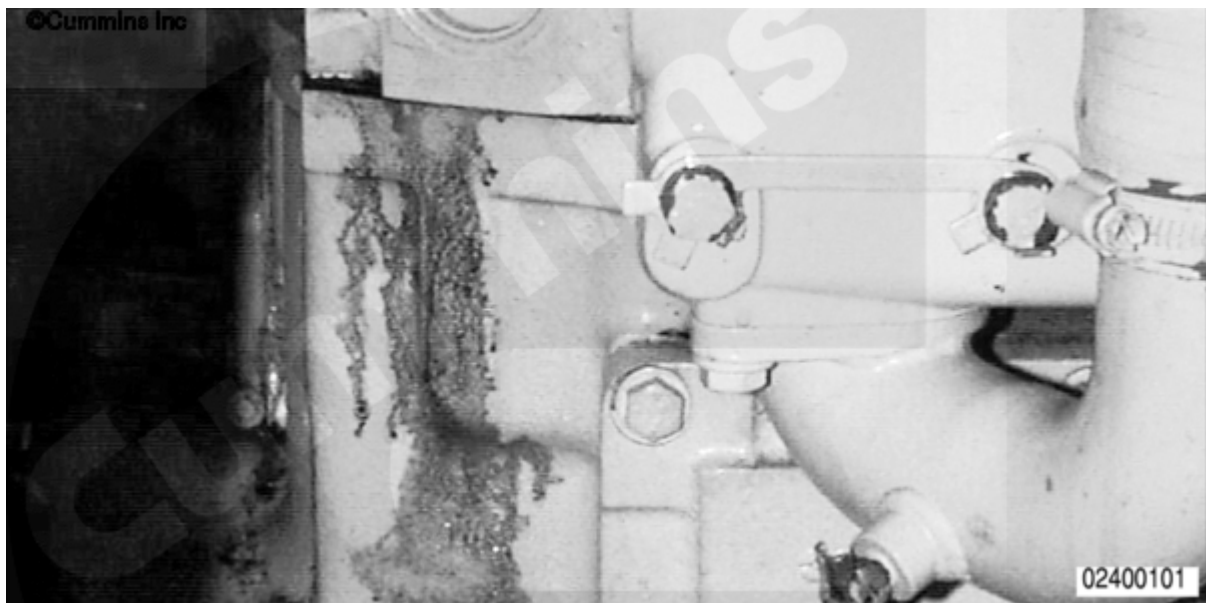
Fig. 7, Multiple Stain Paths at the back of Number 6 Cylinder Head

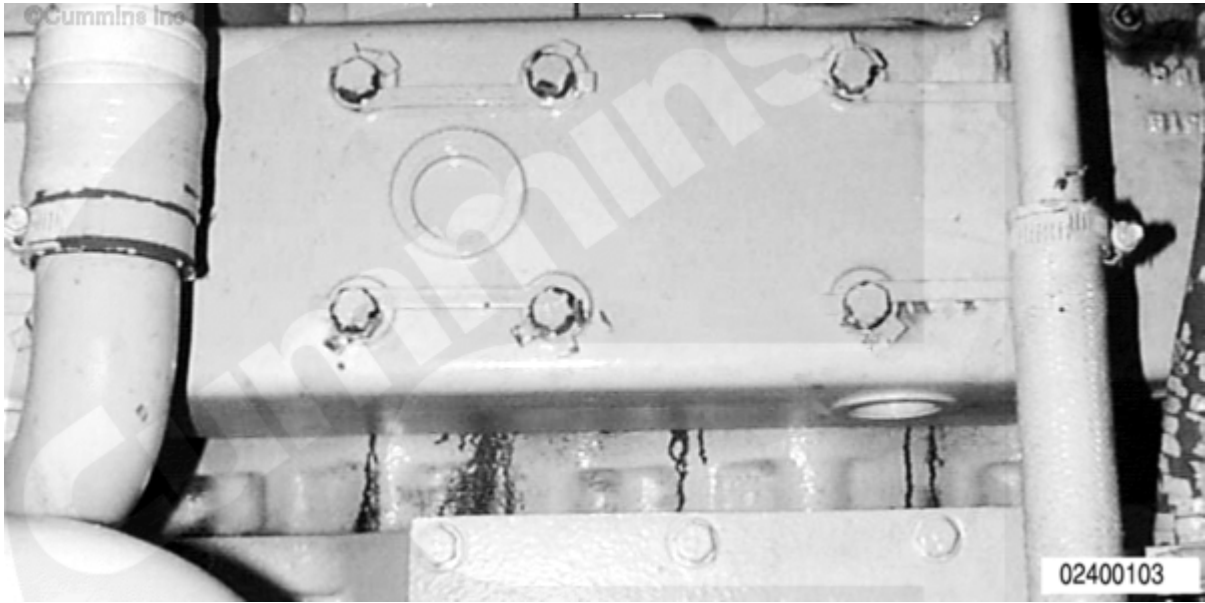
Fig. 9, Numerous Black Streaks between the Oil Cooler and Exhaust Manifold Are Not Engine Oil Leaks
