Service Bulletin Number: 4332738

Turbocharger Training for Fixed Geometry Products

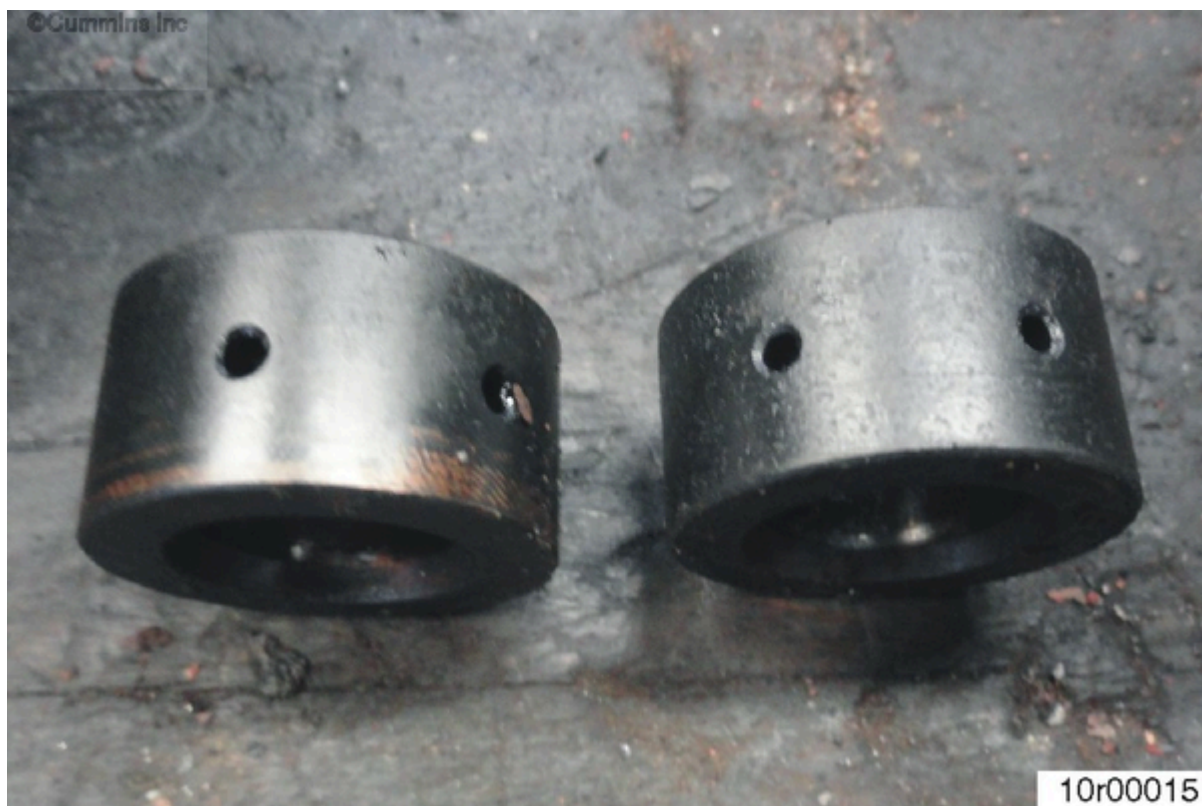
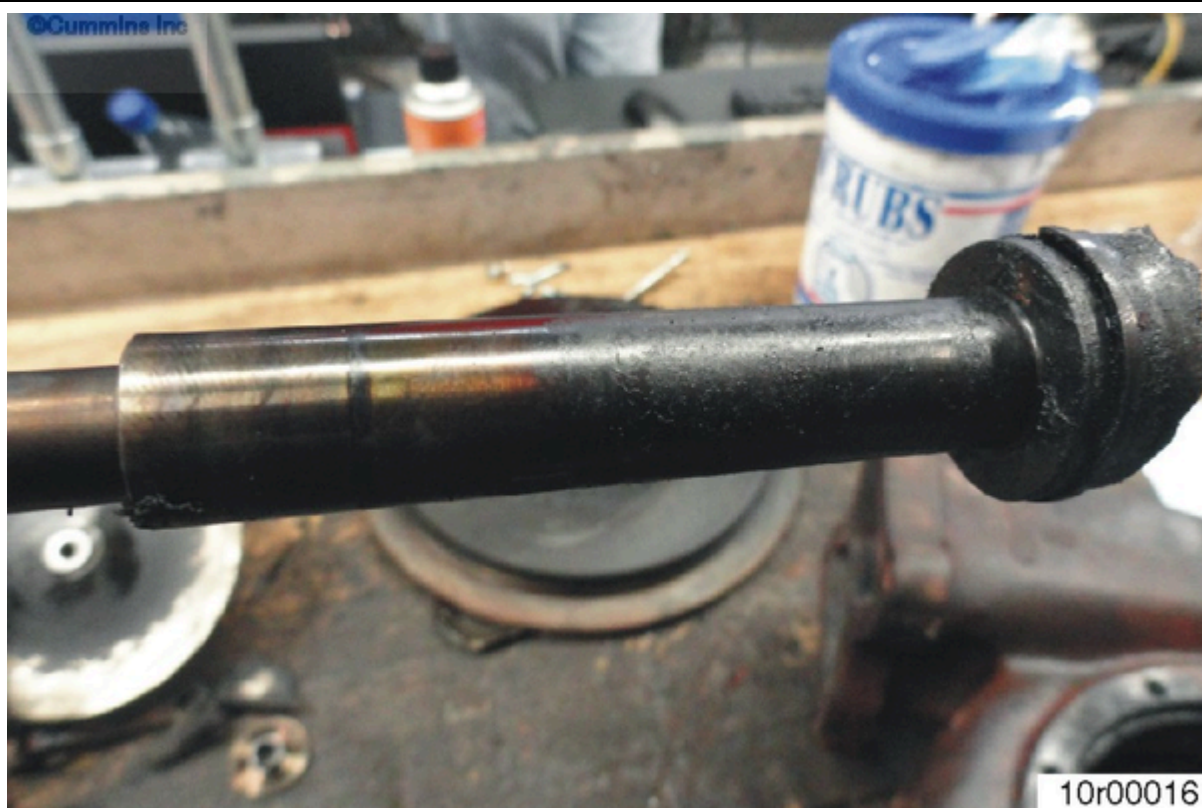
Figure 8: Turbocharger bearings with coked oil burnt onto them.

Figure 9: Impeller/rotor shaft with coked oil burnt onto it.

\* A hot shutdown is when the engine is shut off after being run hard. When the engine is **not** allowed a period of idling after being run hard, the turbine housing is still very hot. With the coolant and oil systems no longer operating, heat transfer can occur from the turbine housing. The oil sitting at the journal bearings can increase in temperature and turn into a hard, coked, oil, as shown in Figure 8 and Figure 9.

Coked oil deposits are abrasive and can wear away the bearing material.

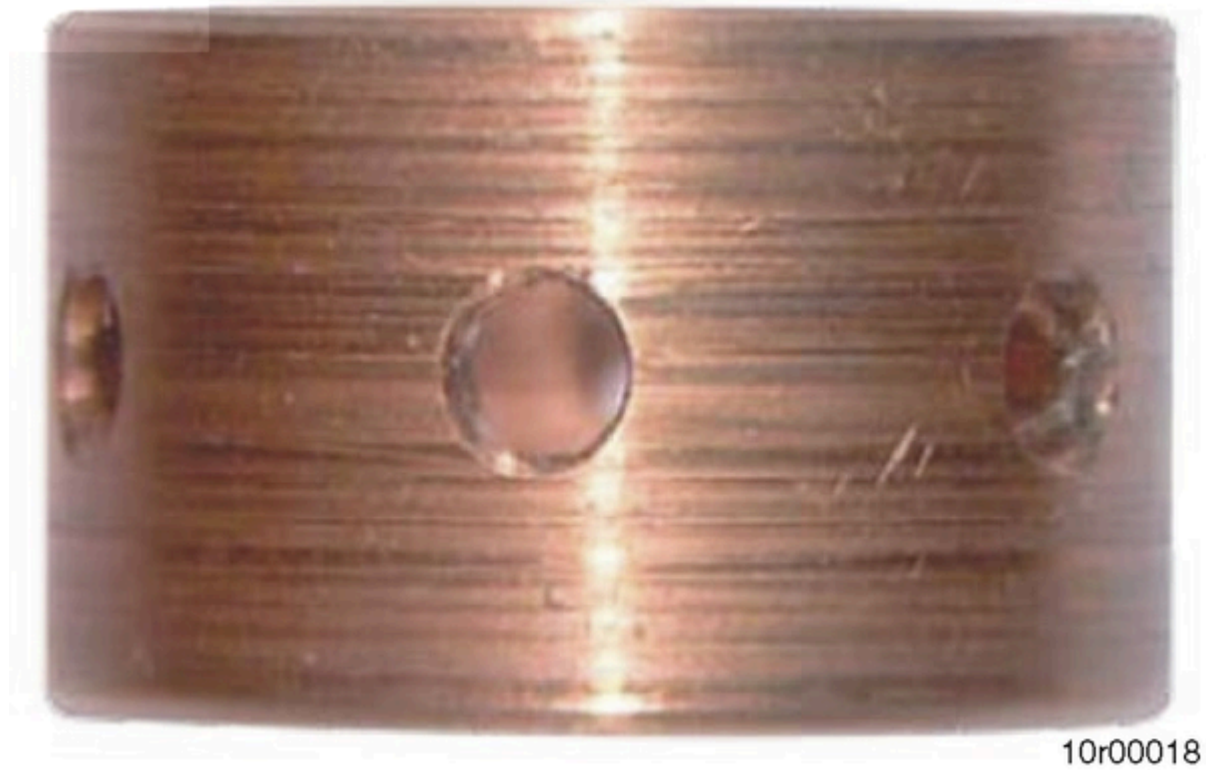
Figure 10: Turbocharger thrust bearing wear.

Figure 11: Turbocharger bearing damage. Debris in the oil can score and wear the journal and thrust bearings.

Figure 10 and Figure 11 show damage from debris in the lubricating oil.

Debris in the oil can wear the bearing material and eventually lead to a bearing failure. If a bearing failure is suspected, the oil should be checked for debris.

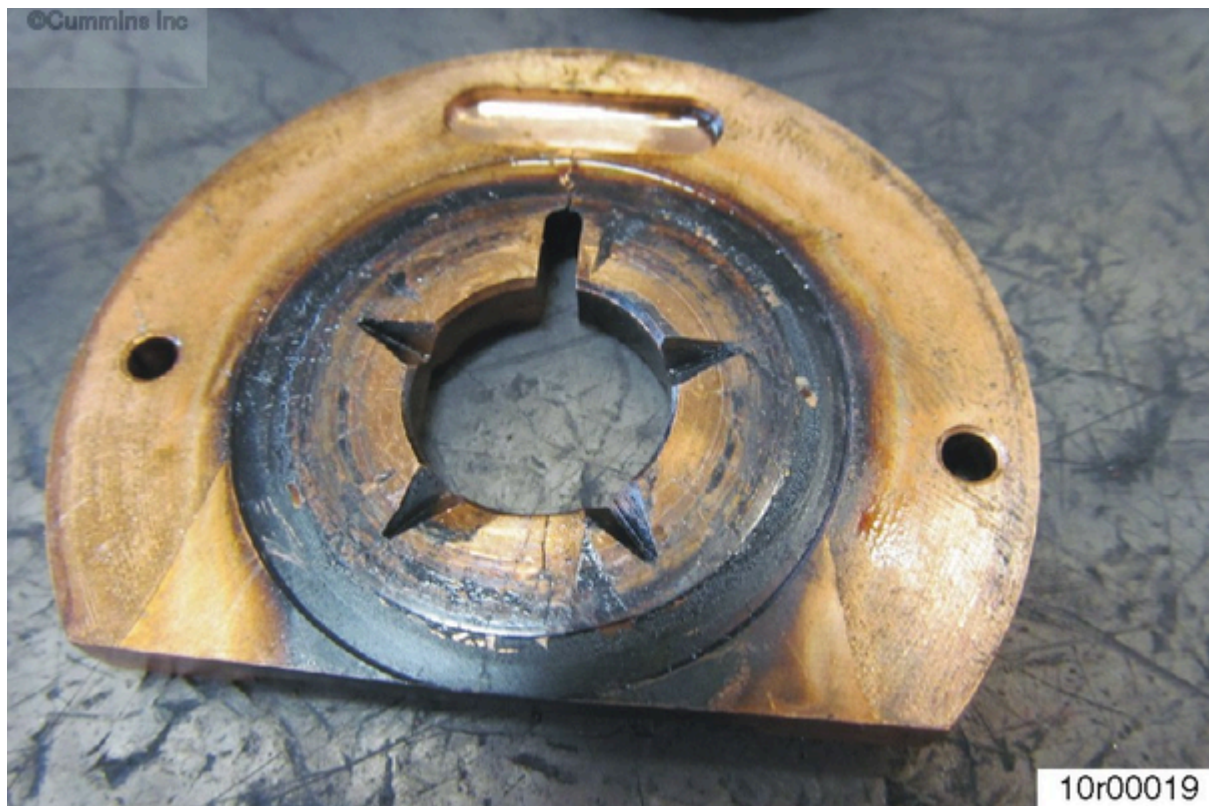
Figure 12: Damaged thrust bearing.

Figure 13: Damaged journal bearings.

Figure 12 and Figure 13 show damage from heat and material transfer due to high friction. Lack of lubrication creates high friction and heat leading to bearing wear.

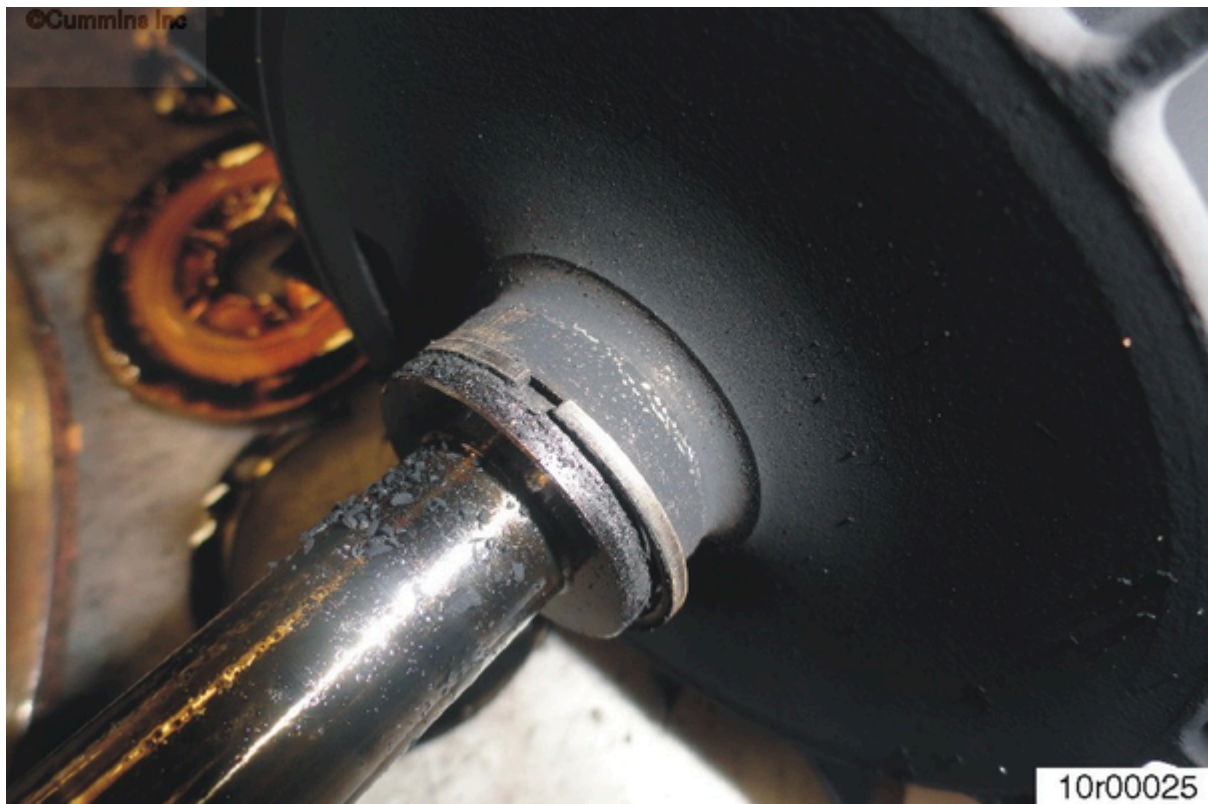
Figure 18: Turbine wheel split ring oil seal.

The turbine side of the turbocharger uses a split ring seal that works just as the compressor side.

Typical causes of noticeable oil leakage past this seal are from high crankcase pressure or a restricted oil drain.

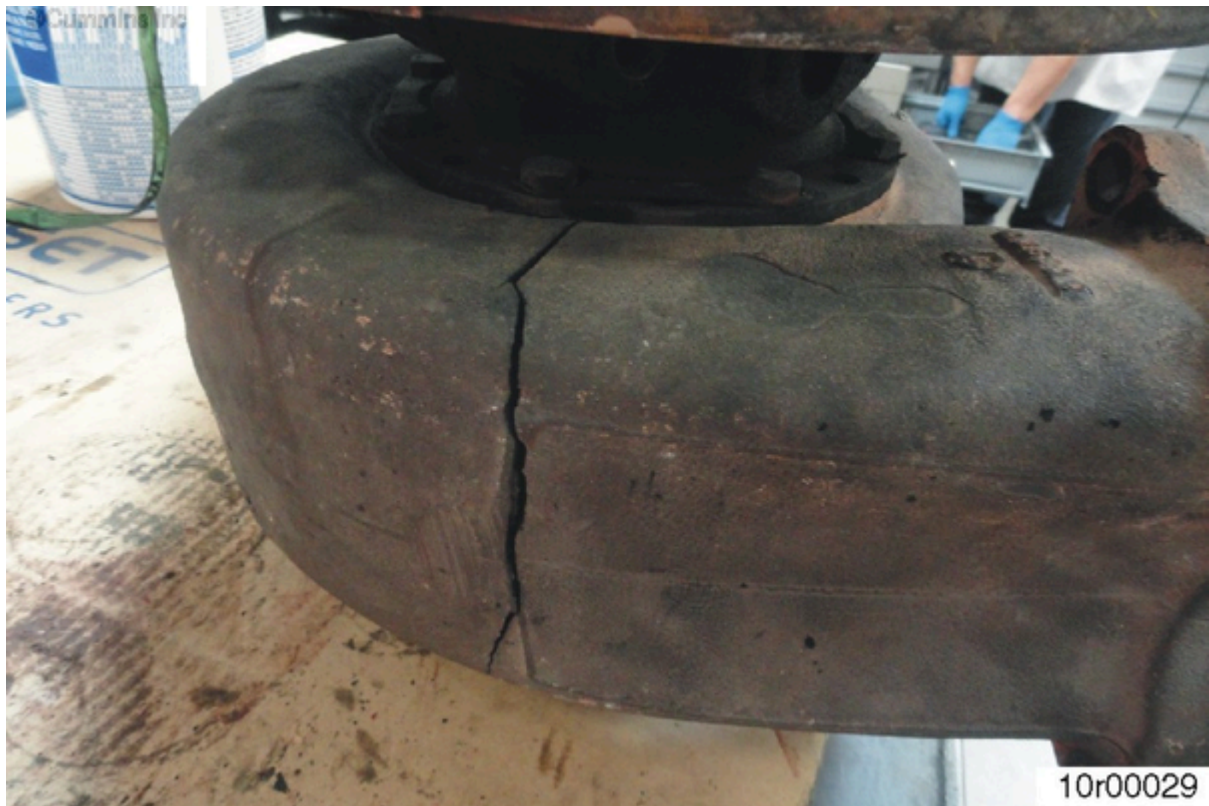
Figure 22: Damage to the turbine housing.

- The turbine journal bearing can fail due to overheated oil.
- The stamped steel heat shields can crack.
- The turbine to bearing housing capscrews can loosen/break due to thread relaxation.
- The turbine housing can crack externally.

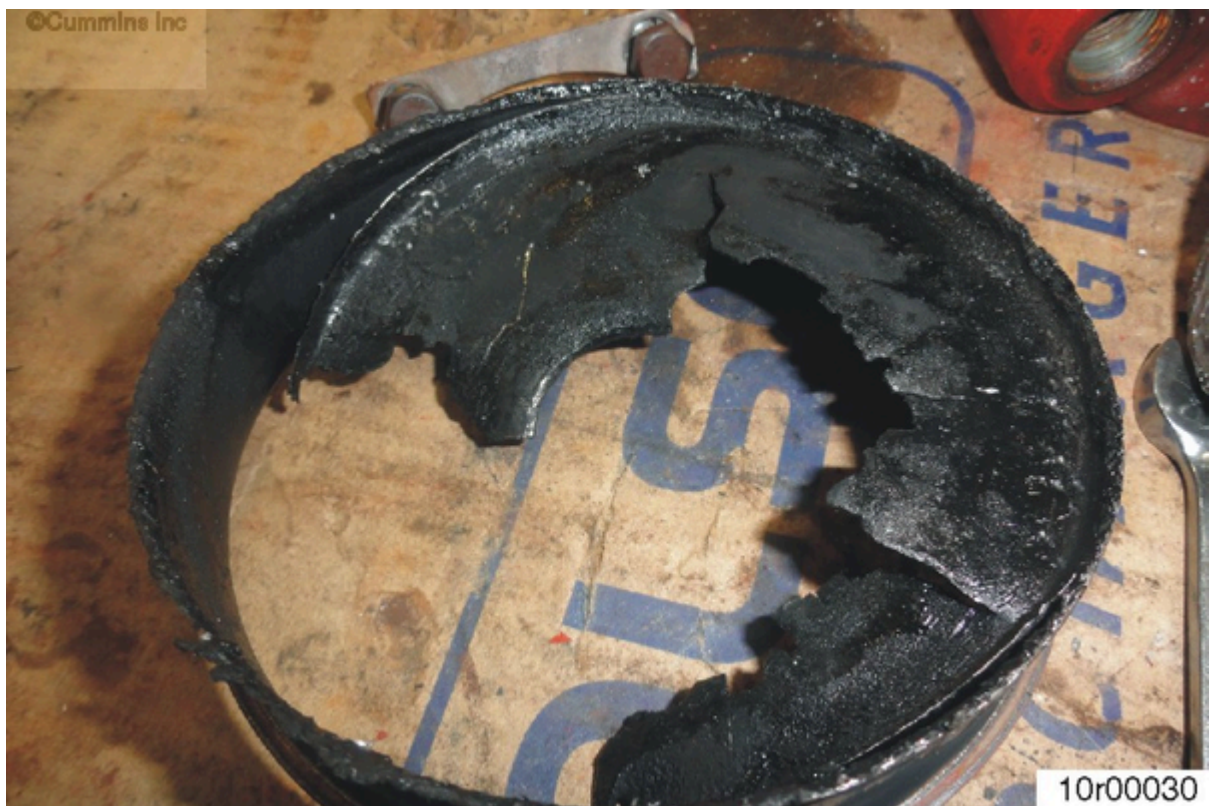
Figure 23: Damage to a heat shield.

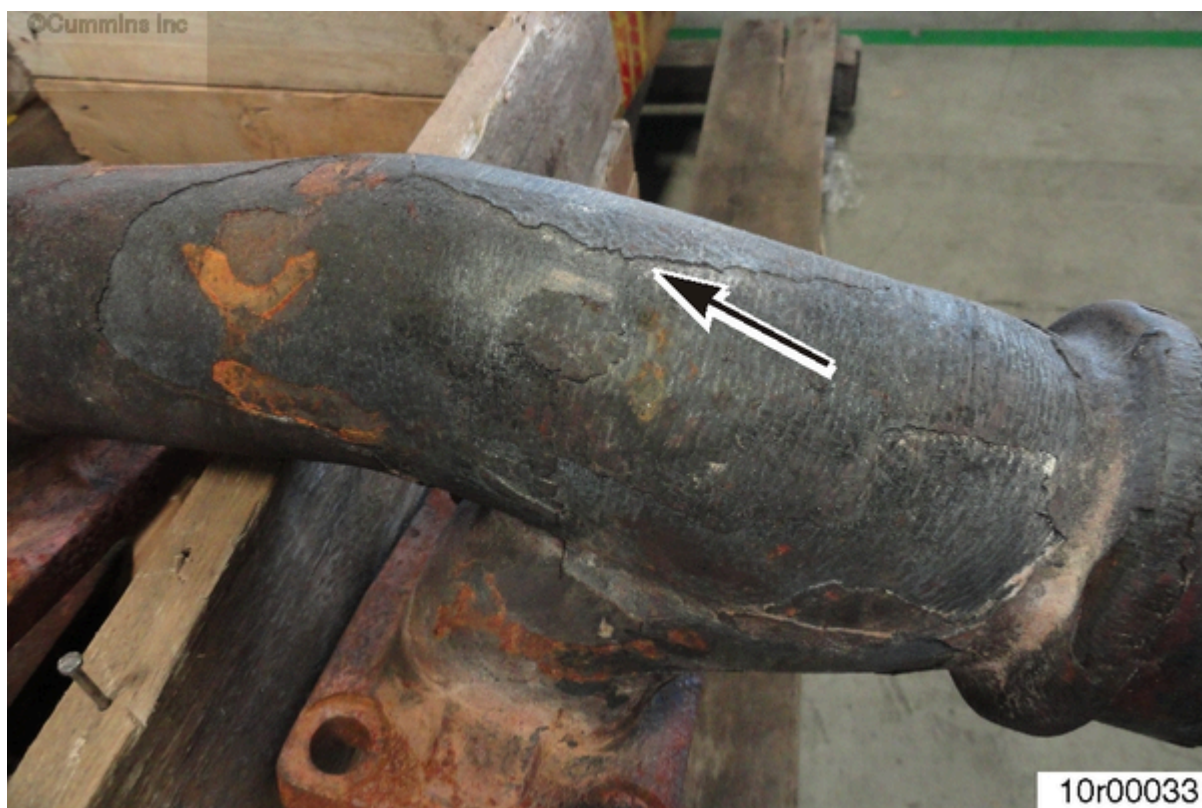
Figure 26: Scaling on exhaust manifold.

Evidence of high exhaust temperatures can be seen from scaling at the turbine housing and exhaust manifold joint (Figure 25). It can also sometimes be seen externally on the turbine housing and exhaust manifold (Figure 26). Material is seen removed from oxidation.

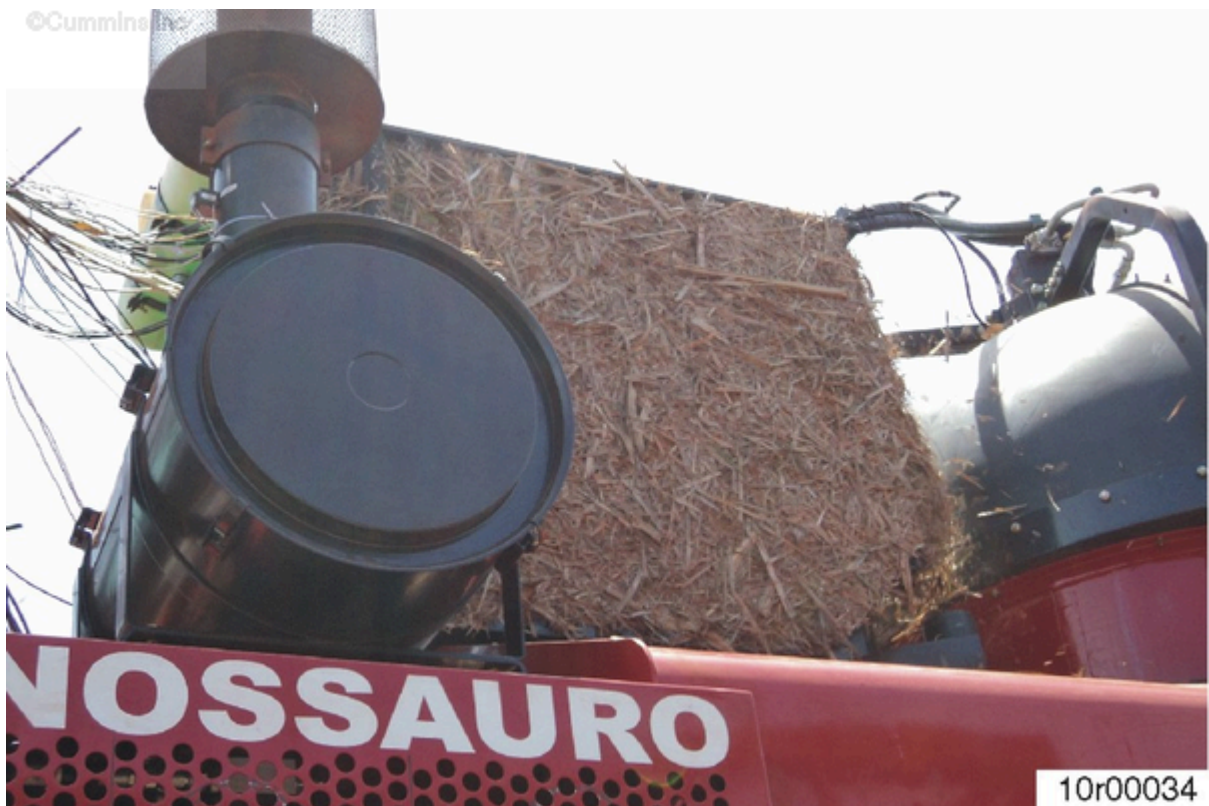
Figure 28: Cooler plugged with debris.

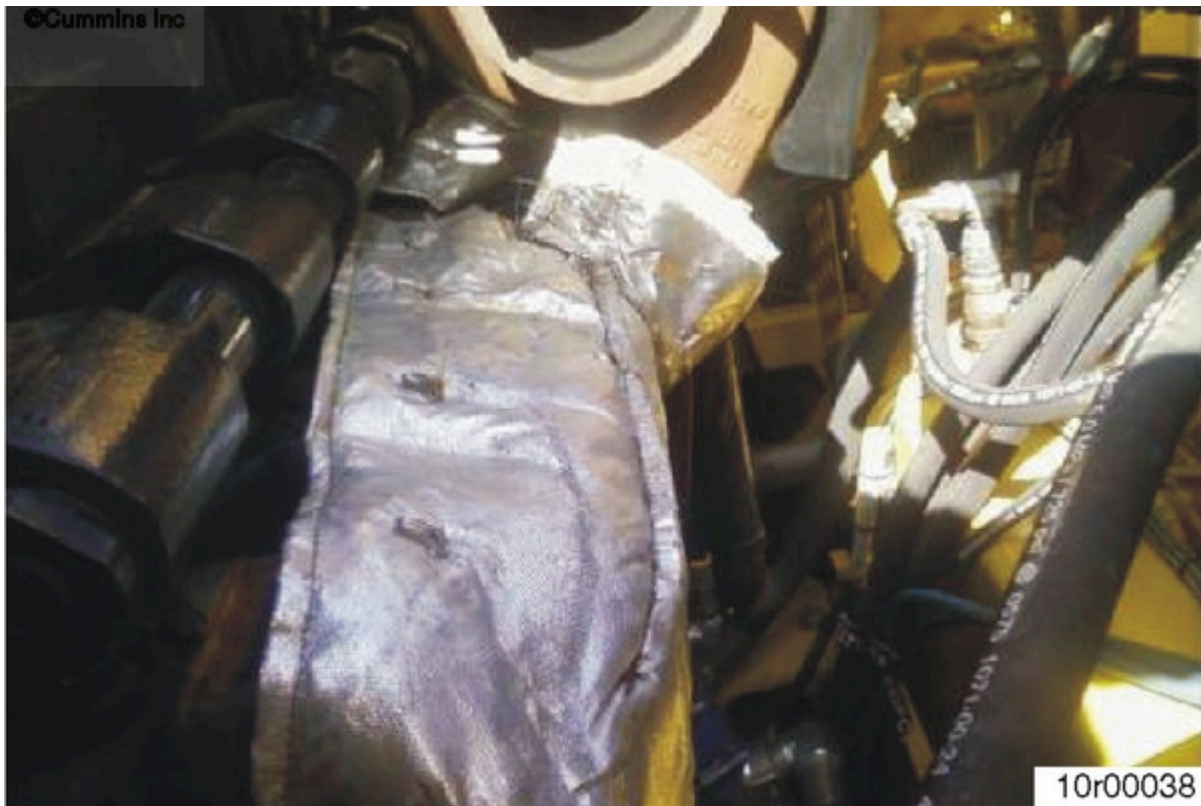
Figure 31: Exhaust manifold heat blanket.

Heat blankets over the turbine housing and/or exhaust manifold can cause heat soak and increase exhaust temperatures. Heat blankets require approval for use in order to keep the exhaust temperatures in a safe range.

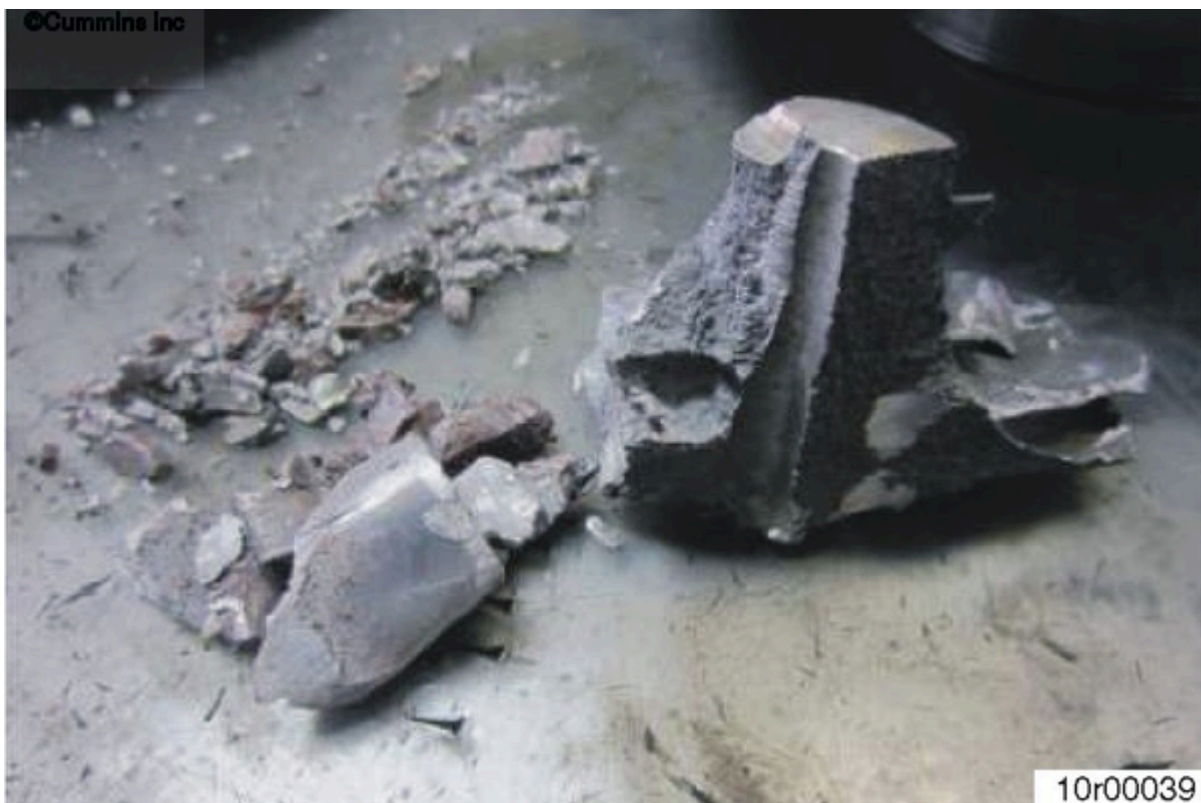
Figure 32: Fractured impeller wheel.

The turbocharger rotor system can reach speeds that exceed the capability of the components. The journal bearings can wear and the impeller can eventually fracture, as seen in Figure 32.

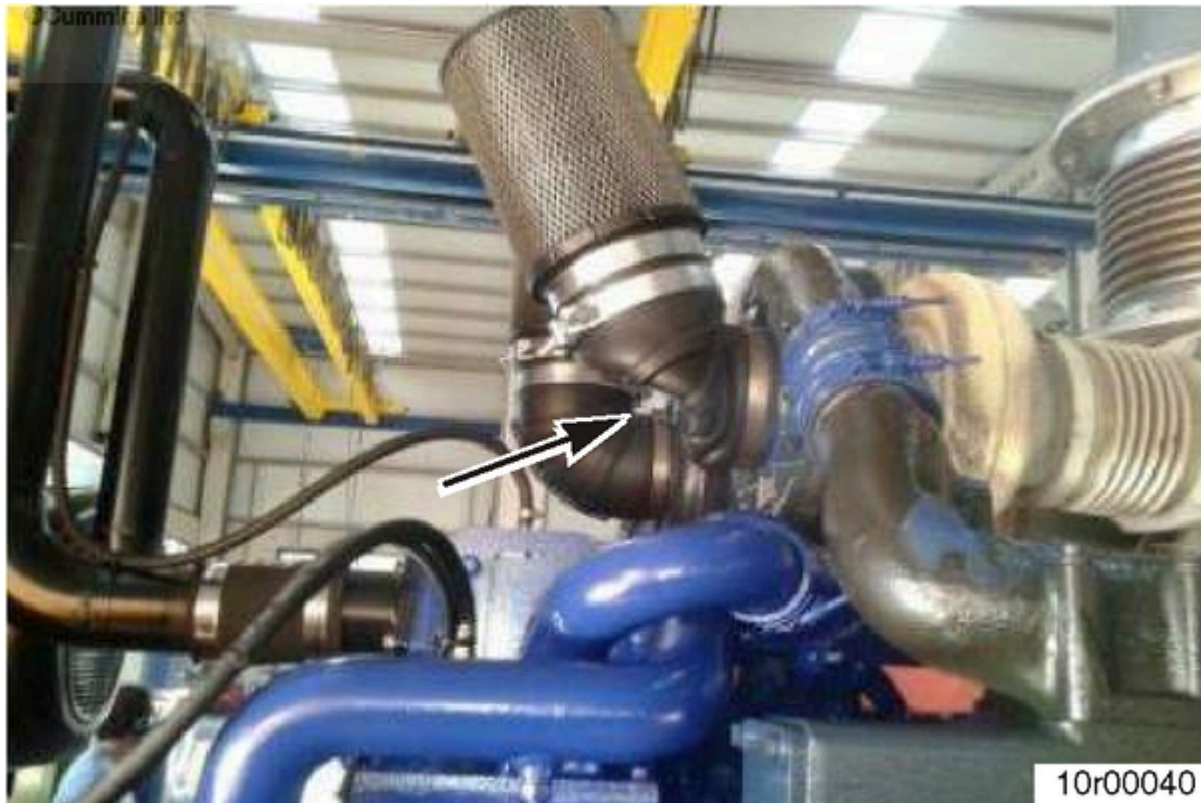
Figure 33: Collapsed intake air hose.

Figure 33 shows an air filtration setup that was too small for the engine and turbocharger. Part of the intake hose collapsed when the turbocharger was drawing more air than the filter would allow.

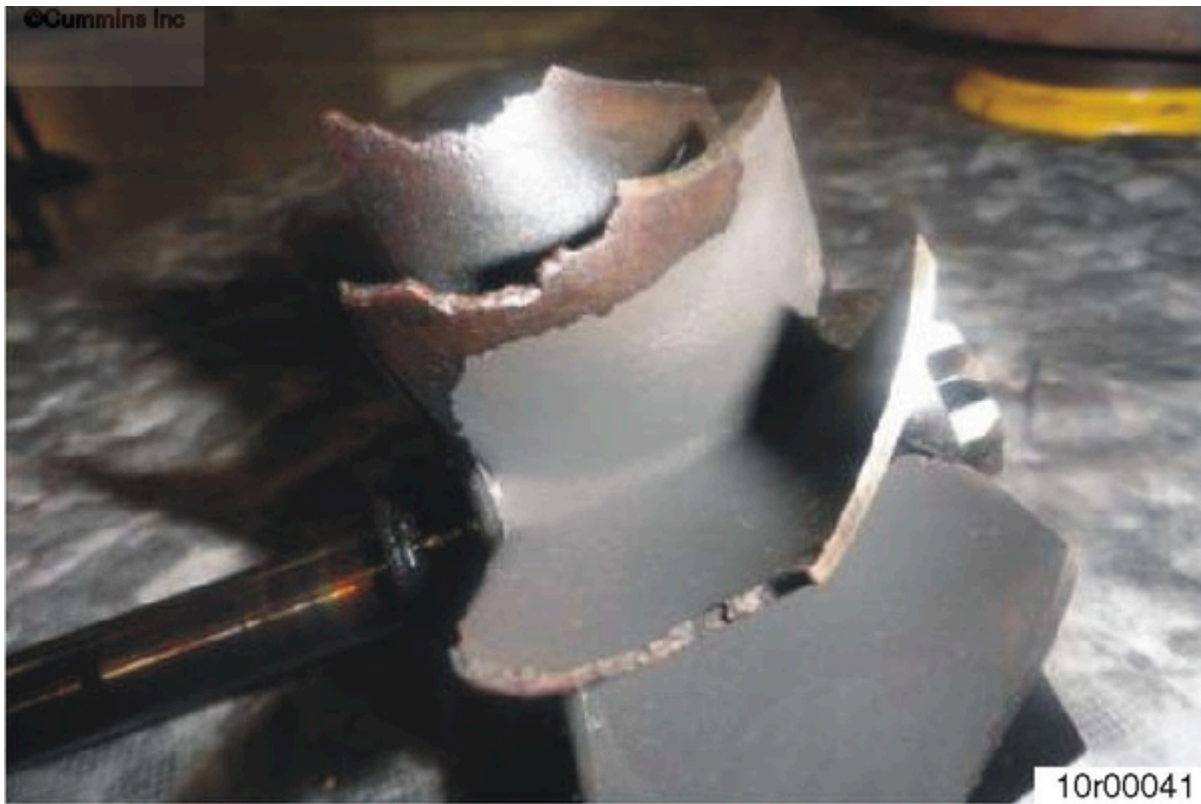
Figure 34: Turbine wheel damage.

Objects that enter the exhaust, such as a valve and piston material, or an injector tip, generally move at a very fast rate into the turbocharger. This can damage the blades of the turbine wheel.

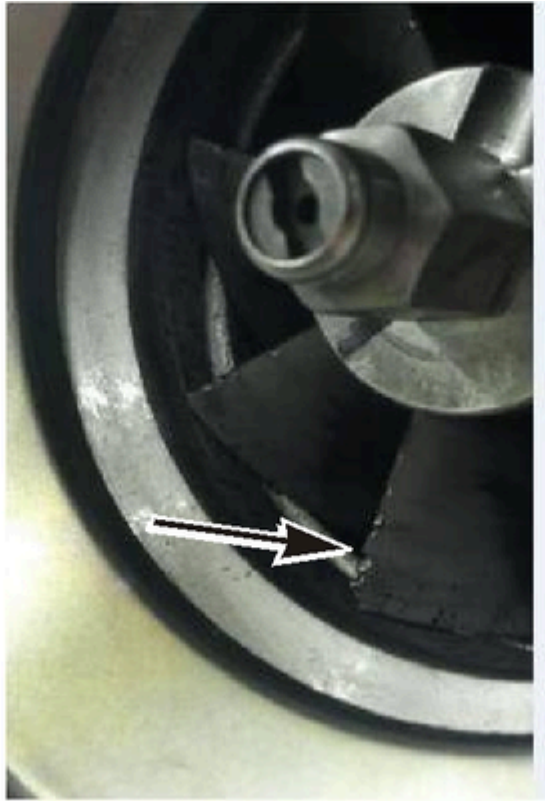
Figure 35: Impeller damage from small debris.

Objects as small as weld splatter can cause some damage to the impeller blades (Figure 35), which could affect performance.

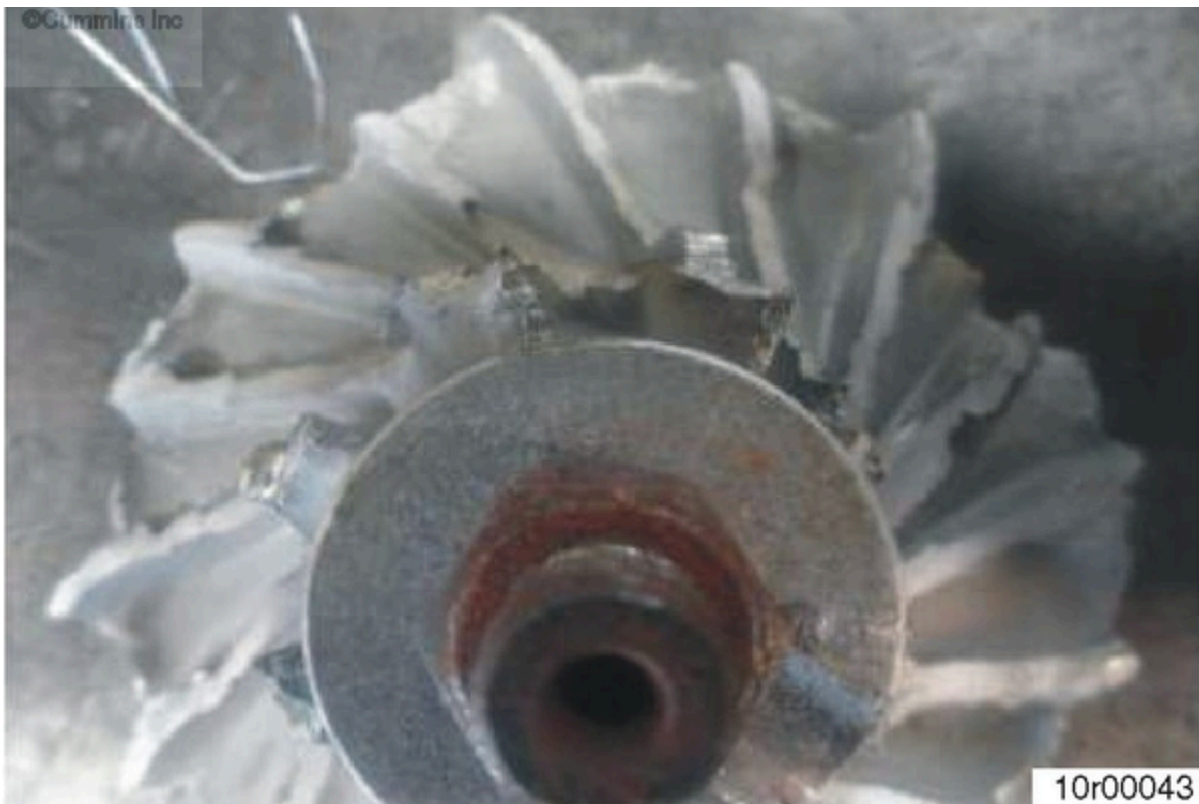
Figure 36: Impeller damage from large debris.

Larger objects entering the intake can cause a turbocharger failure, as seen in Figure 36.

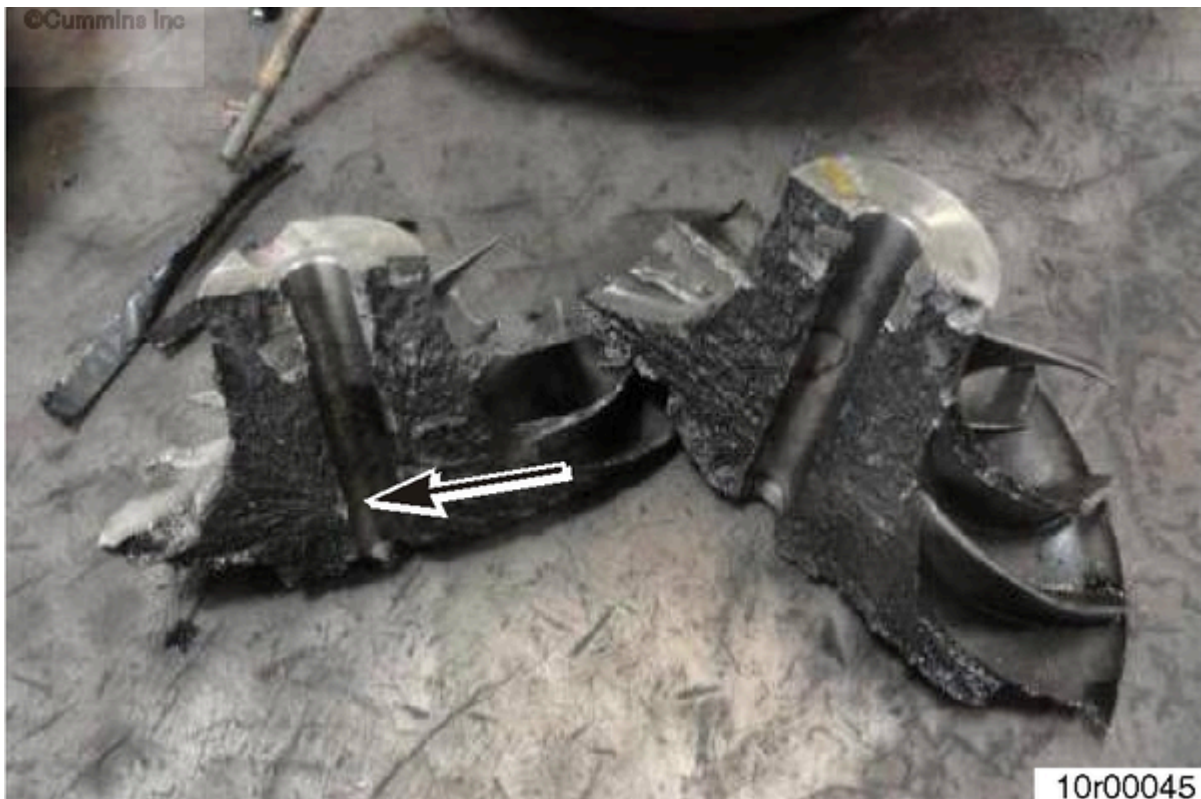
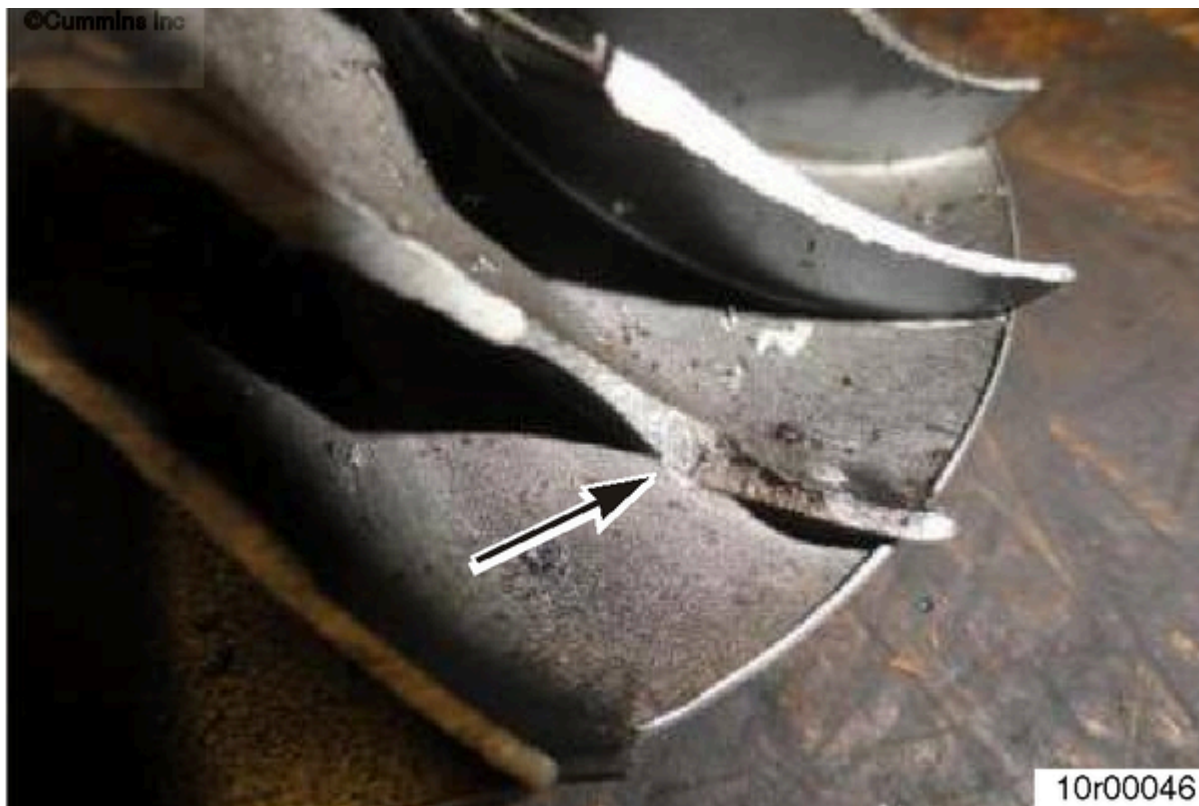
Figure 38: Initiation point in failed impeller.

Figure 39: Initiation point in failed impeller.

Figure 38 and Figure 39 show fatigue initiation points in impeller castings.

The stress and strain put on the impeller wheel will cause the wheel to fatigue over time. The fatigue life varies by wheel material, method of manufacturing, application, and other factors. Low cycle fatigue is most commonly found to occur on the impeller.
