Service Bulletin Number: 5504213

Turbocharger Lubricating Oil Leak Troubleshooting

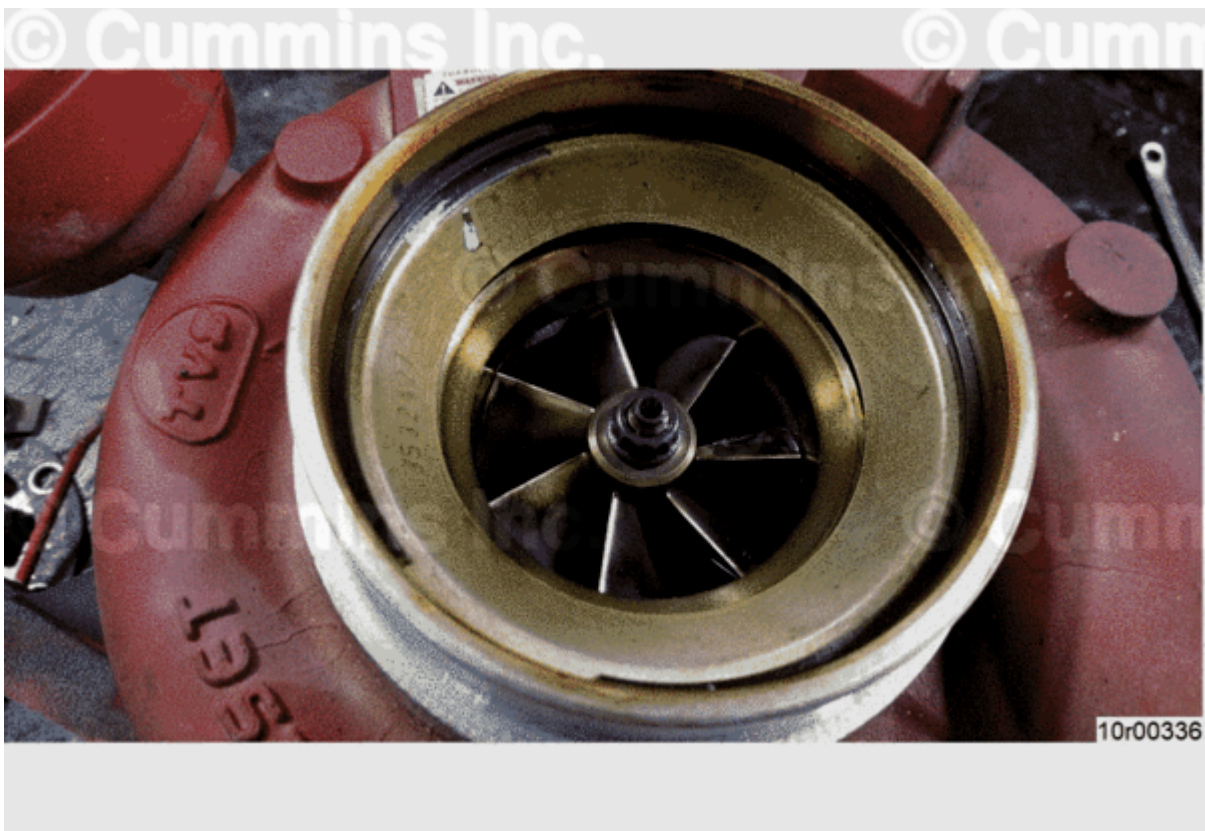
If the charge air cooler plumbing is leaking oil, see Figure 4 below for example of oil in compressor inlet due to closed crankcase ventilation oil carryover.

Figure 4, Turbocharger Compressor Inlet (Acceptable with Oil Deposits From CCV Oil Carryover).

If there is evidence of oil in the turbocharger compressor inlet, check the closed crankcase ventilation system. See Service Bulletin, Closed Crankcase Ventilation System Engine Lubricating Oil Carryover and Associated Turbocharger Lubricating Oil Leak, Bulletin 5659915.
