Service Bulletin Number: 5613318

Released Date: 17-jan-2020

Checking For Dirt and Dust Ingestion While Troubleshooting High Blowby

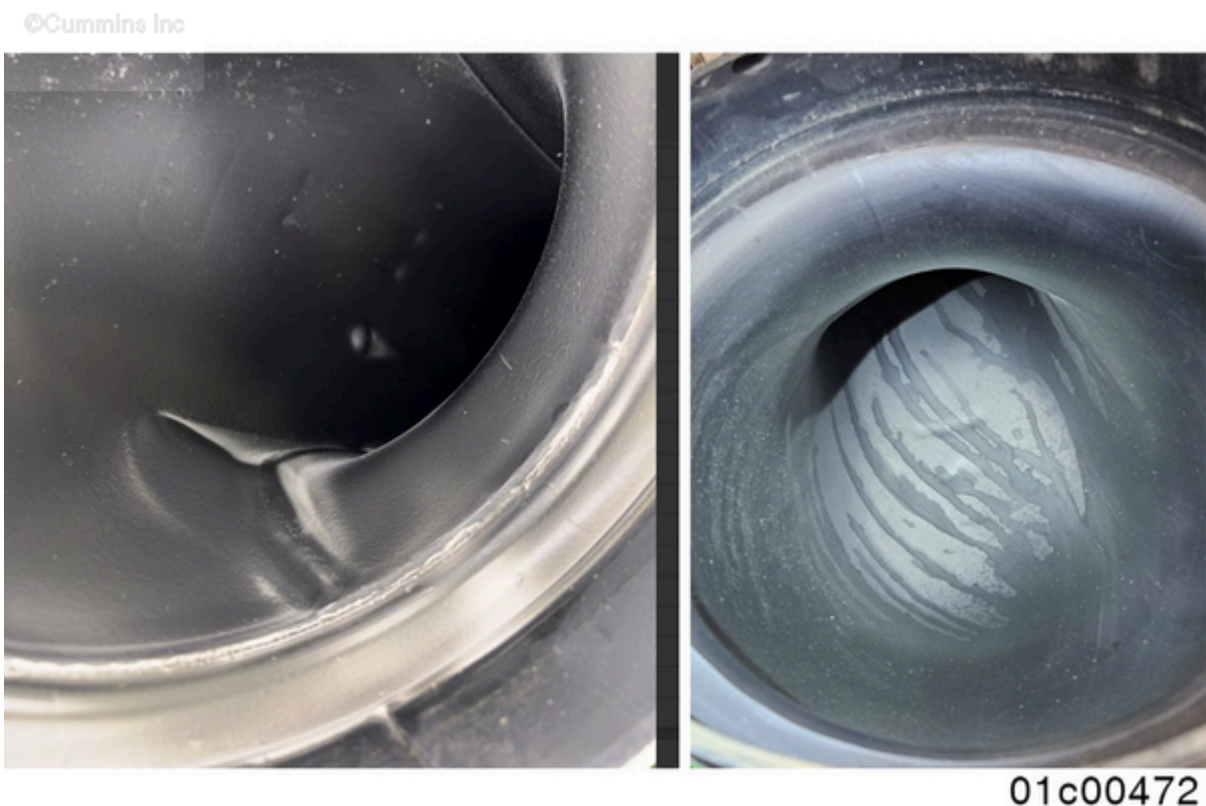
Figure 1, Dust present in intake piping.

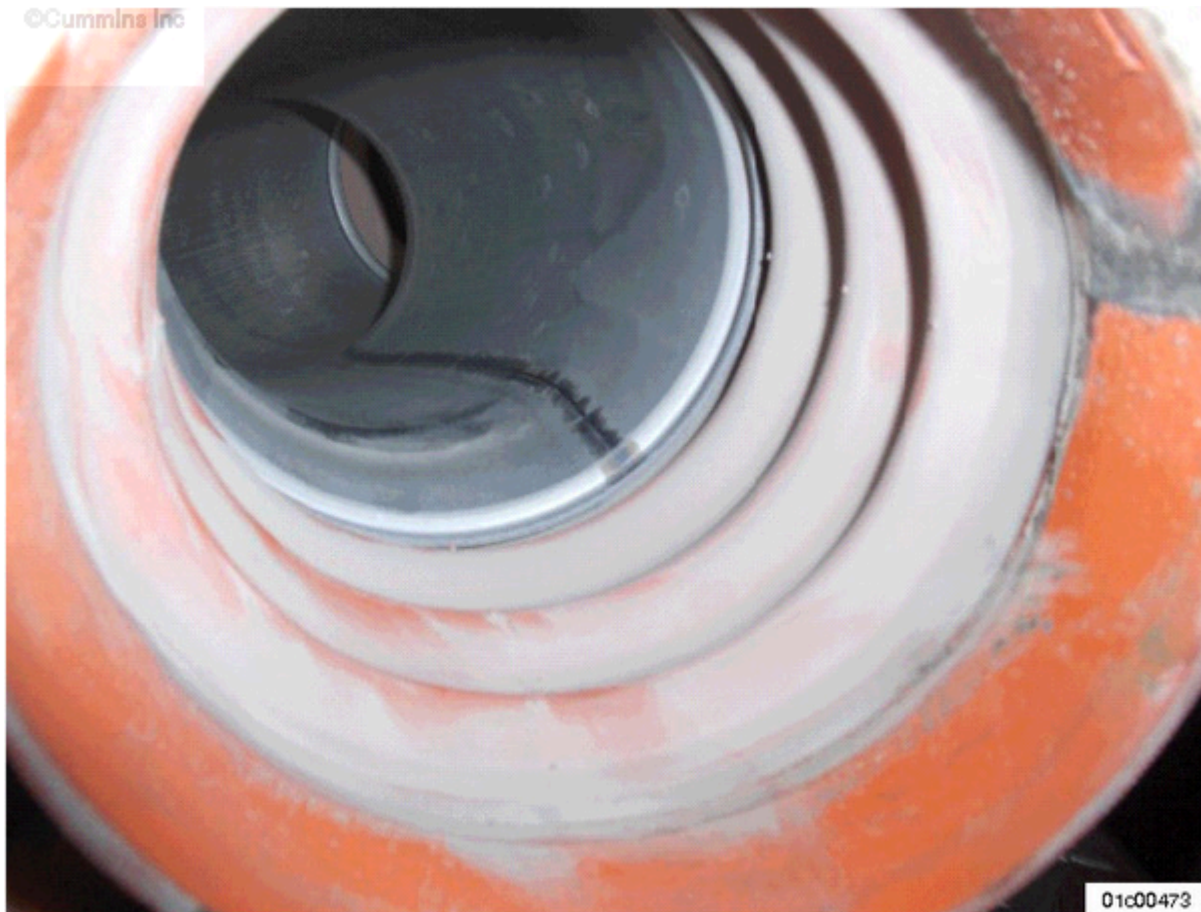
Figure 2, Dirt present in Charge-Air Cooler (CAC) hose.

- Charge-air cooler - Replace if contaminated with dust.
- Main and rod bearings - Light, smooth scratches are acceptable for reuse. Bearings exhibiting deep scratches and/or raised or ragged edges **must** be replaced

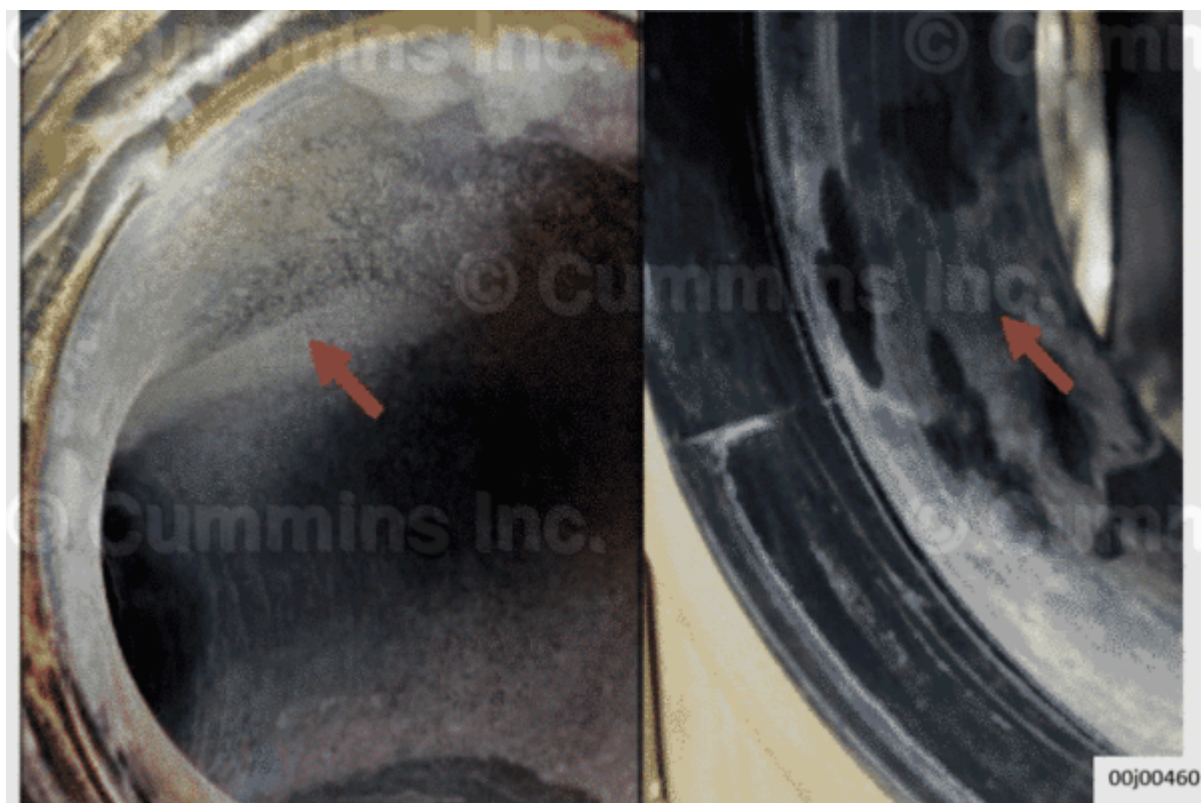
Figure 3, Often, the clean side of soft black rubber will age, causing a white "chalking".

This is **not** dust nor does it rub off. Chalk is **not** a defect, but can hide dust evidence and make pictures hard to interpret.

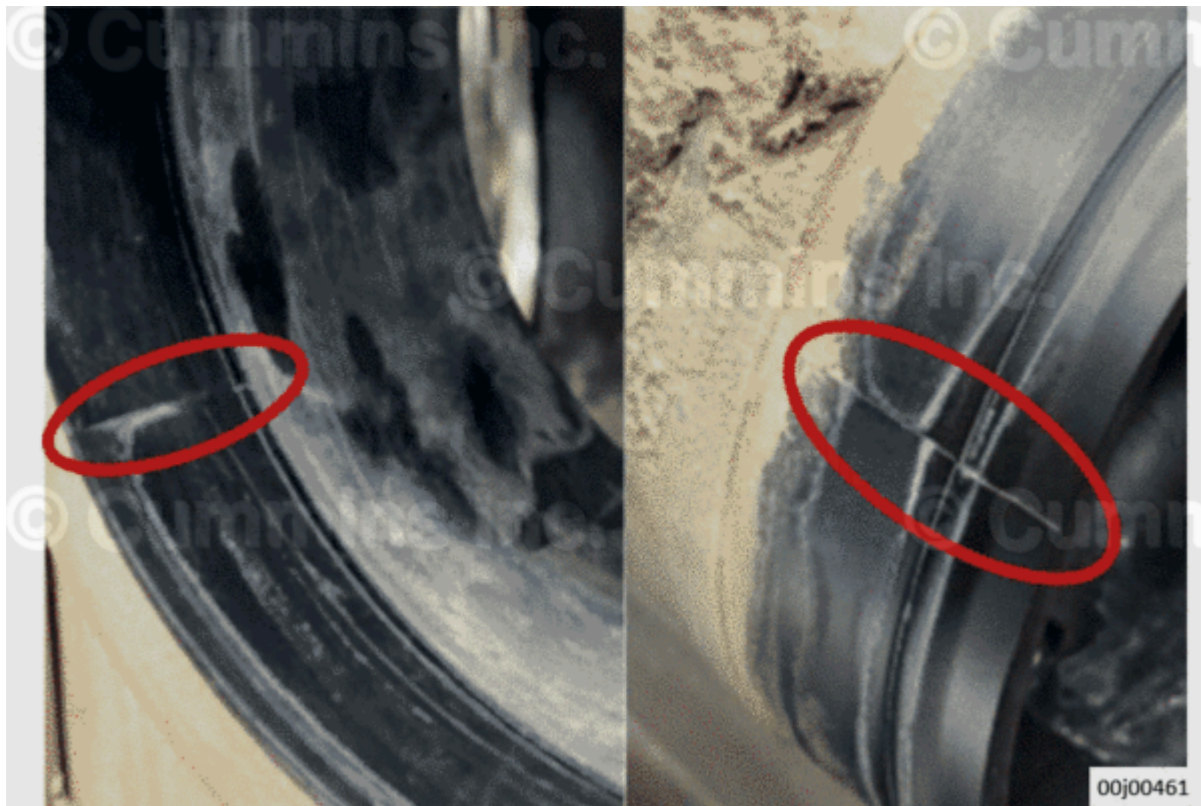
Figure 4, Chalk transfer from soft rubber to hard pipes can show witness of proper sealing. The soft rubber hose (left) conformed to small irregularities on hard plastic mating pipe (right). This is a proper seal.

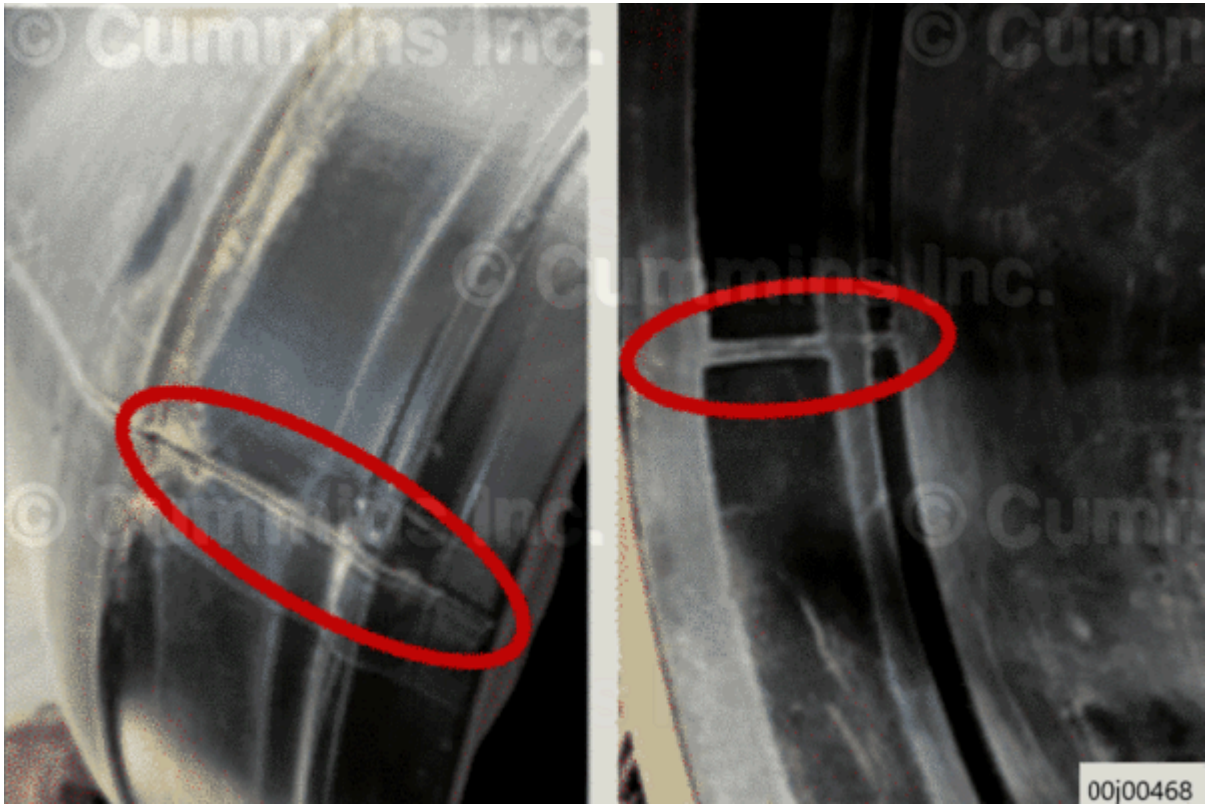
Figure 5, Chalk can also help identify leak paths when clamp load is low, or a dust leak path is present.

Often dust is a different shade color than the white chalk, allowing a visual clue of the dust leak path.

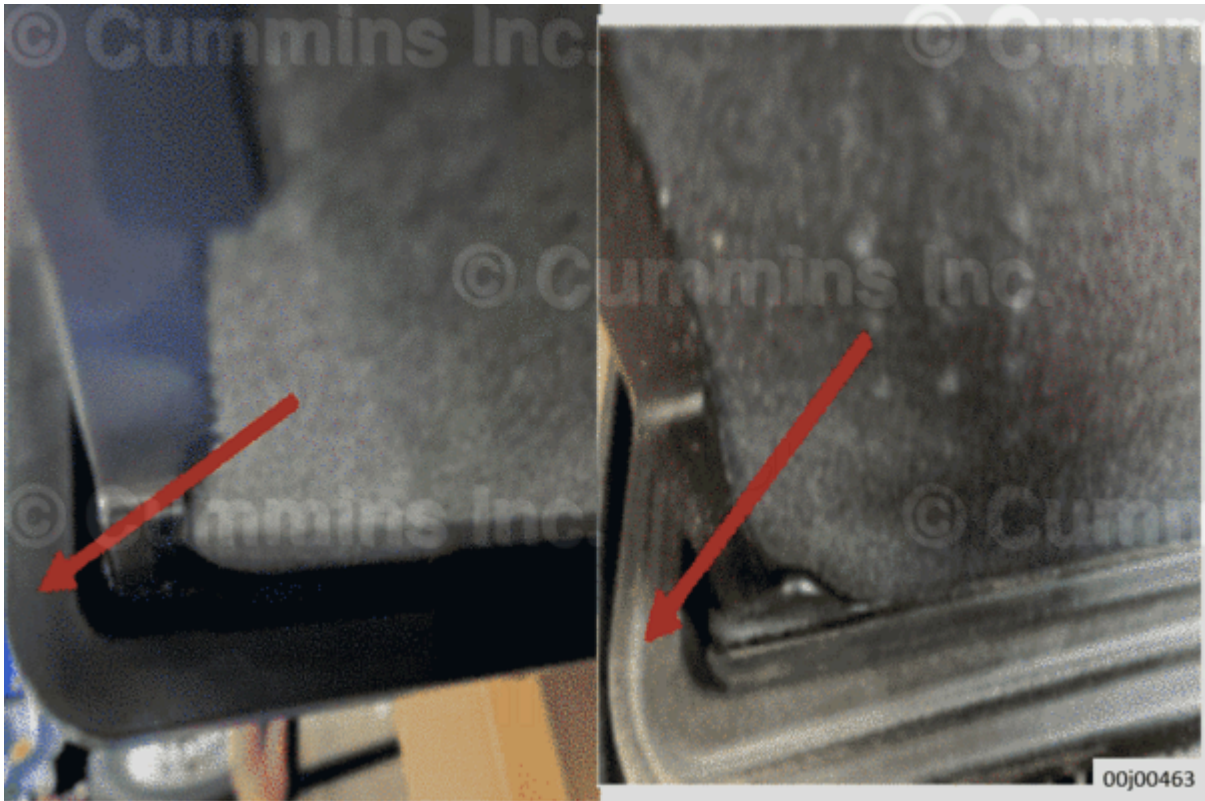
Figure 7, Air filters are a service item and not to be reused.

Left, a new filter rubber seal. Right, once torqued, the seal deforms permanently. This picture shows a leak path from low bolt torque allowing dust past the primary sealing surface.

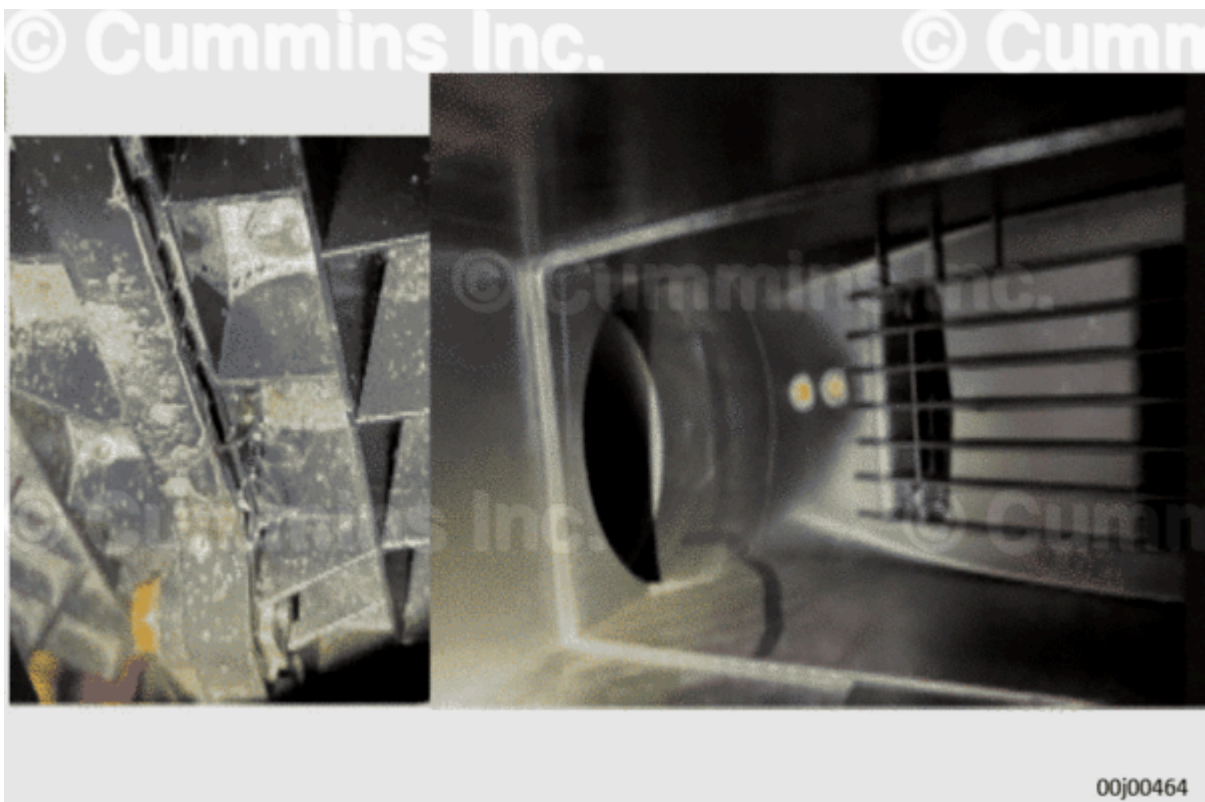
Figure 8, Bolt torque was low on this joint and primary seal showed a leak path.

The act of checking torque return to mark sealed this leak path. This joint was on the bottom side and very difficult to see.

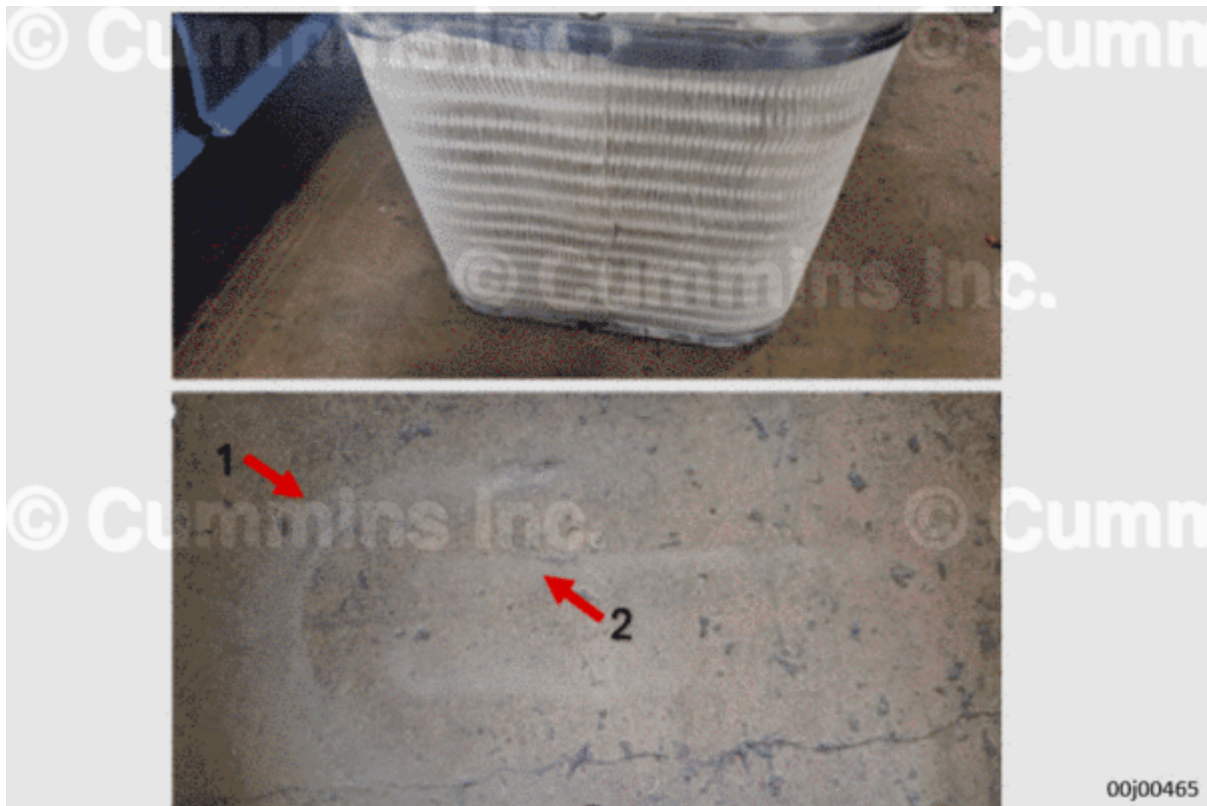
Figure 9, Dust present on the clean side of filter shows a defect in the media.

When tapped on the floor, dust fell from both the clean and dirty sides of the filter.

1. Dust from the dirty side – acceptable
2. Dust from the clean side – **not** acceptable, proof of filter defect

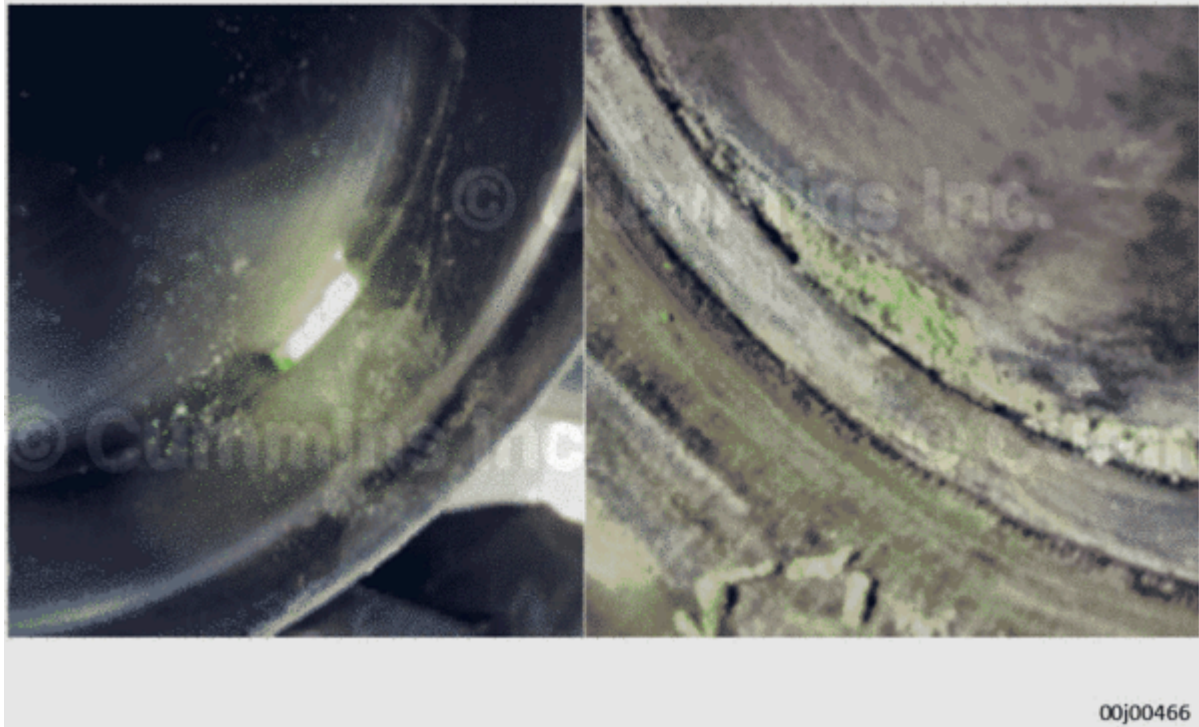
Figure 10, SAE testing standards require the airbox to limit rainwater intake.

In winter, water mixed with road salt can pass through the air filter elements. Salt can then cause corrosion.

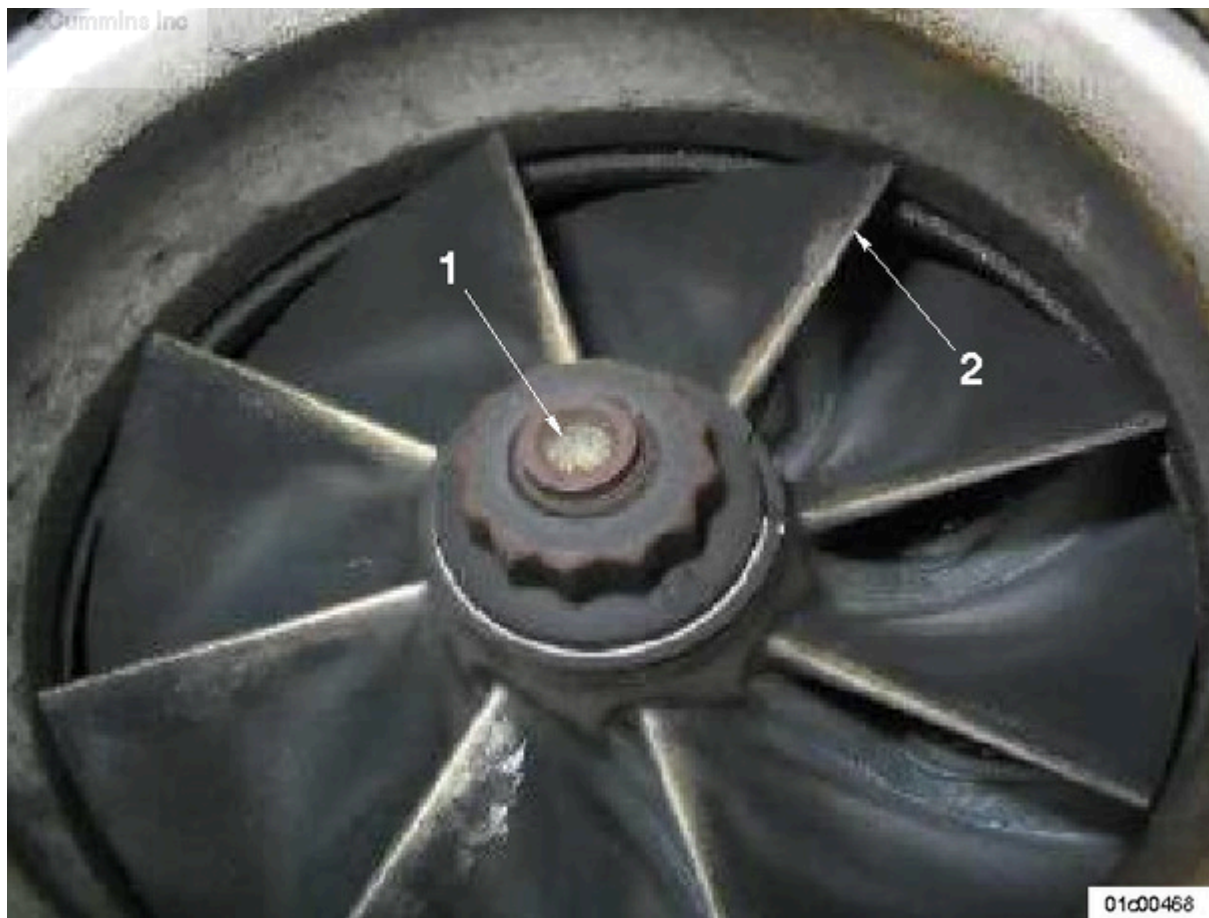
Figure 11, Turbocharger compressor shaft.

1. Dirt can be found packed into the compressor end of the turbocharger shaft.
2. Leading edge of compressor wheel shows wear from dust ingestion.

- Turbocharger - Inspect the leading edge of the compressor wheel for wear (replace if wear is present or if visibly contaminated with foreign object debris)

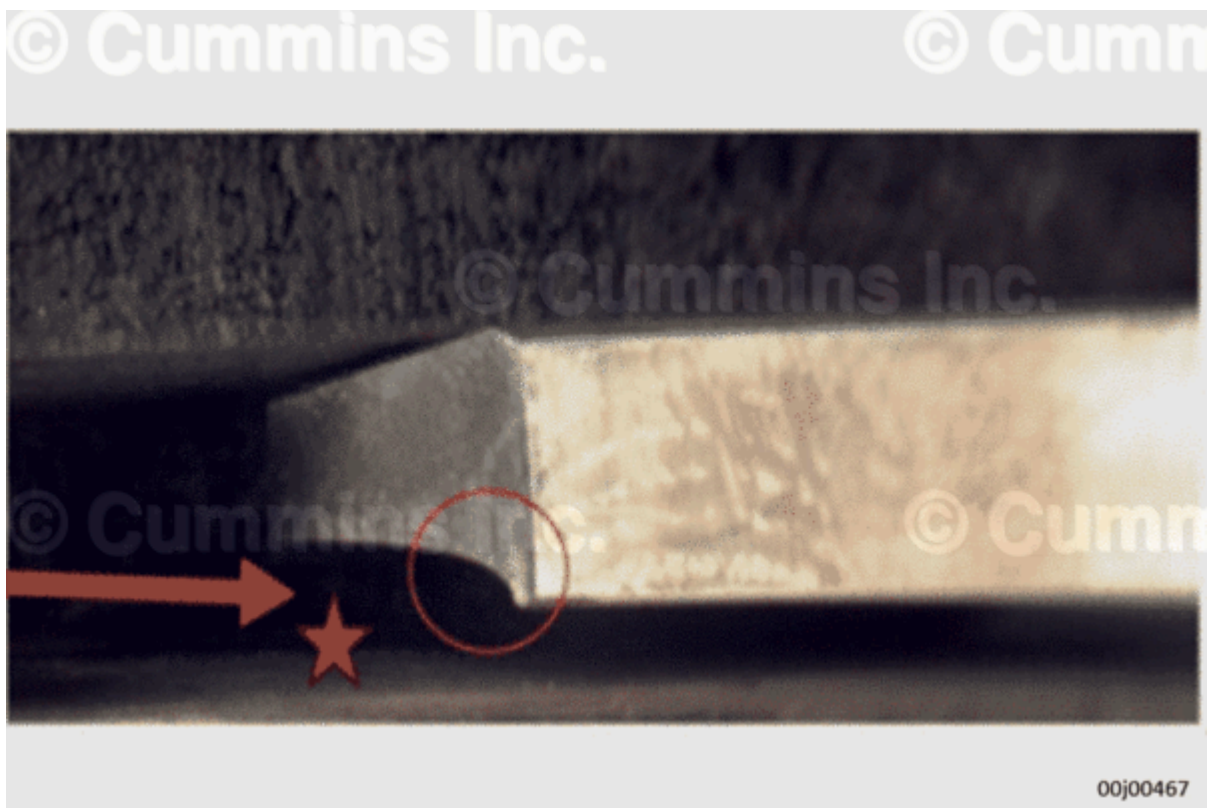
Figure 13

Piston Ring Wear - Full face wear on the top compression ring, combined with full face wear on the intermediate ring, indicates the presence of dust ingestion, which accelerates ring wear. Notice the presence of a lip on the bottom side of the compression and intermediate rings.

Mechanics of top ring wear due to dirt or dust ingestion:

If material that is harder than the piston and ring enter the engine, it can become embedded between the bottom side of the top ring and the piston ring land. Once the debris is embedded, it stays in place creating "sandpaper".

Repetitive motion of the ring against the piston sands away the bottom of the ring. The lip created is the part of the ring that never enters the piston.
