Technical Service Bulletin: TSB120028

Fleetguard® CH44105 & CH44120 Centrifuge Retainer Change

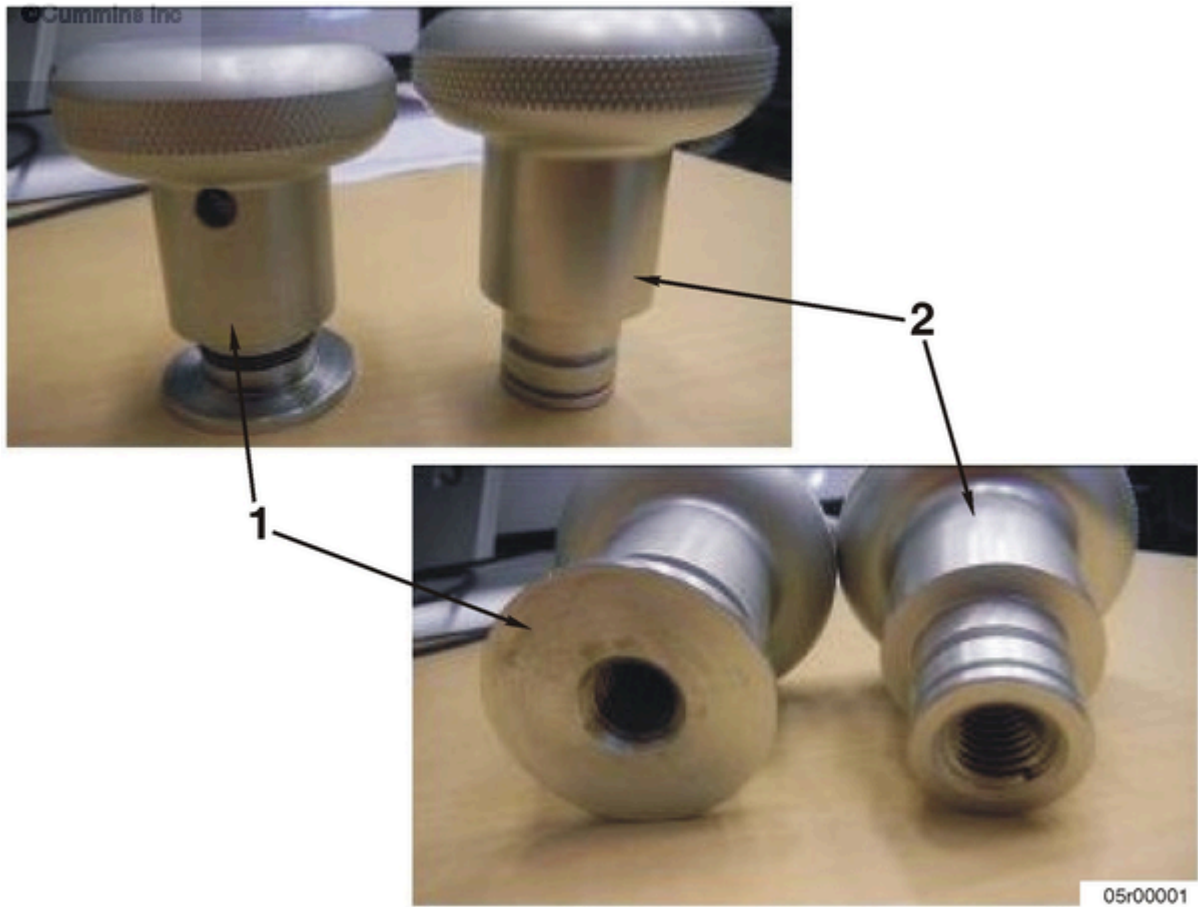
A batch of Fleetguard® CH44105 centrifuges has been produced that have out of specification top retainers. The new style retainer (#2 in Figure 1) was a cost reduction design change to the CH44105 & CH44120 products purchased by Fleetguard®. The new style retainer is out of specification in flatness and parallelism. This causes the edge of the retainer to act as a cutting tool against the bushing material on the top of the internal rotor shaft, causing the bushing to malfunction. Additionally, the smaller outside diameter (OD) of the retainer has an increased load per unit area (#2 in Figure 2).

Figure 1: Old (1) and New (2) Centrifuges Retainer Designs

This has been corrected by Fleetguard® by reverting all centrifuges in stock back to the older style retainer. In Plant the engine serial number (ESN) first for engines built with known good centrifuges is 33189155, built 12 September 2011.

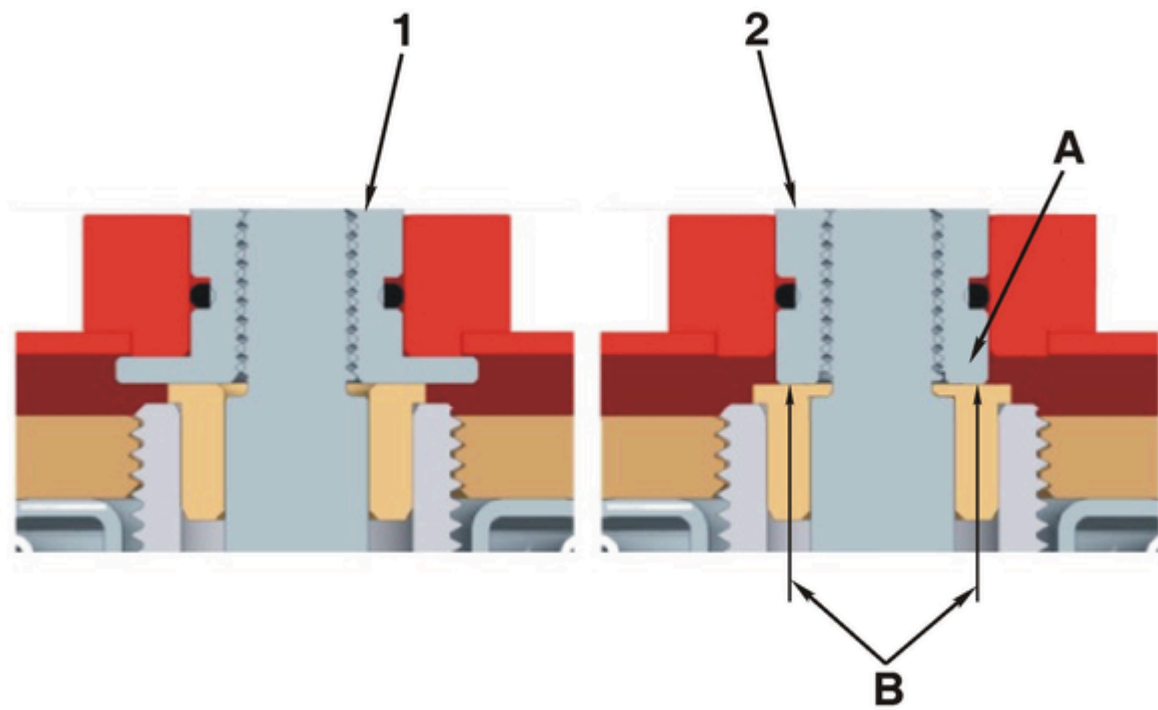
Figure 2: Cut-Away Views of Old (1) and New (2) Centrifuge Retainer Designs.

(A) New knob design **not** fully utilizing bearing surface area.

(B) Location of the bushing wear.
