Technical Service Bulletin: TSB140055

QST30 Industrial - Fuel Leak - Turbocharger Oil Supply Hose Rubbing Number 4 Left Bank Injector Fuel Supply Tube

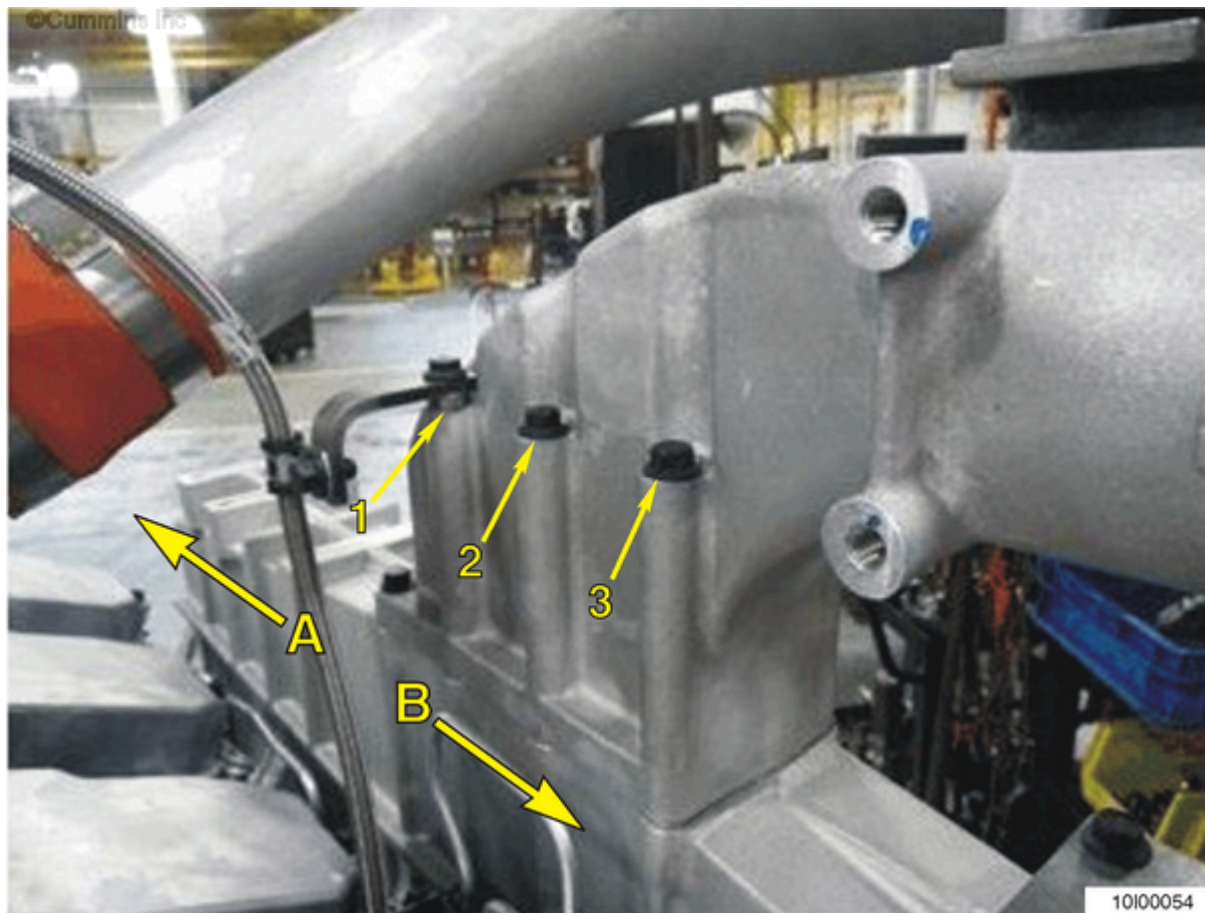
Air Crossover Bolt Hole Location.

1. Front capscrew hole.
  2. Middle capscrew hole.
  3. Rear capscrew hole.
- A. Front of engine.  
B. Rear of engine.

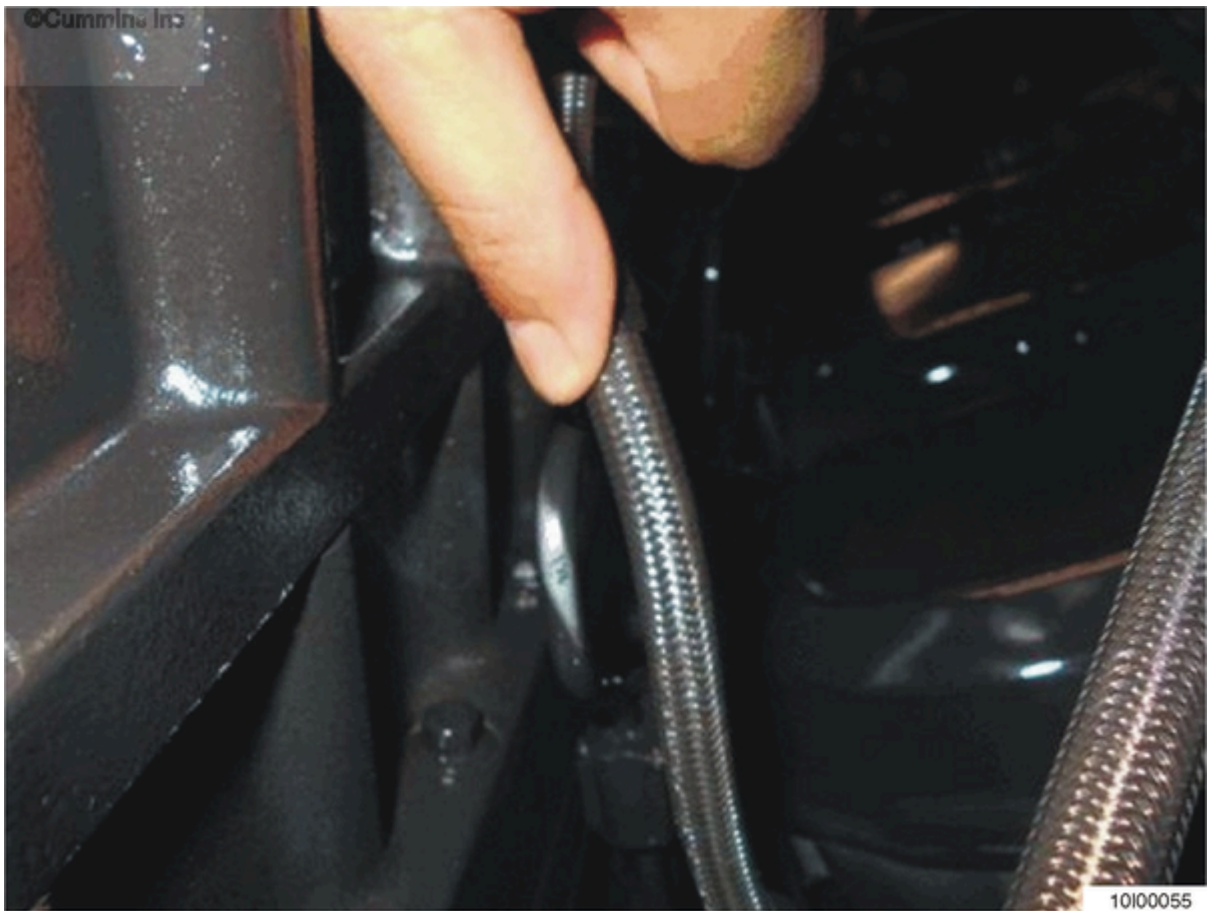
An injector fuel supply tube leak has been reported on QST30 industrial engines. The fuel leak is caused by rubbing or chaffing contact between the left bank turbocharger oil supply hose, Part Number 3087969, and the number 4 injector fuel supply tube, Part Number 3093373. Reported leaks have occurred in less than 1000 hours of engine operation.

Reported wear.

Make sure there is ample clearance between the turbocharger oil supply hose and the injector fuel supply tube. A P-clip may need to be rotated 180 degrees from the current orientation to make sure of proper clearance between the turbocharger oil supply hose and the injector fuel supply tube. If wear is observed between the turbocharger oil supply hose and the injector fuel supply tube, both should be replaced.

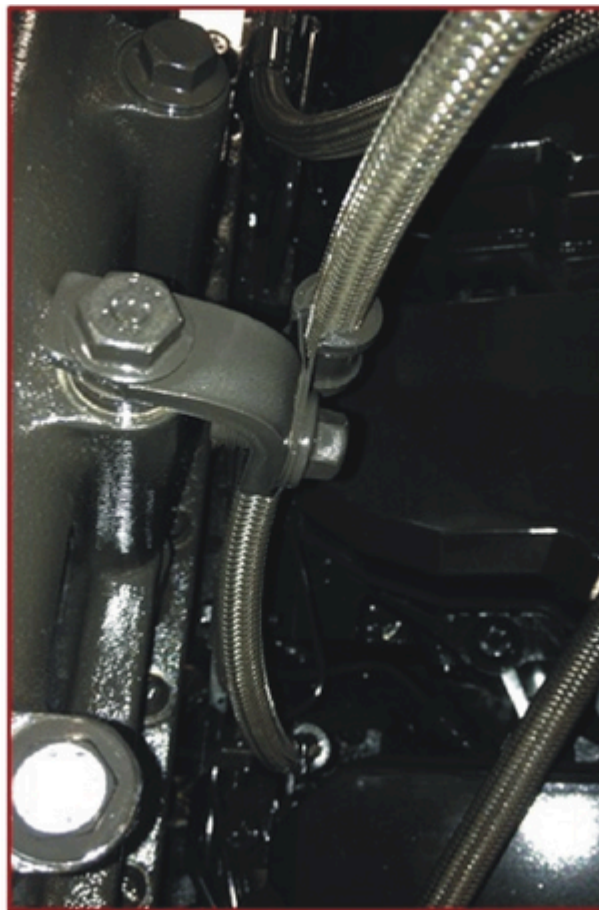
Looking down on the left bank of the engine.

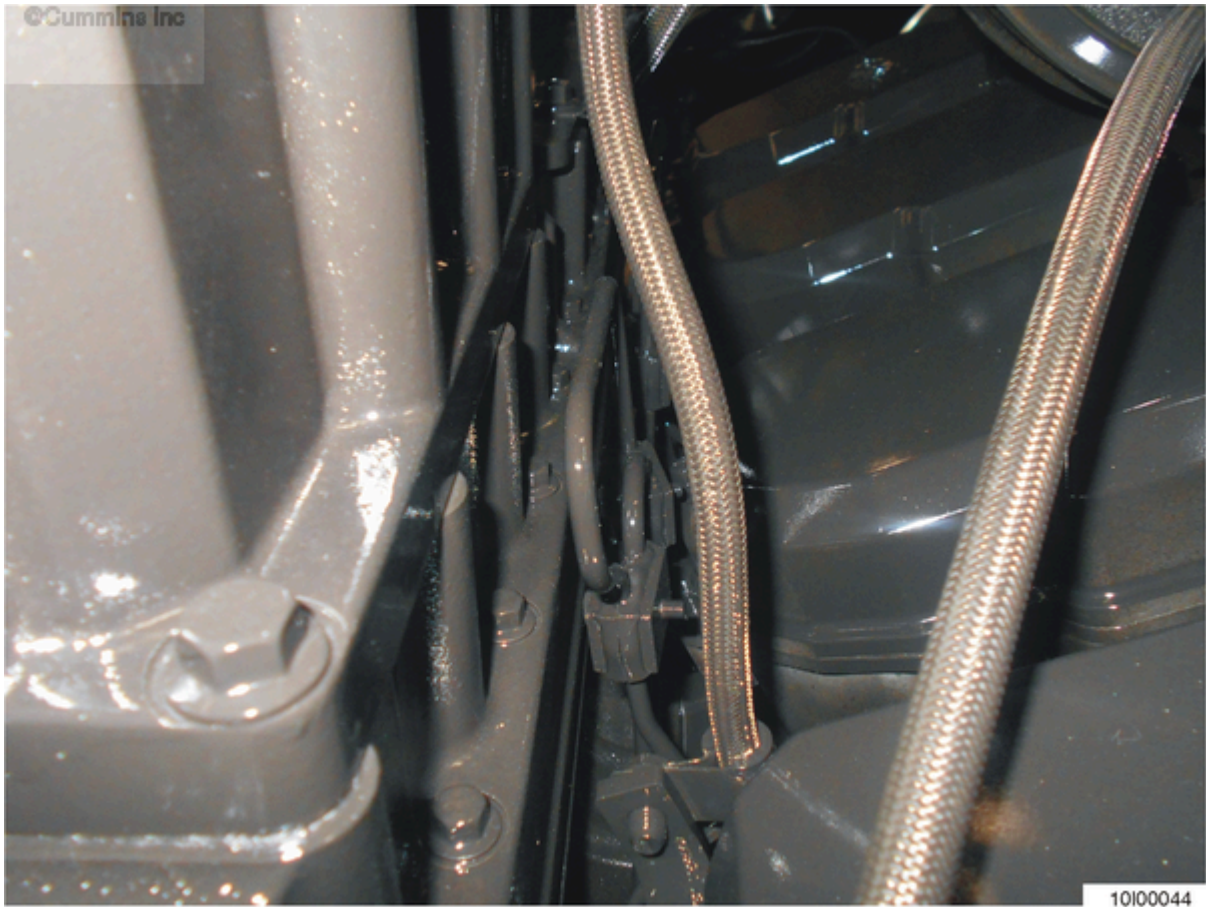
Proper line routing making sure the turbocharger oil supply hose does **not** rub against the injector fuel supply tube or the drain tube. (Viewed forward from the rear of the engine.)

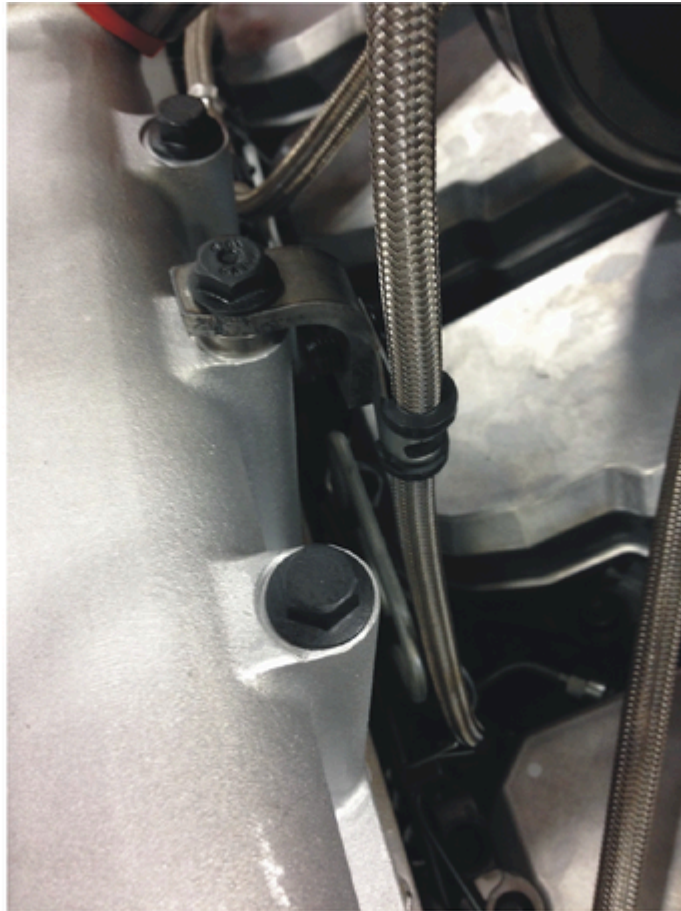
10J00212

Looking down on the left bank of the engine, after rotating P-clip.

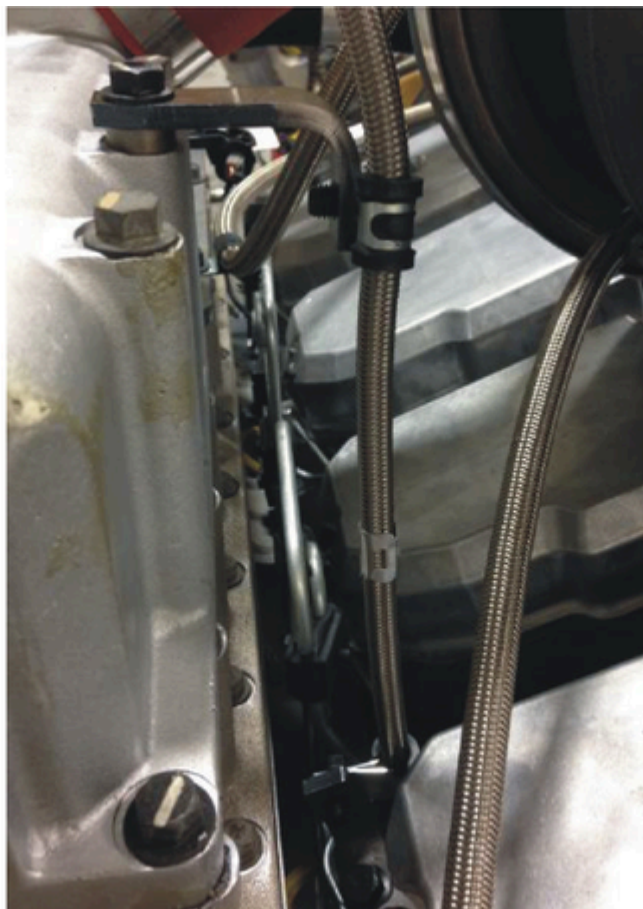
06I00011

60 mm bracket, Part Number 4371605, installed on engine, ESN first 37261832.

Engines with these TP options, built on or after 22-May-2014, have the 60 mm bracket installed.  
ESN first is 37261832.

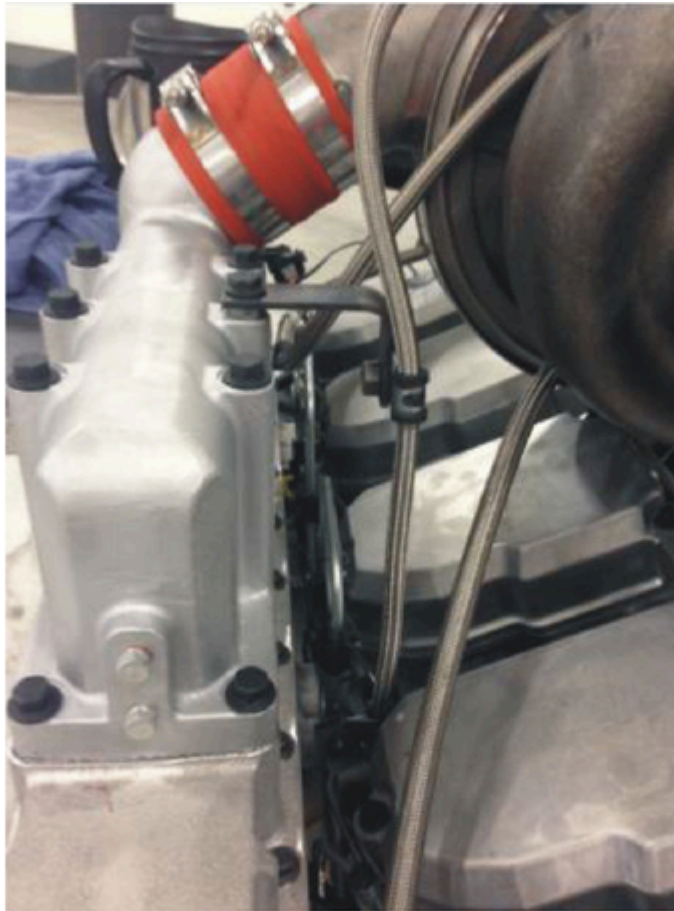
06I00012

100 mm bracket, Part Number 3094824, installed on engine.

Make sure that either Part Number 3094824, 100 mm bracket, or Part Number 4371605, 60 mm bracket, is installed on the engine with the following turbocharger plumbing options:
