Technical Service Bulletin: TSB160011

Released Date: 03-Sep-2019

New Exhaust Gas Temperature Sensor and Injector Quadrant Wiring Harness and Mounting Brackets

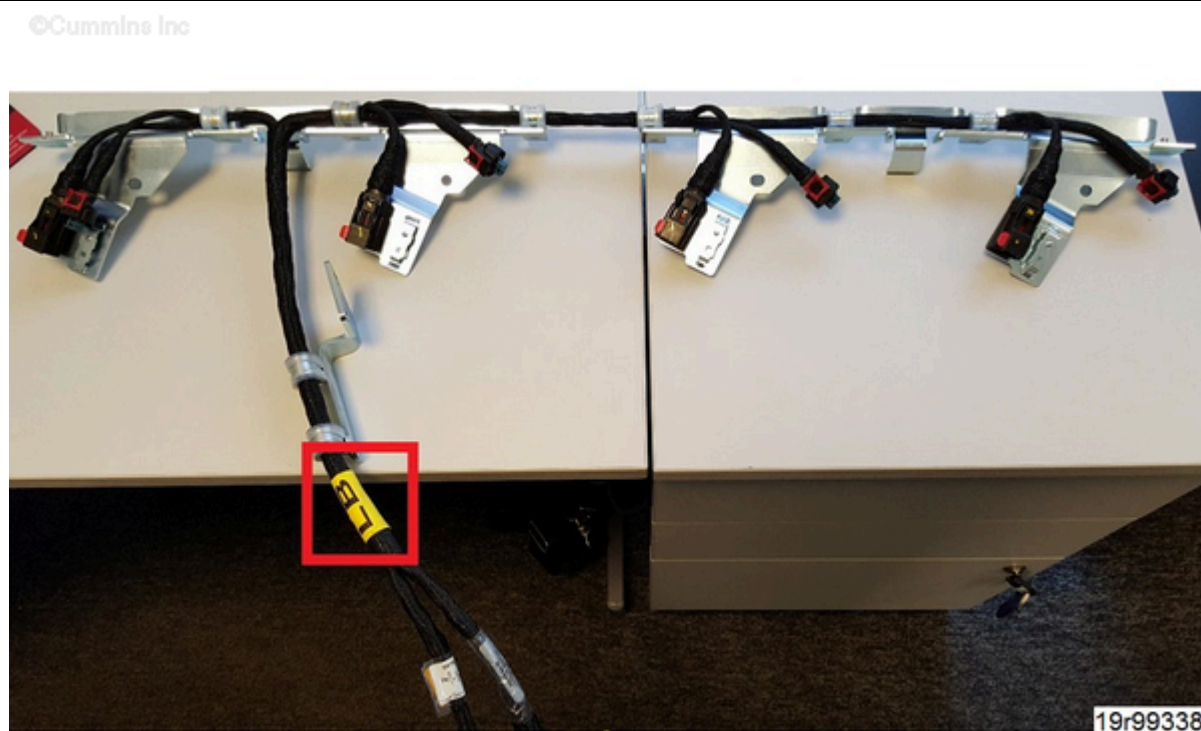
- The cylinder bank (left bank or right bank) on which wiring harness is to be used is identified by yellow tag. See Figure 1 below.

Figure 1, Left Bank Wiring Harness Identified By Yellow Tag.

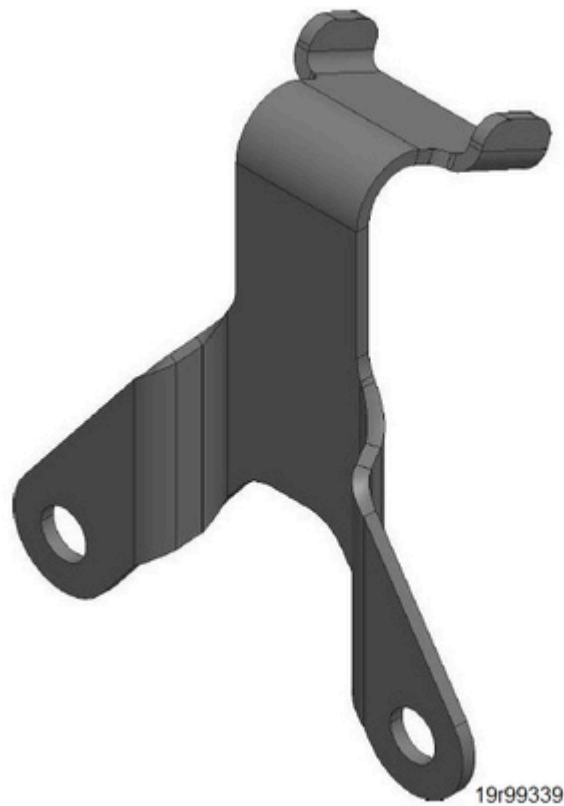
19r99339

Figure 2, Camshaft Cover Bracket.

New camshaft cover brackets are also required when installing the new wiring harness and bracket assemblies. The camshaft cover bracket is mounted on the cylinder block and one **must** be installed for every engine quadrant wiring harness used.

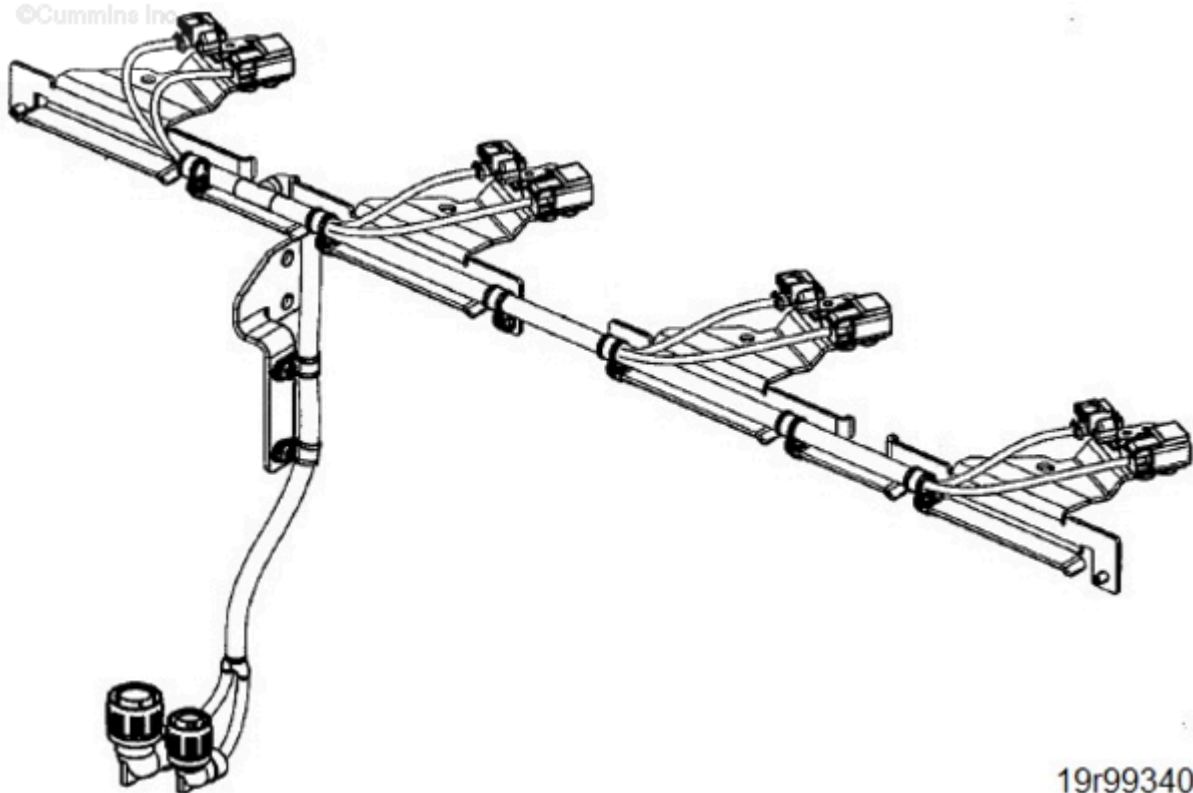
19r99340

Figure 3, Standard Filter Head Wiring Harness.

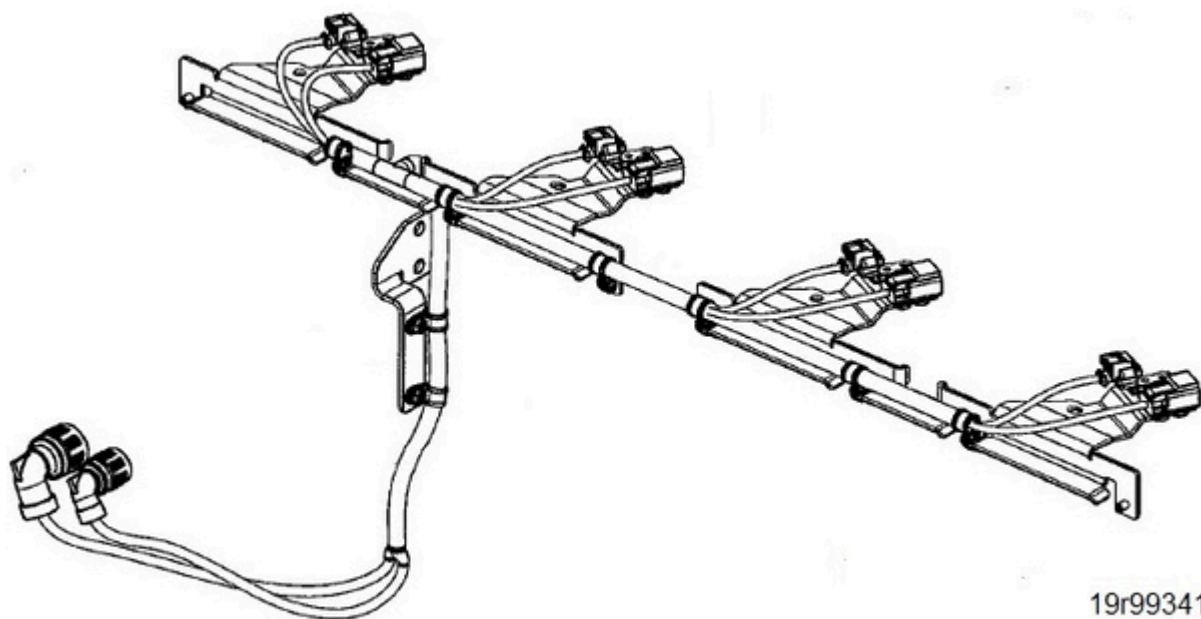
Figure 4, Eliminator™ Wiring Harness.

**Note :** When up-fitting an engine equipped with an Eliminator, use Eliminator<sup>TM</sup> specific wiring harness, Part Number 5372102, for quadrant above Eliminator<sup>TM</sup>, all other quadrants use standard harness. See Table 1 above for part numbers. See Figures 3 and 4 below.
