Technical Service Bulletin: TSB180083

V-Ribbed Belt Tension Drive Load Change for Industrial Applications

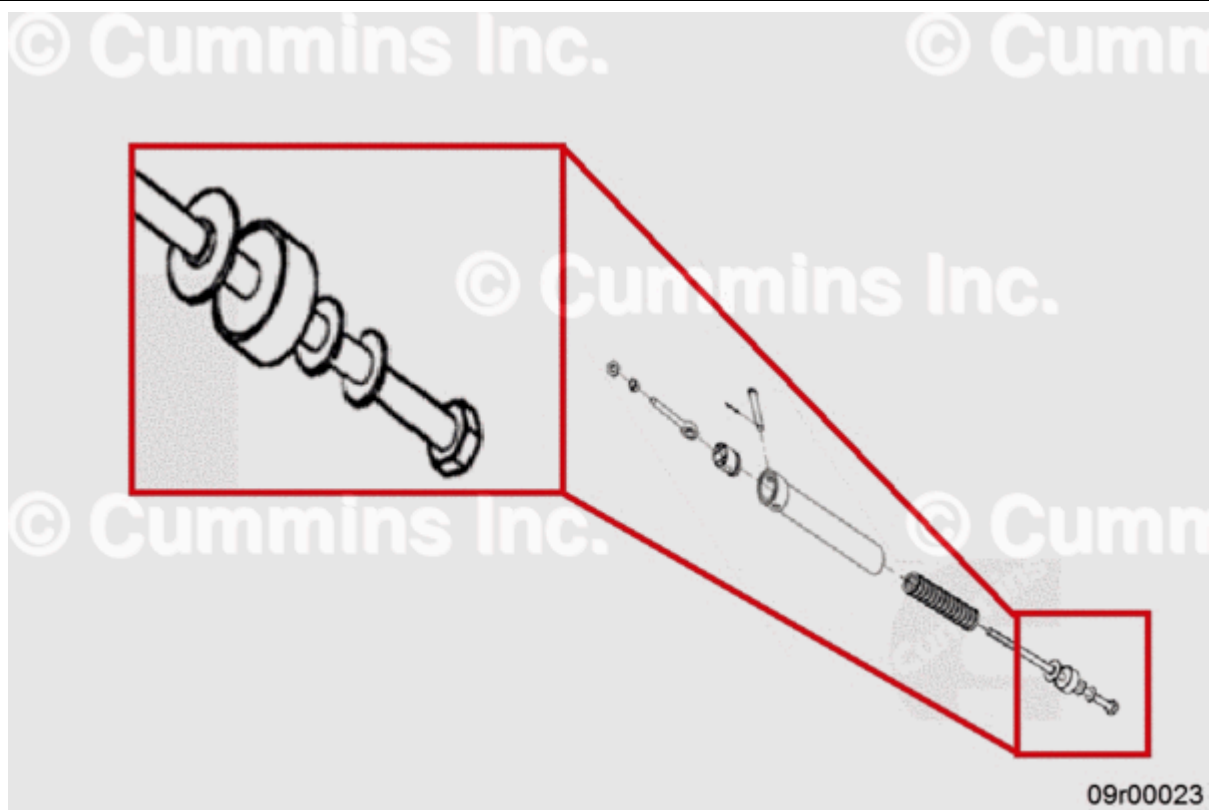
Figure 1, Location of Additional Washer

- High coolant temperature fault code caused by belt rib wear, belt pattern wear, or belt shredding.

- High inertia fan blade and high deacceleration rate spikes can lead to belt wear or malfunction.

After verifying belt tension is below 525 or above 625 lbs, adjust belt tension using belt tension gauge tool, Part Number 3164750. Reference procedure 008-087 in the corresponding Service Manual. If tension load adjustment does **not** reach 525 lbs, and belt does **not** align properly, add additional washer, Part Number 3036900, to tensioner assembly as shown in Figure 1 below.
