Technical Service Bulletin: TSB190194

Image Analyzer Issue in INSITE™ Electronic Service Tool

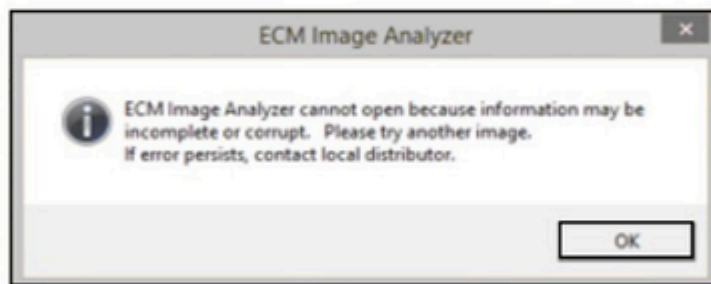
Work order images created with INSITE™ electronic service tool versions 8.5.0 and 8.5.1 are not able to be properly viewed in ECM Image Analyzer in newer INSITE™ electronic service tool versions. See Figure 1 below for error displayed.

Figure 1, ECM Image Analyzer Error Message in INSITE™ Electronic Service Tool.

Create a new work order image with the latest version of INSITE™ electronic service tool.
