Technical Service Bulletin: TSB200057

Fractured Low Temperature Aftercooler Water Pump Shaft

- QST30 CM552

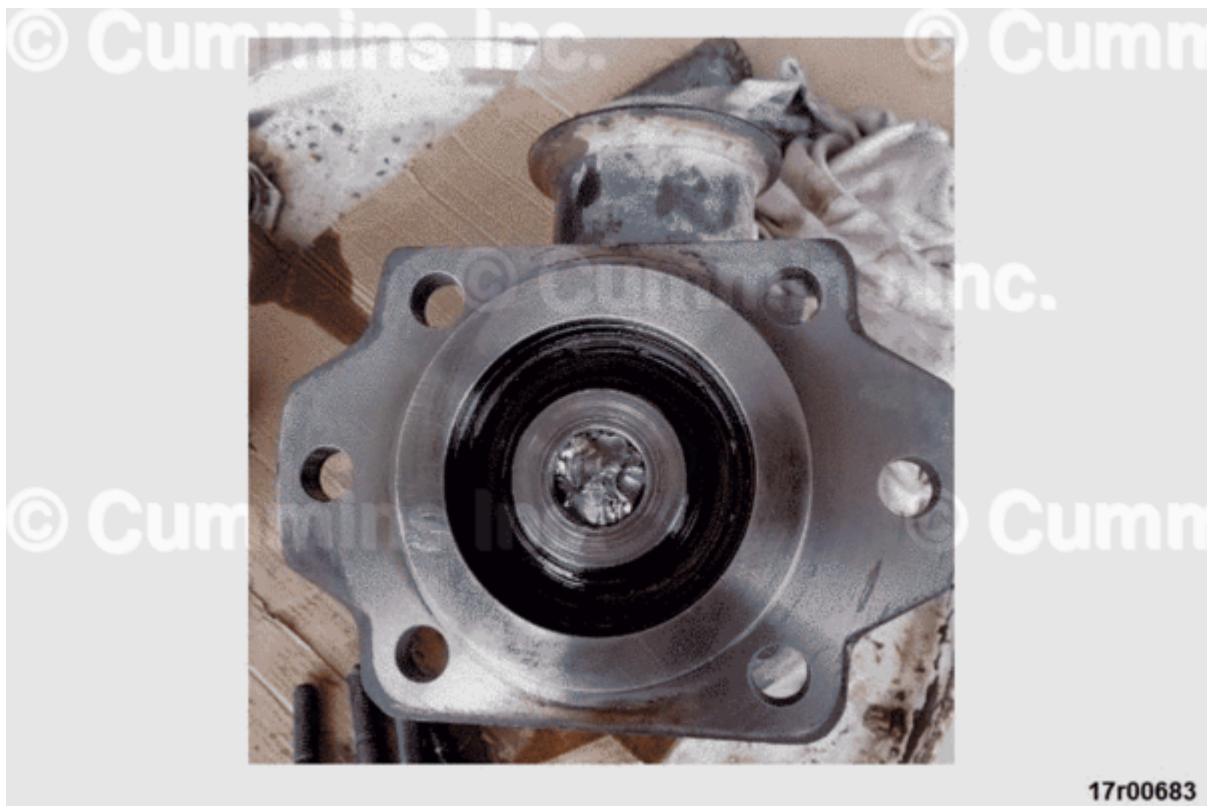
- High intake manifold temperature.

- Fractured low temperature aftercooler water pump shaft.

Inspect low temperature aftercooler water pump shaft. See Figure 1 below.

Figure 1, Fractured Low Temperature Aftercooler Water Pump Shaft.

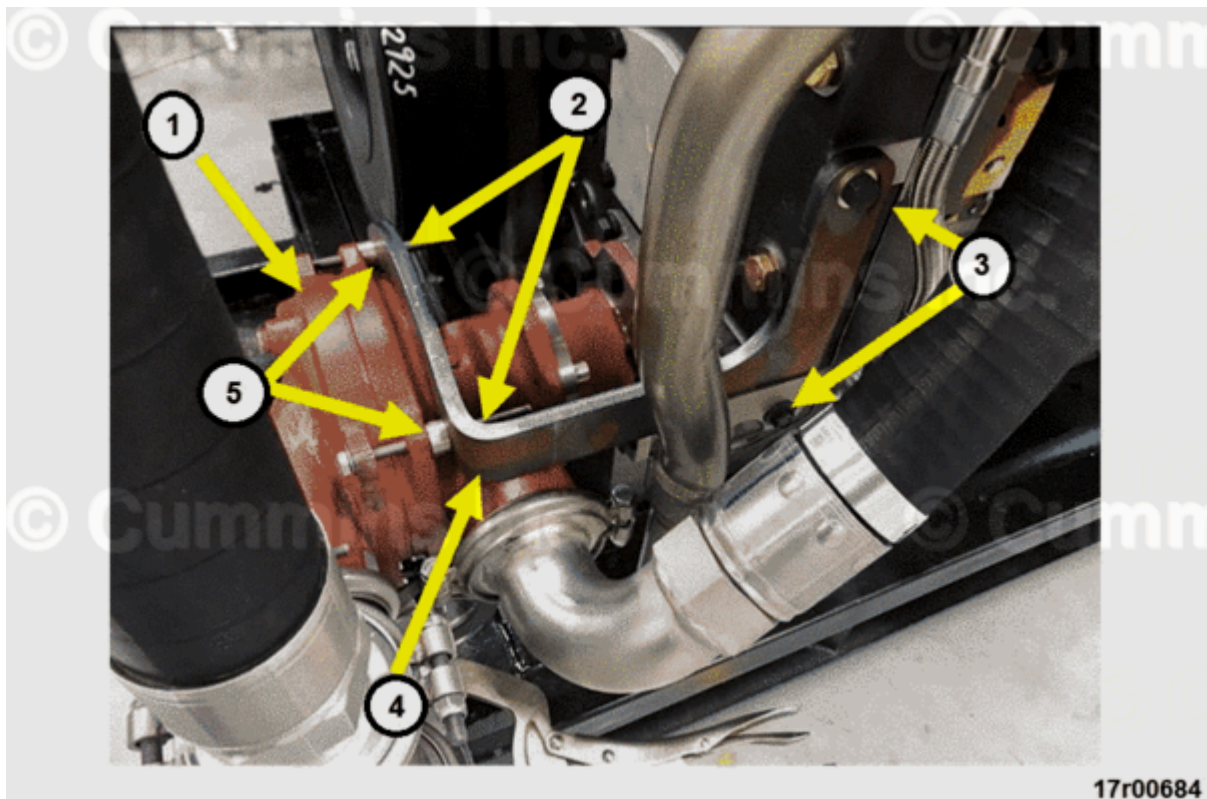
A new water pump and water pump brace were released. See Figure 2 below for new mounting arrangement.

Figure 2. New Low Temperature Aftercooler Water Pump Mounting Arrangement.

Install two mounting spacers (5) between the water pump housing (1) and water pump brace (4).

Install water pump brace mounting capscrews (2).

- Torque Value: 65 N•m [ 48 ft-lb ]

Install water pump brace mounting capscrews (3).

- Torque Value: 33 N•m [ 24 ft-lb ]
