# Technical Service Bulletin

Technical Service Bulletin: TSB210107

Engine Wiring Harness Approved Repairs

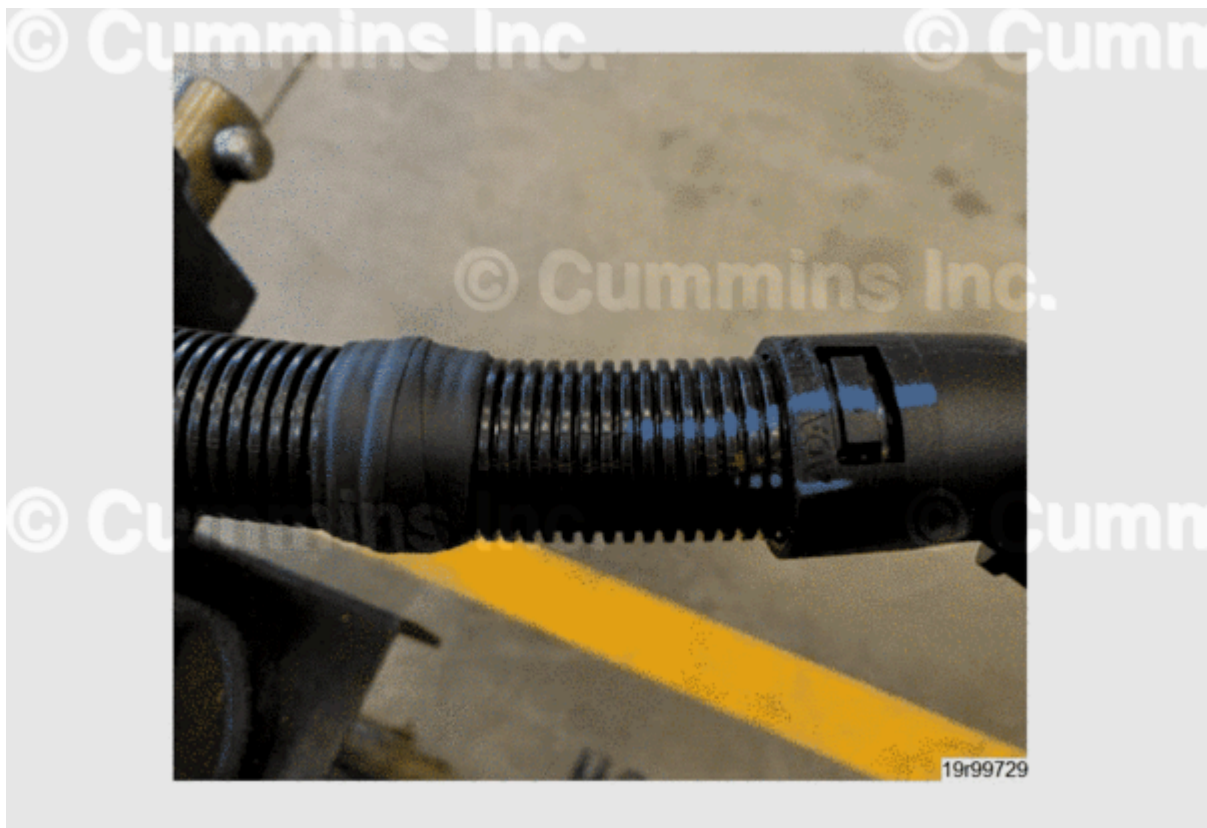
Figure 3, Rubber Tape Application.

- Measure and mark approximately 15 cm [ 6 in ] from the engine wiring harness connector and apply a wrap of rubberized tape. Make a wrap of approximately 3 cm [ 1 in ] wide and verify orientation is similar to Figure 3 below. The tape should self-adhere. The tape is added

as a precaution to help seal the heat shrink / cold shrink added later. The tape will also help fill the voids of the harness conduit.

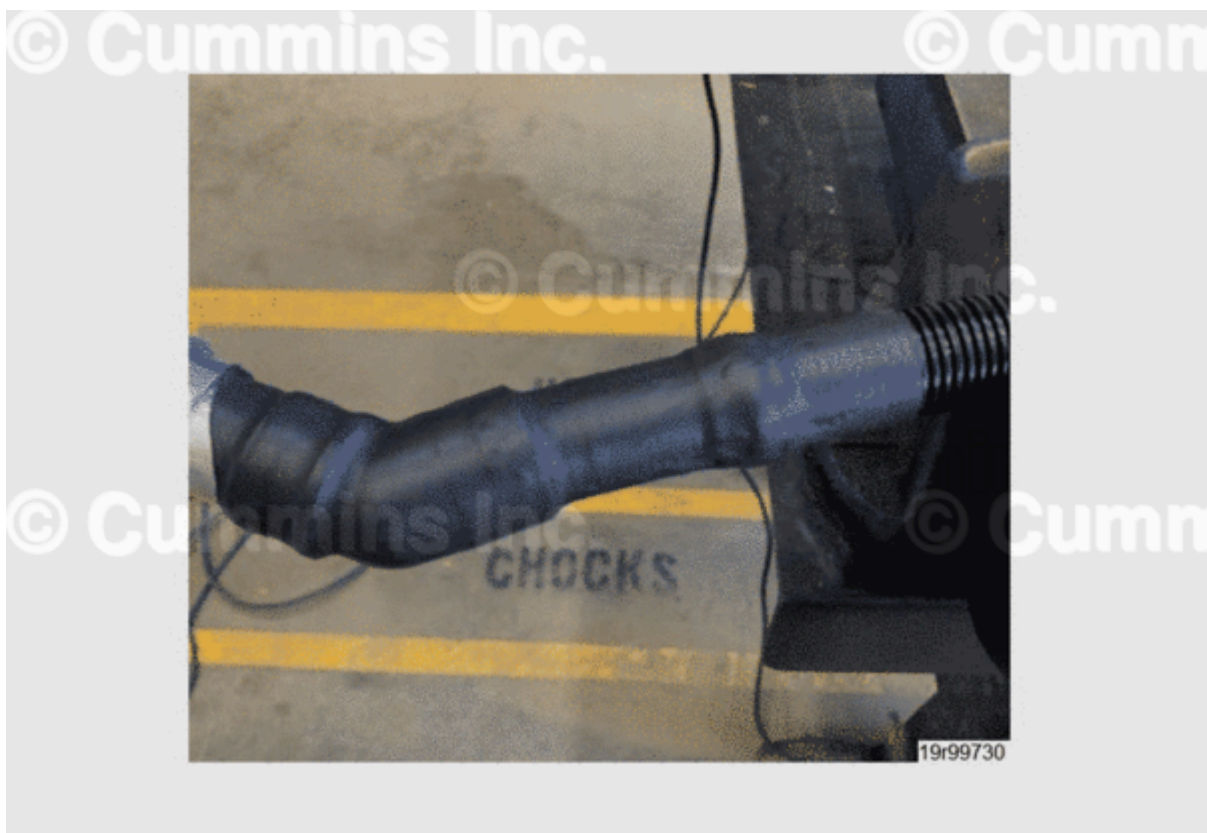
Figure 4, Finished Heat Shrink Wrap.

- Take the heat or cold shrink and slide over the engine wiring harness connector. Verify heat or cold shrink is kept as close as possible to the engine wiring harness connector. Cut an appropriate length of wrap, verify the wrap is long enough to cover past the applied rubberized tape.
- If using heat shrink, use a heat gun to start the shrinking process. Start the process at the engine wiring harness connector end, verifying that as much shrink tube as possible is kept on the connector end and slowly move down the rest of the wrap until all shrink tube is completed. See Figure 4 below.

**Do not overheat or over shrink the wrap as this can cause splitting.**

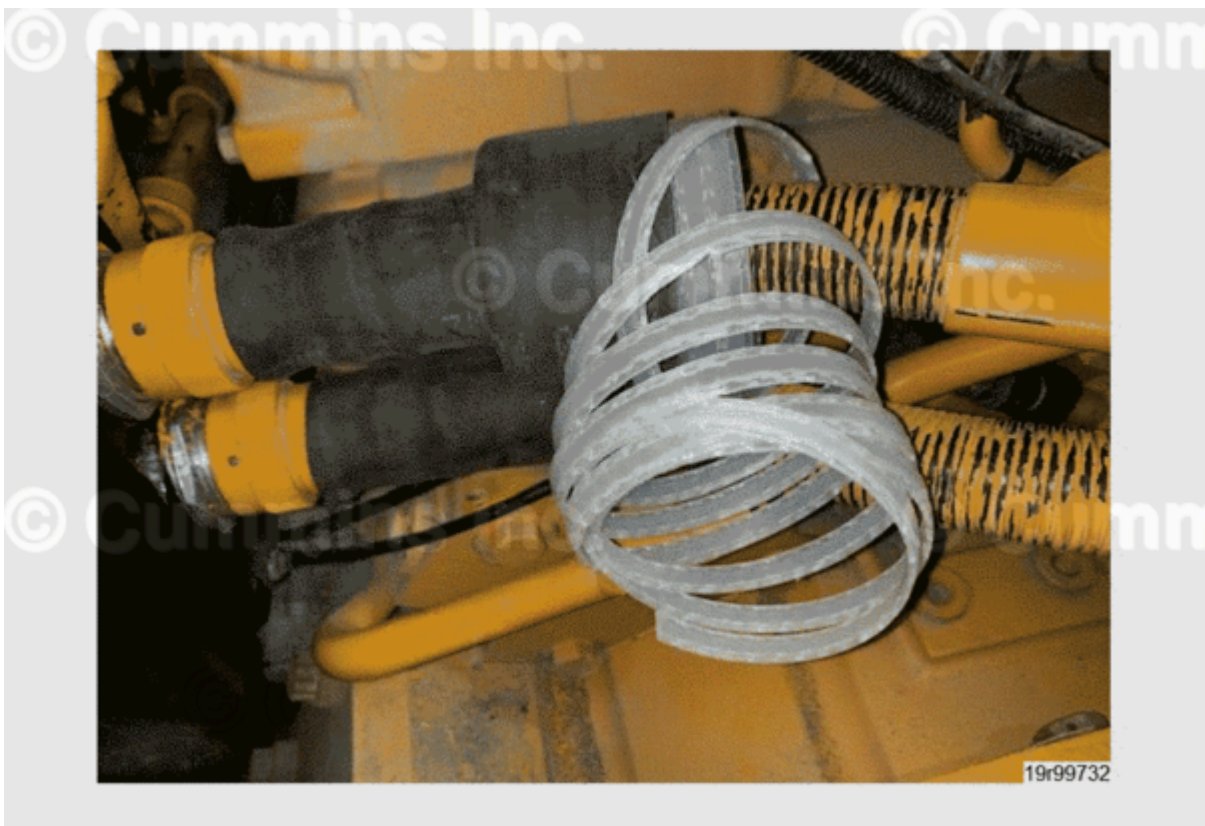
Figure 6, Cold Shrink Application.

- If using cold shrink wrap, application may be easier with the connector installed. If this case, install the connector, hold the cold shrink flush against the connector body carefully to **not** interfere with the rotating part of the connector. See Figure 5 below.
- Pull on the plastic tab so the cold shrink is applied. Note the direction of the pull-tab when using cold shrink. Cold shrink should be pulled from the front and through the cold shrink itself towards the back.

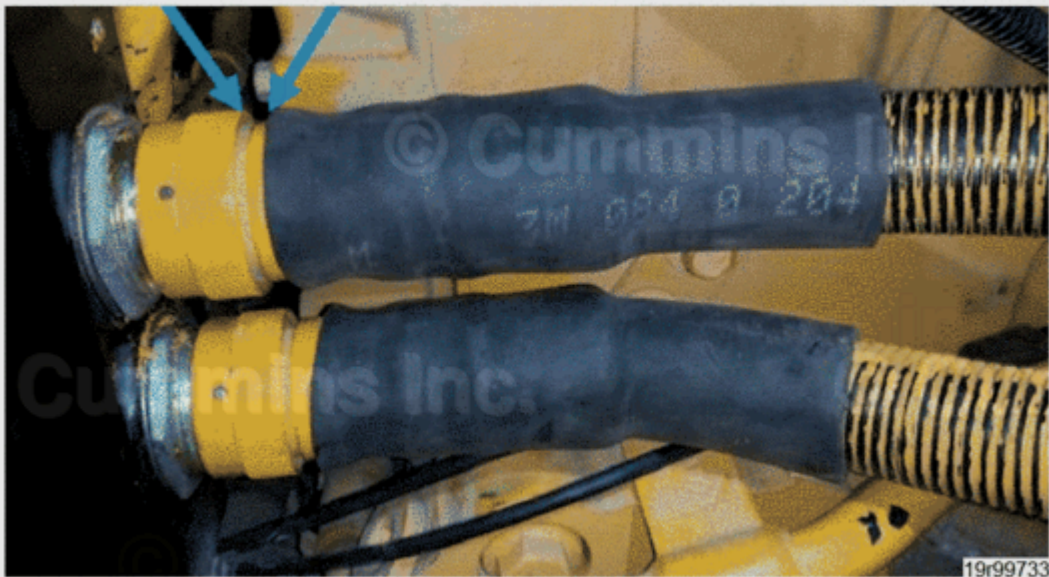
Figure 7, Completed Wrap Installation.

- In the application of either heat or cold shrink, verify that the wrap is applied as close to the rotating part of the connector as possible. This will ensure the best seal with the wrap.
