Technical Service Bulletin: TSB210148

Released Date: 08-Nov-2021

Cooling Fan Drive Belt and Accessory Drive Belt Walking, Shredding, and or Falling Off

- QST30 CM552
- QST30 CM2350 T101
- QST30 CM2350 T103C

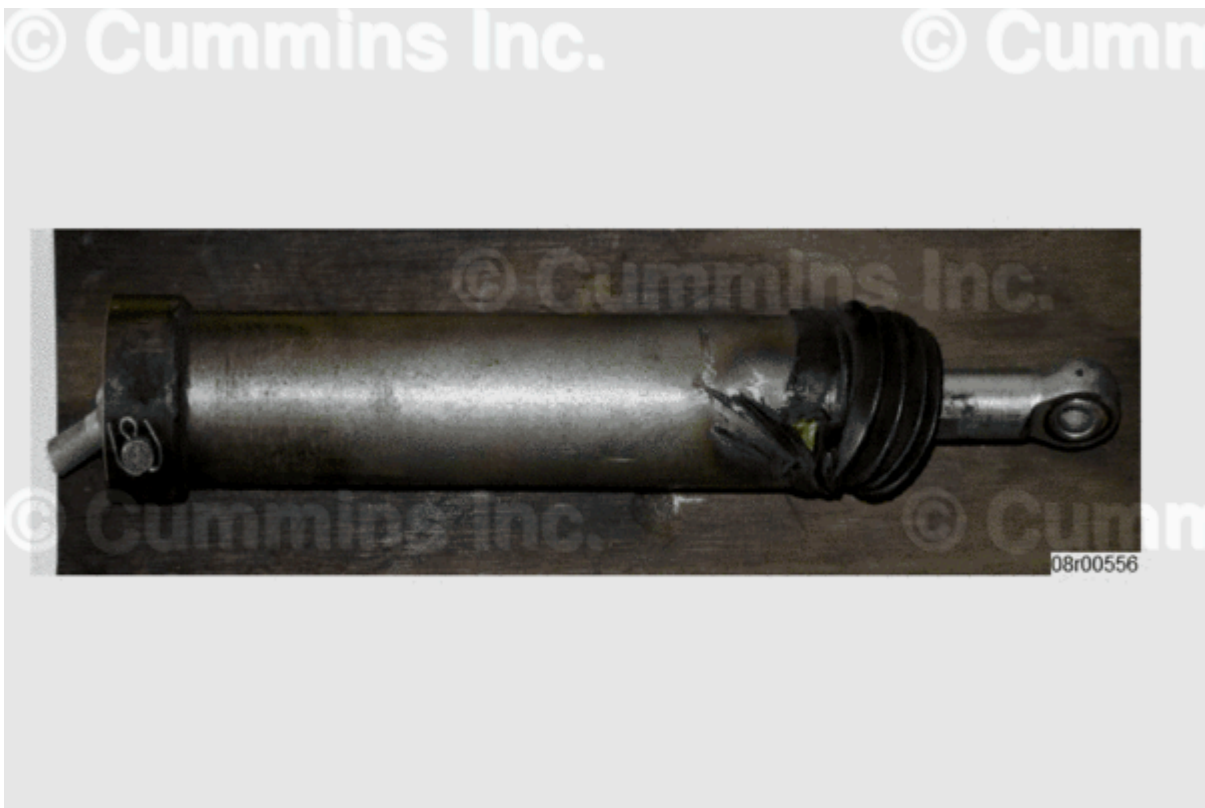
Figure 3, Male Rear Rod End Broken at Shaft.

- If fan drive belt linear tensioner rod ends are broken (see Figure 3 below), replace tensioner assembly or just replace rod ends as provided in Service Parts Availability Table 1 below.
