Technical Service Bulletin: TSB210213

Wire Harness Relay Mounting Improvements

- QST30 CM552
- QST30 CM850

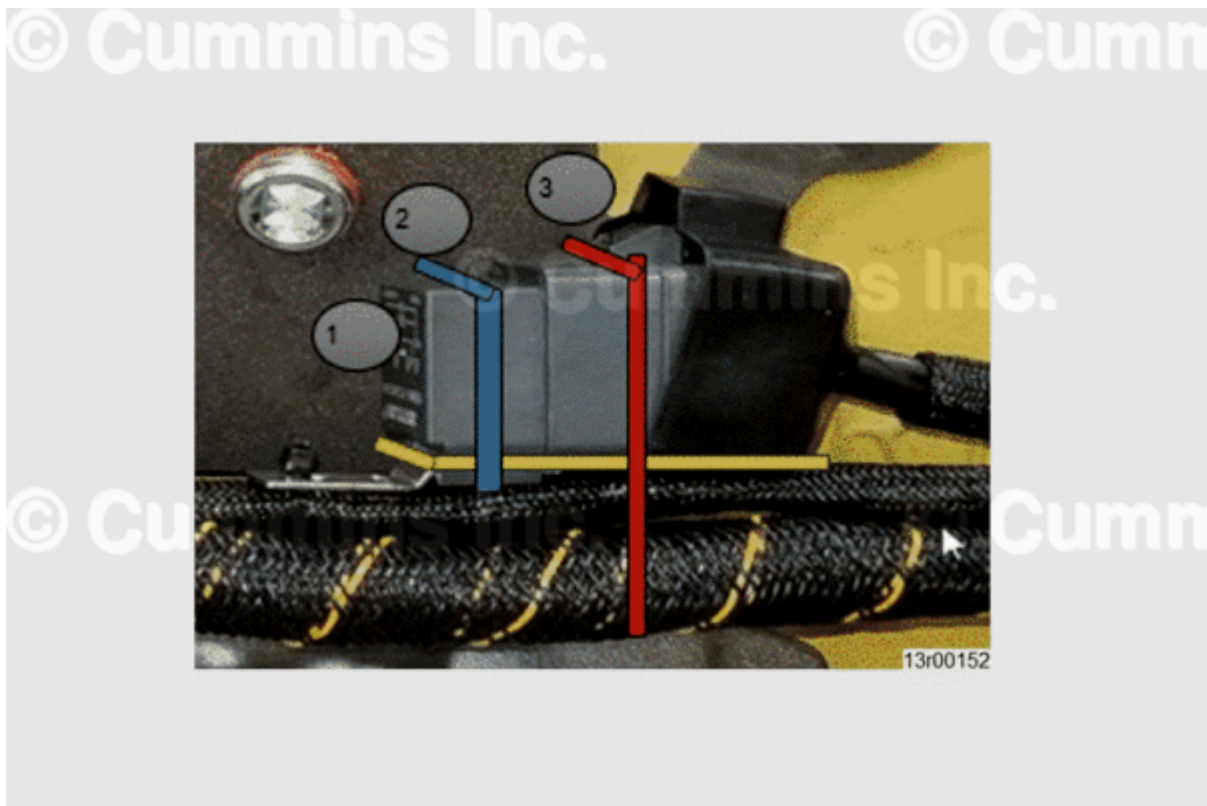
Wire harness relay, Part Number 3658780, can become partially disconnected causing contact malfunction.

Figure 1, Wire Tie Placement on Wiring Harness Relay.

- If wiring harness relay has already malfunctioned, replace the wiring harness relay. See corresponding Service Manual. Reference Section 019-211 in Section 19.
- Wire ties can be added to improve wiring harness relay support and prevent contact malfunction.
- Add quantity three of part number 3062329 as instructed:
  - Install one wire tie around two wiring harness relay halves (yellow tie), verify tie is routed under wiring harness relay boot.
  - Install second wire tie (blue tie) to wrap around wiring harness relay and bottom wire tie.
  - Install the last wire tie (red tie) around wiring harness relay and bottom wire tie and wiring harness. Reference Figure 1 below. Figure 2 shows production solution.

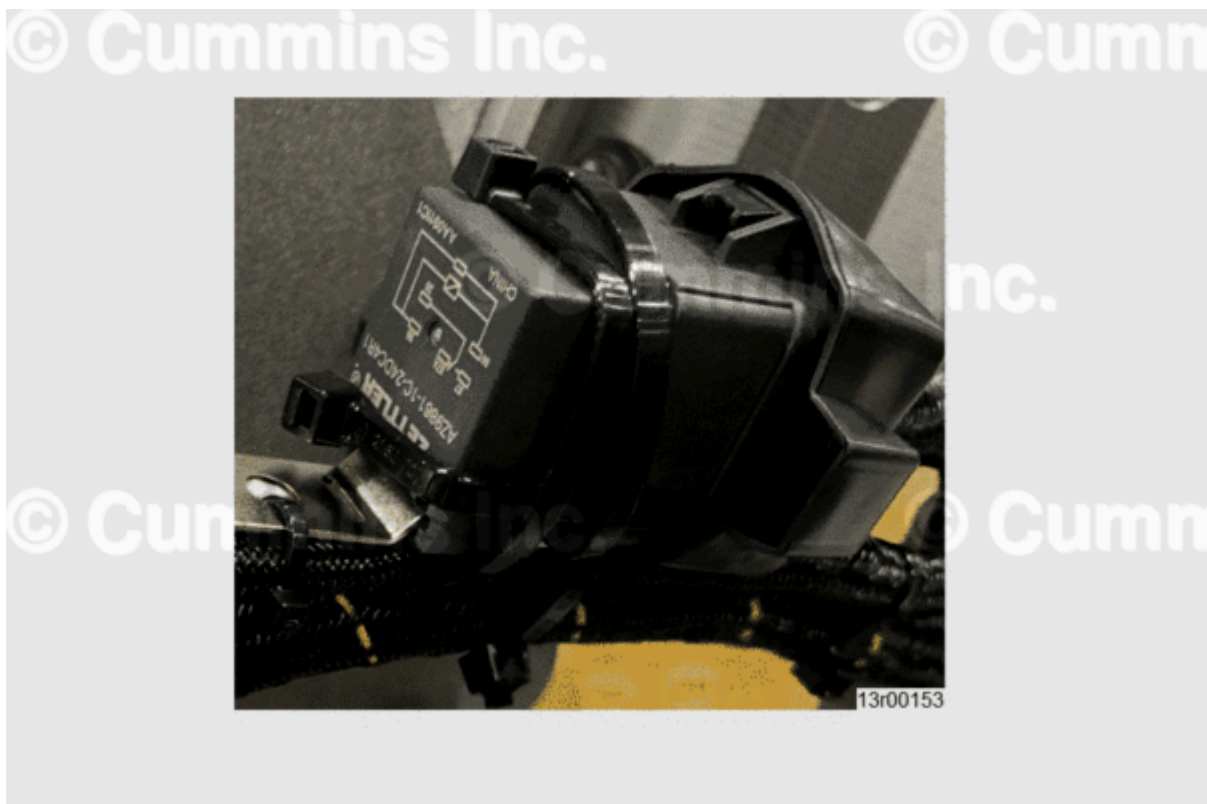
Figure 2, Production Solution on Wiring Harness Relay.
