Technical Service Bulletin: TSB210256

External Coolant Leak: Incorrect Lifting Bracket Capscrews

- QST30 CM552
- QST30 CM850

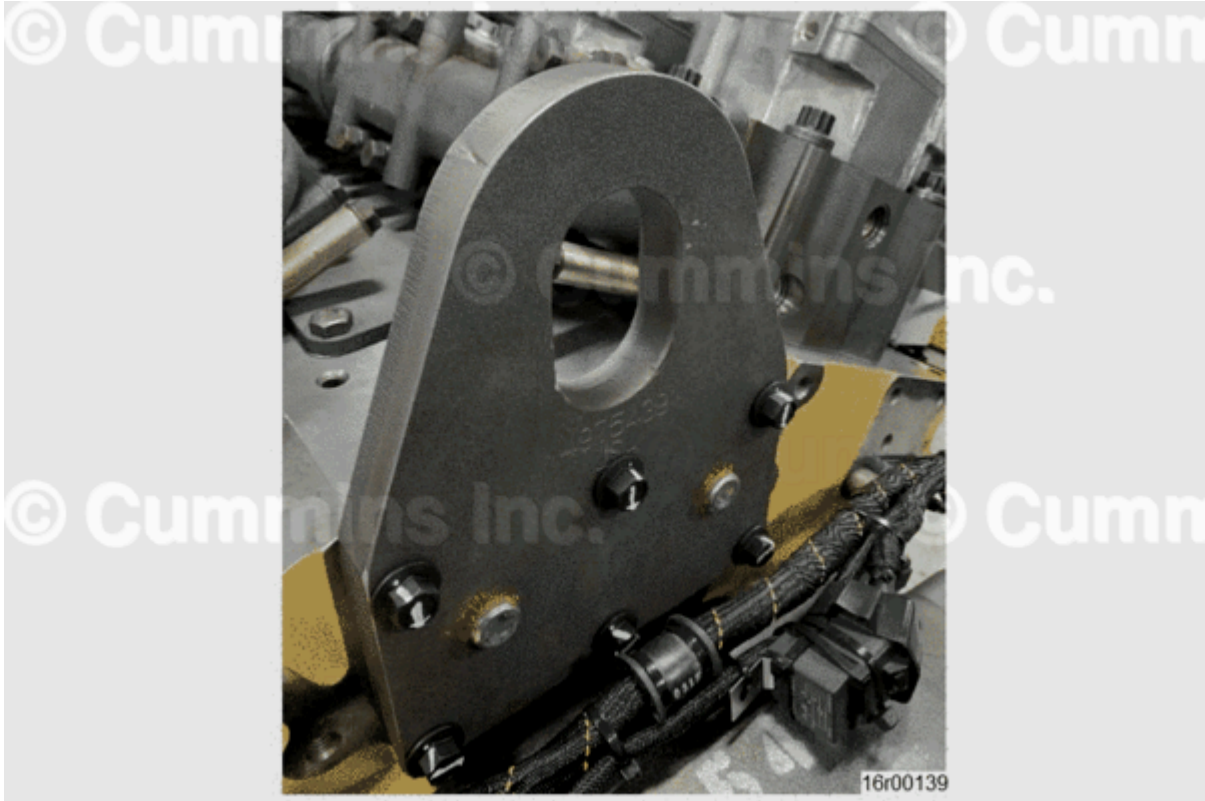
- Lifting bracket capscrews **not** fully seated
- External coolant Leak

- Incorrect length capscrews installed
- Lifting bracket capscrews were incorrectly packaged and 50 mm capscrew were installed instead of the proper 45 mm capscrews.
- The longer capscrew can result in an inadequate final torque to the lifting bracket and a coolant leak.

Figure 1, QST30 Lifting Bracket With 6 Capscrews Shown.

- Engines are to be inspected to verify the lifting bracket capscrews are fully seated.

Install proper length lifting bracket capscrews. See Table 1 below for part numbers.

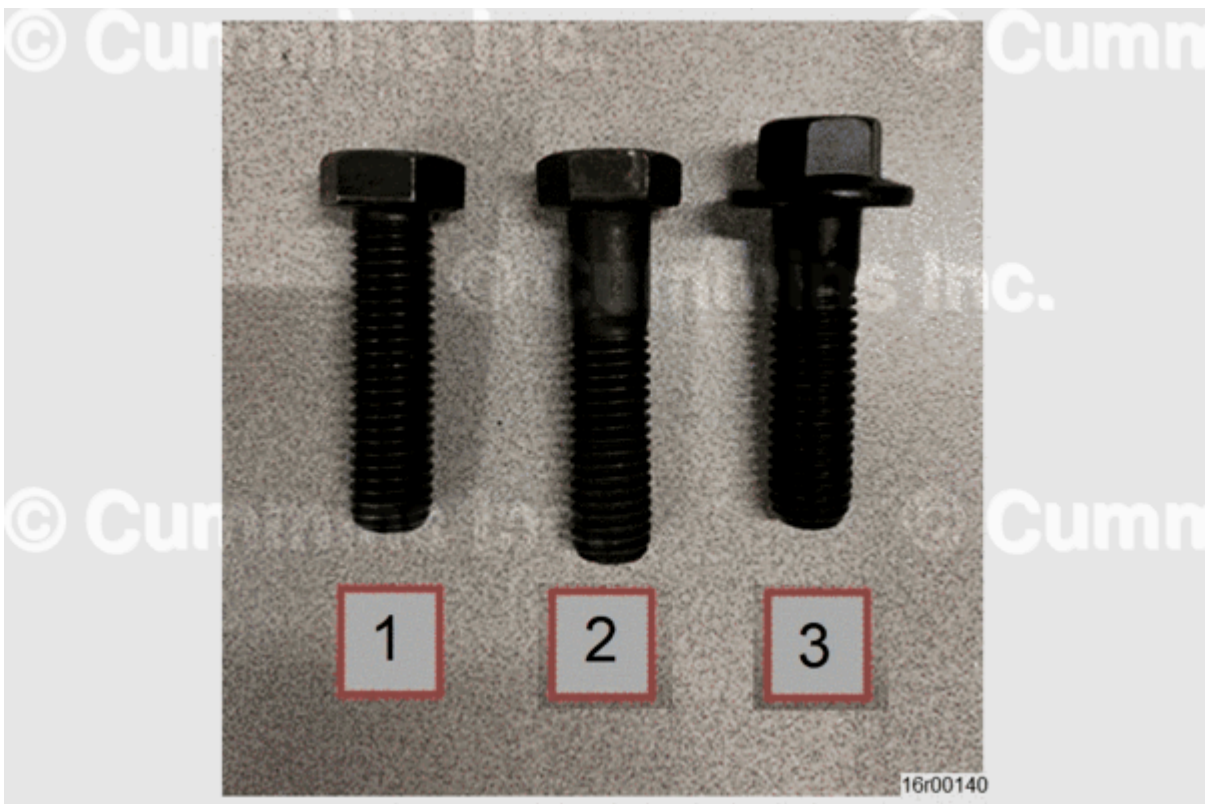
Figure 2, (1) Correct Capscrew, Part Number 3093754; (2) Incorrect Capscrew, Part Number 3093755; (3) Acceptable Substitute Capscrew, Part Number 3093940 .
