# Technical Service Bulletin

Technical Service Bulletin: TSB220022

Released Date: 04-Oct-2024

Engine Control Module (ECM) Will Not Communicate or Will Not Accept ECM Calibration Code

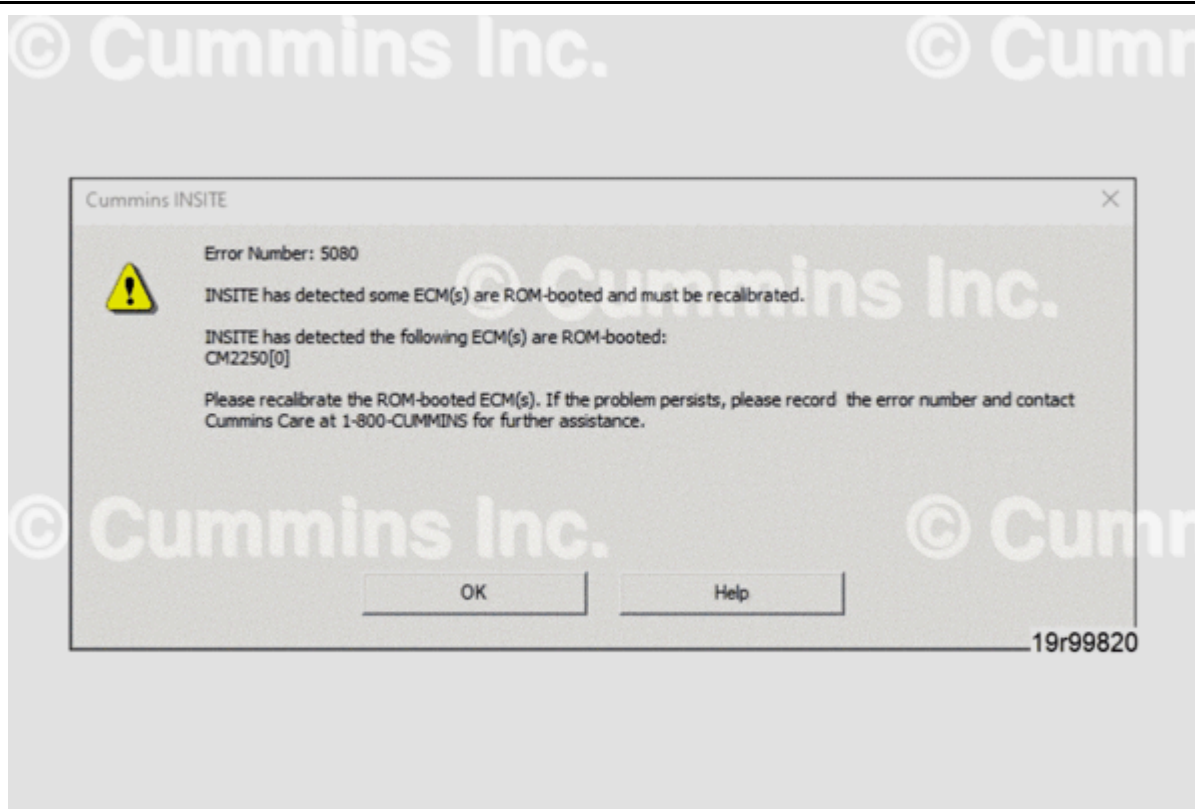
Figure 1, Example of the Error Message From INSITE™ Confirming the ECM Is Rom-Booted and Needs Recalibration.

Before replacing the ECM, reset the ECM using the ROM boot process and attempt to recalibrate the ECM.

- Reset the ECM software using the ROM boot procedures listed in Table 1 and verify that INSITE™ shows a similar message as in Figure 1 below.
- Recalibrate the ECM using the ECM calibration procedures listed in Table 1 below.
- For general tool information, including the correct installation configuration and required cables, see the ECM-specific Bench Calibration Base Harness Service Tool Instruction, Bulletin 3377791.
- If the bench calibration base harness or any of the required hardware is **not** available, follow the technical escalation process.
