Technical Service Bulletin: TSB230019

New ReCon® Aftertreatment NOx Sensors Causing Fault Code 3232 or 2771

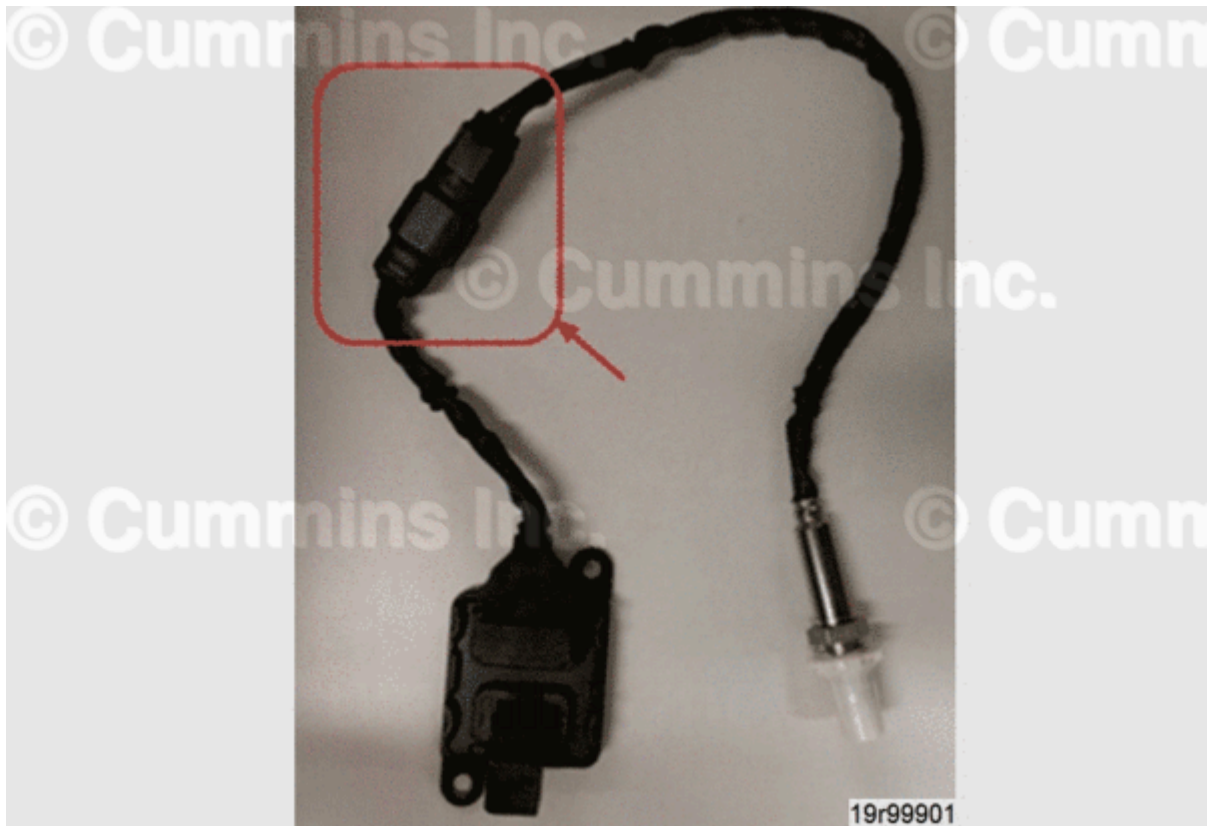
Fault Code 3232 or 2771 is active at key-on immediately after installing a “new” ReCon® (RX) aftertreatment NOx sensor. This issue **only** affects ReCon® (RX) aftertreatment NOx sensors (Part numbers are listed in Table 1) that have gone through the remanufacturing process. These aftertreatment NOx sensors can be identified by the inline connector that is present in the aftertreatment NOx sensor probe wiring as shown in Figure 1.

Figure 1, Aftertreatment NOx Sensor Probe Inline Connector.

Replace the aftertreatment NOx sensor. See corresponding Service Manual. Reference Procedure 019-451 or 019-463 in Section 19.
