Technical Service Bulletin: TSB230092

Released Date: 07-Jun-2023

Fan Clutch Oil Supply Manifold Solenoid Re-orientation

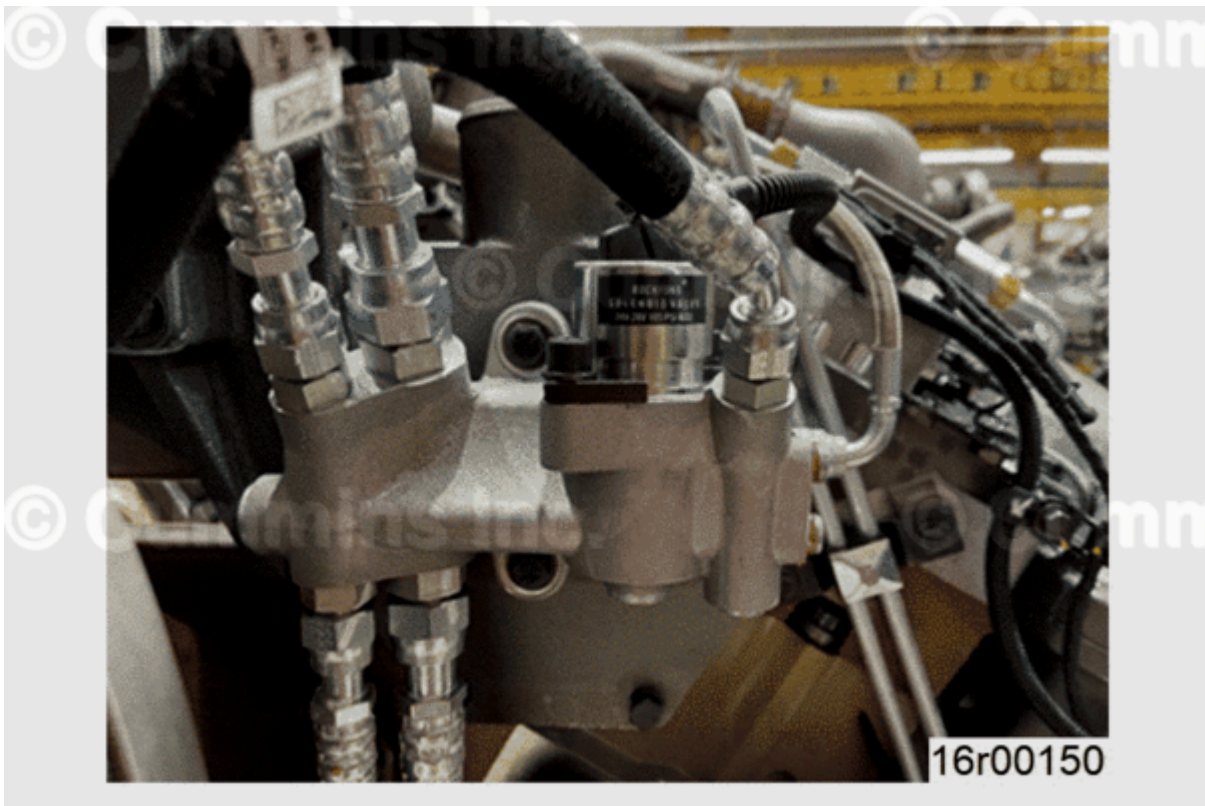
Fan clutch oil solenoid coil malfunction causes permanent cooling fan engagement. Fault codes 245 and 2377 become active. Permanent full fan speed can cause over-cooling and excessive noise.

Figure 1, Existing Oil Manifold Installation.

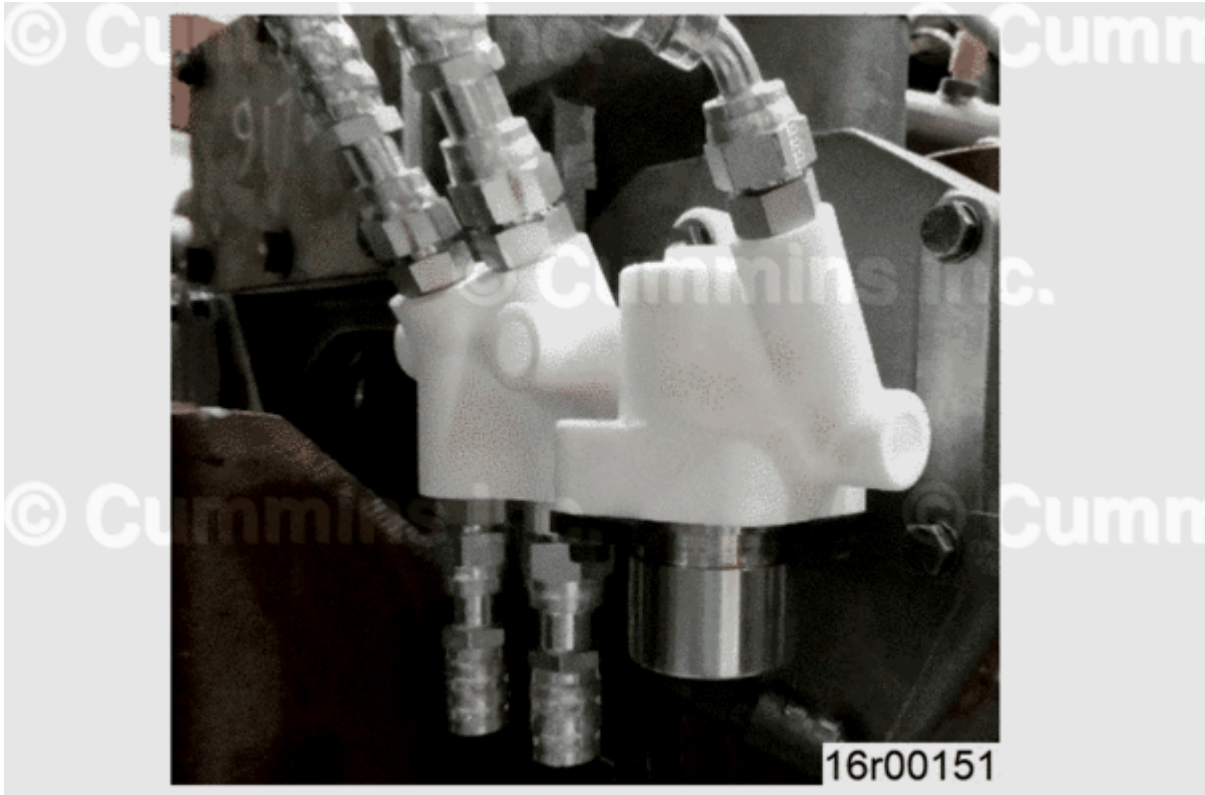
Figure 2, New Design Oil Manifold Installation.

The new design oil manifold rotates the solenoid mounting location by 180°. In this orientation, cooling oil is gravity fed to the solenoid coil, reducing coil temperature and therefore the risk of malfunction.

A new fan clutch oil manifold has been designed to improve oil cooling on the oil control solenoid coil. This fan clutch oil manifold is released in a parts kit (part number 6468466). The parts kit contains all the required components to upfit the new manifold and separately available solenoid (part number 3641305) to the engine.

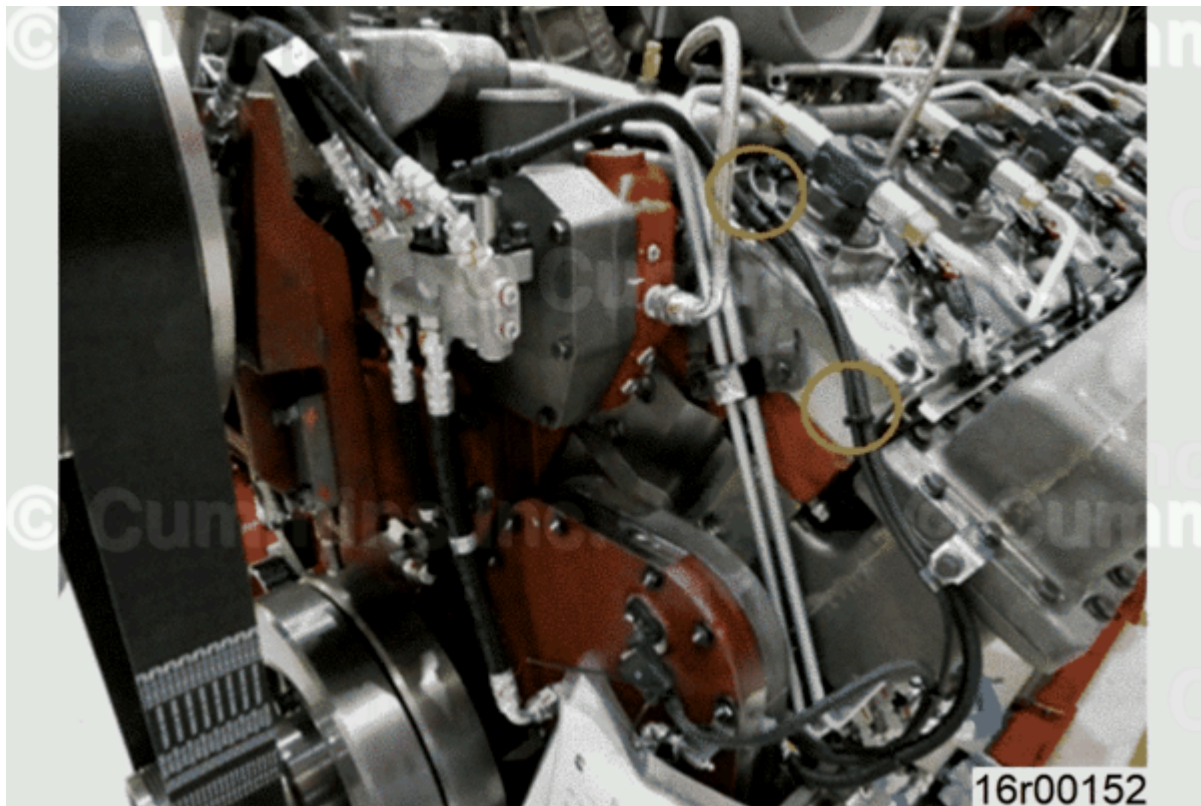
Figure 3, Tier 2 Engine Wiring Harness Routing.

- Remove the solenoid harness from the shared P-clip, holding the solenoid harness and the engine harness, to the rocker cover (circled yellow). Cut the cable tie securing the solenoid harness to the existing engine harness. Figure 3 shows the existing route for Tier 2 engines.

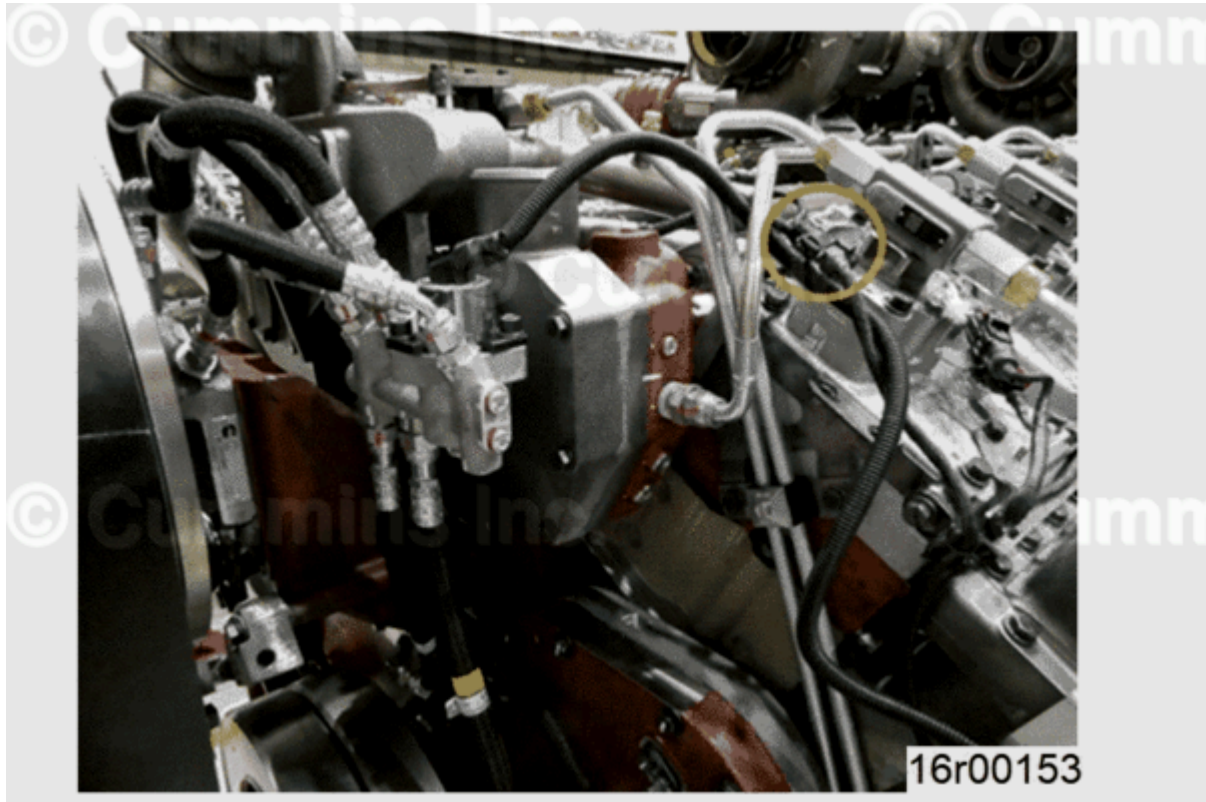
Figure 4, Tier 4 Engine Wiring Harness Route.

- Figure 4 shows the existing Tier 4 solenoid harness route, which has an engine harness P-clipped to it on the rocker cover. Remove the solenoid harness from the engine harness P-clip.

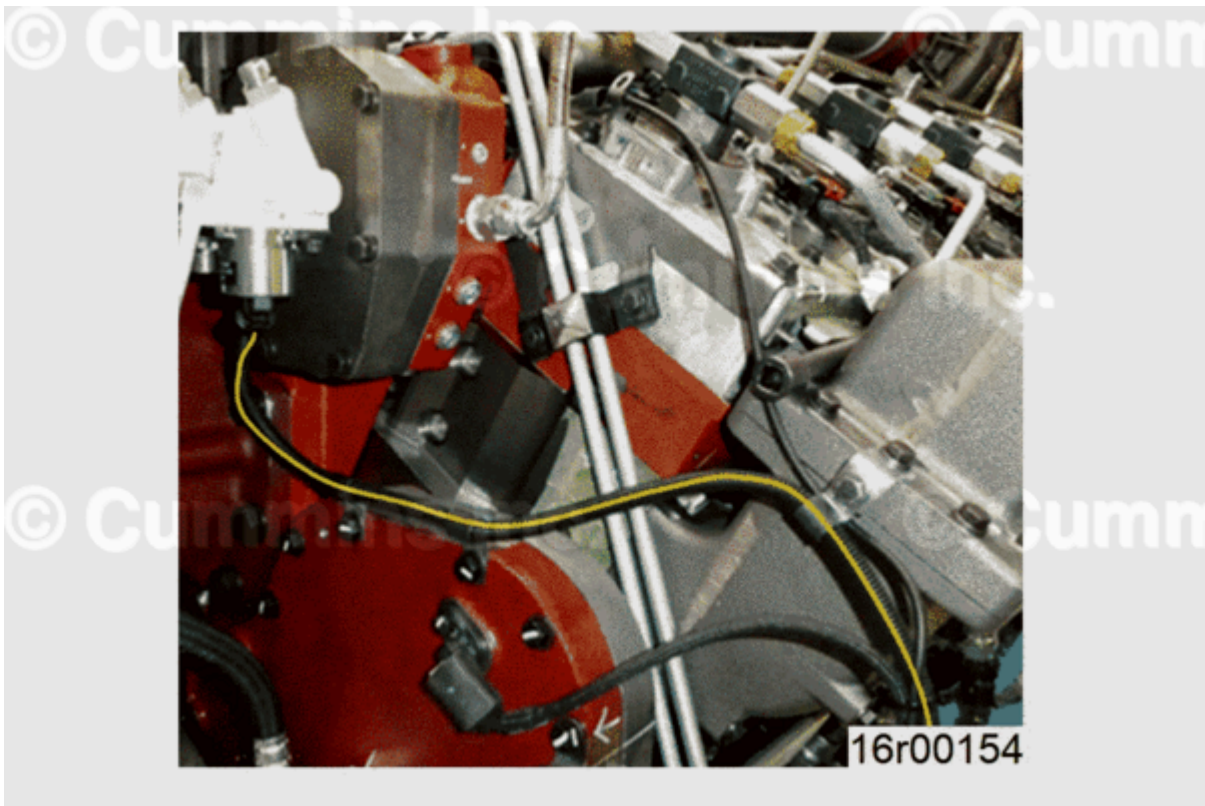
Figure 5, New Solenoid Harness Routing.

Following installation of the fan clutch oil control manifold and solenoid, the solenoid wiring harness **must** be re-routed to allow connector alignment with the new solenoid position. This process differs for Tier 2 and Tier 4 engines. Verify the route required and re-route as shown in Figure 5.

- Secure existing Tier 2 and Tier 4 non-solenoid harnesses as per the original installation.
- Re-route the solenoid harness to the new solenoid position. Figure 6 shows the required new route using two P-clips (part number 68152A) on existing gear cover capscrew locations across both Tier 2 and Tier 4 engines.
- Remove two gear cover capscrews and install the solenoid harness through the P-clips, vertically upwards as shown.
- Install the capscrews.

**Torque Value:** 75 n·m [ 55 ft-lb ]

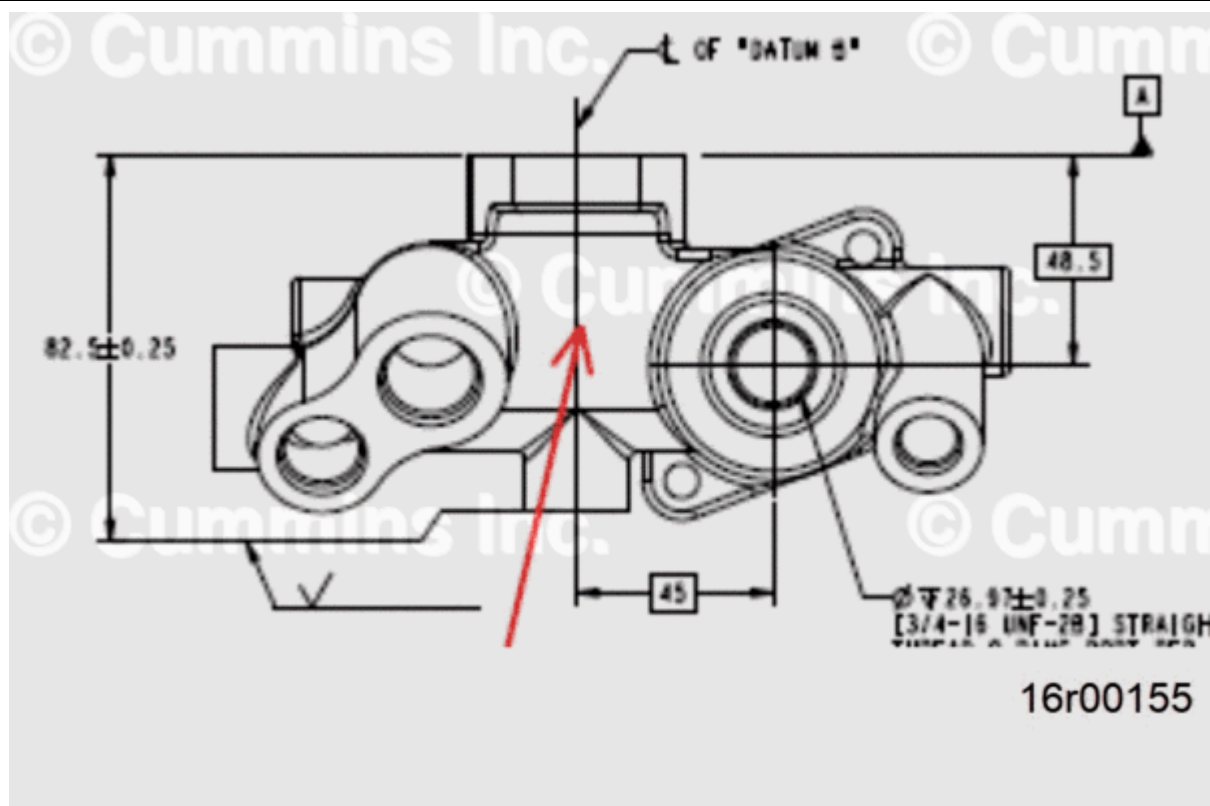
The new oil manifold is different in shape to the existing part, allowing the oil control solenoid to sit upside down. The new part number is stamped in the location shown in Figure 6 The existing part number is stamped exactly 180° opposite to this on the bottom face. Both part numbers are stamped on the face opposite to the solenoid when viewed as installed.

Figure 6, Part Number Stamping Location on New Fan Clutch Oil Manifold.
