Technical Service Bulletin: TSB240059

Repair Strategy for Fuel Lift Pump Relay and Wiring Harness: Fault Codes 583, 2265, 2266

- QST30 CM552

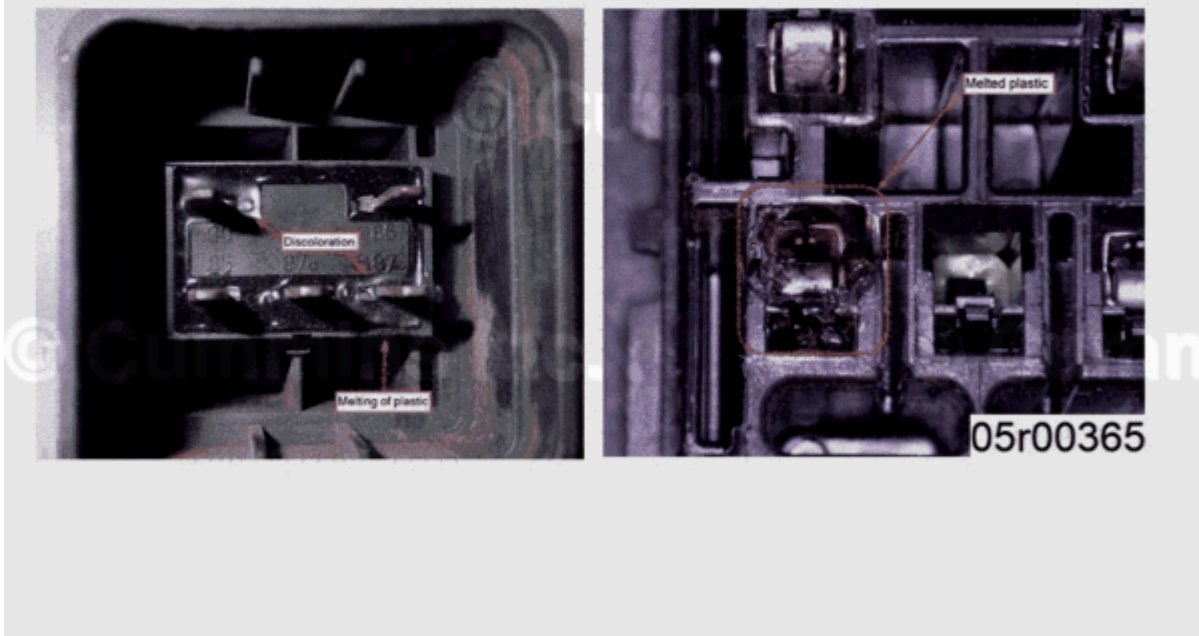
- Burned or malfunctioning fuel lift pump relay.
- Engine Difficult to Start or Will Not Start (No Exhaust Smoke)
- Potential fault codes:
  - 583
  - 2265
  - 2266

After following the published troubleshooting manual procedures, if a fuel lift pump relay is found to be dysfunctional, inspect the fuel lift pump relay and wiring harness connector for signs of heat damage, such as melted plastic.

Figure 1, Examples of Burned Fuel Lift Pump Relay and Wiring Harness Connector.

If any signs of heat damage are present on either the fuel lift pump relay and/or the wiring harness connector, replace both the fuel lift pump relay and wiring harness.
