Technical Service Bulletin: TSB250157

Turbocharger Speed Sensor and Crankshaft Position Sensor Update

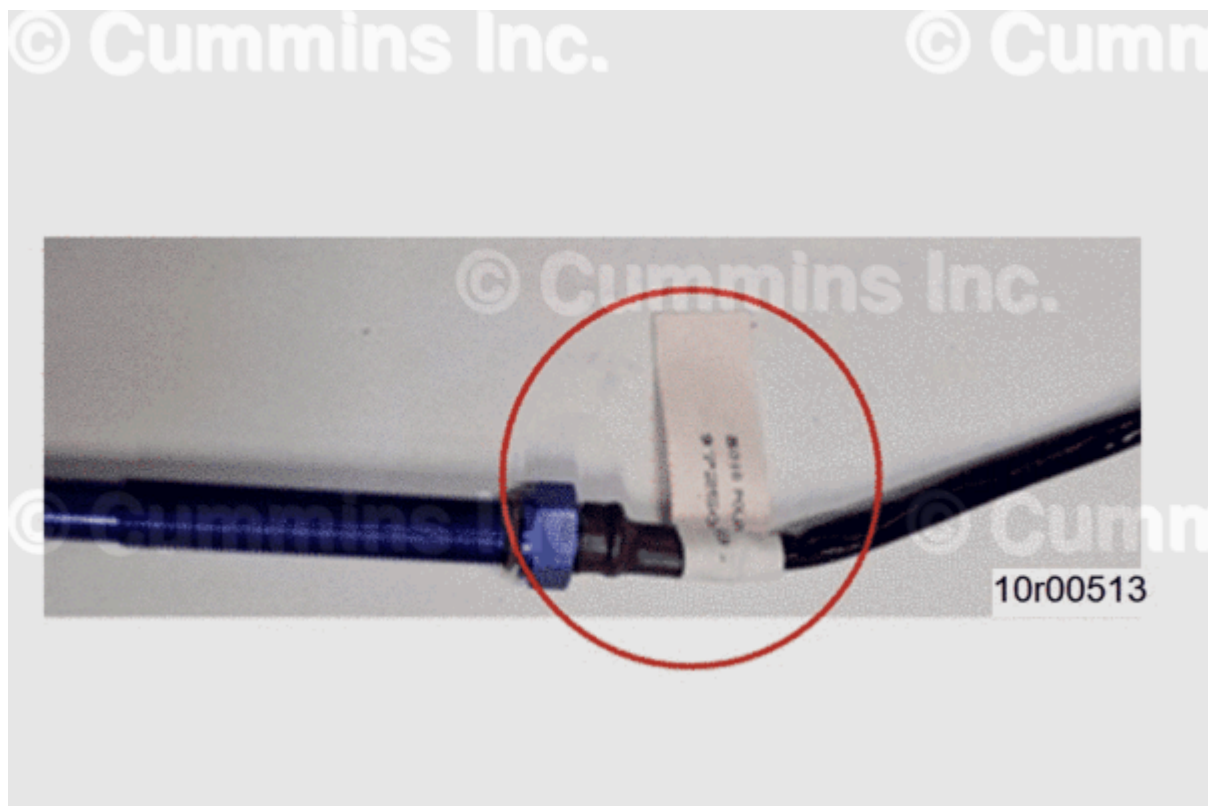
Figure 1, Crankshaft Position Sensor Date Code Location.

- The anodized aluminum material compromised the epoxy, creating a leak path for water ingress. This caused shorting of the internal electronics, resulting in sensor signal loss, electronic control module (ECM) fault codes, and engine shutdown.

- The change is documented on the sensor using the printed date code. Date codes as follows:
- Crankshaft position sensor part number, 5491808 - Date Code: 25062
- Turbocharger speed sensor part number, 5491809 - Date Code: 25230

- The anodizing layer on the inner side of the aluminum body of the turbocharger speed sensor and crankshaft position has been removed.
